# THE POSSIBLE INFLUENCE OF SOILS CONDITIONS ON EARTHQUAKE EFFECTS: A CASE STUDY

J. C. CASTANO<sup>1</sup>, J. L. ZAMARBIDE<sup>2</sup>, I. ARANGO<sup>3</sup> and M. A. BUFALIZA<sup>1</sup>

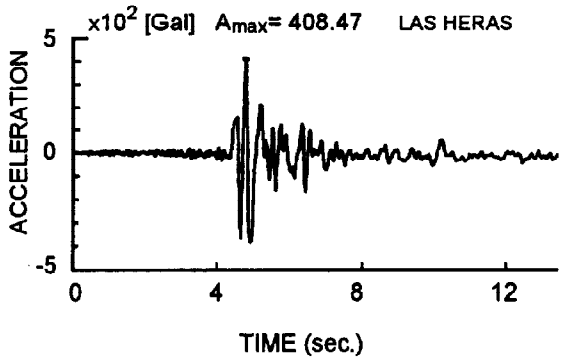
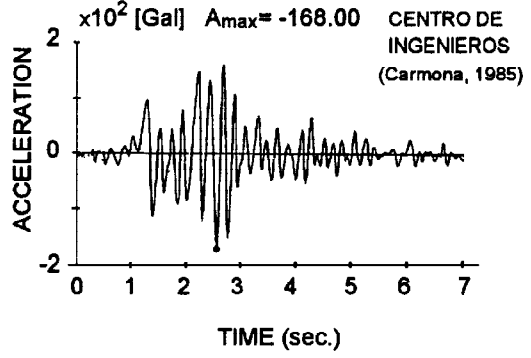
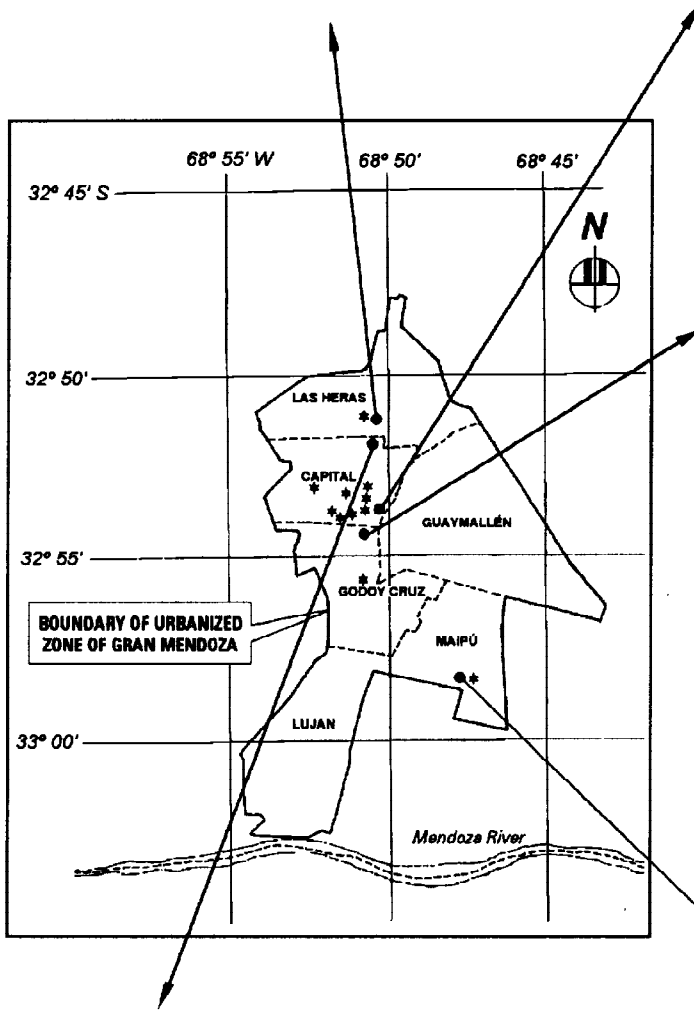
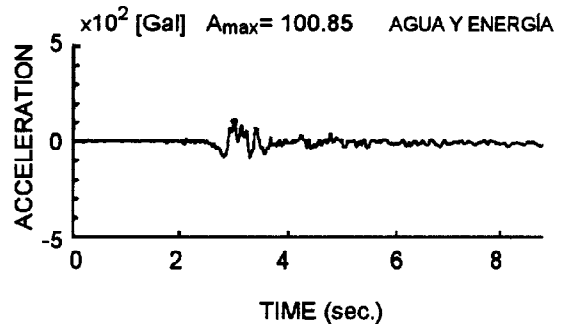
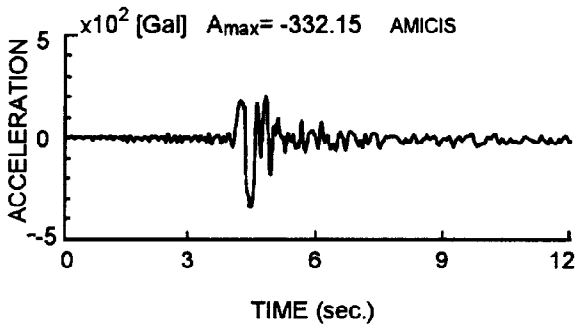
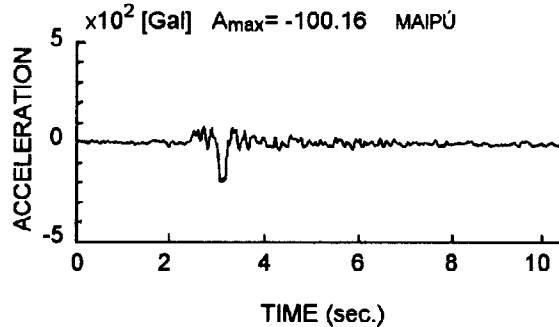
Several accelerographs recorded this event, five of them located within the Gran Mendoza area. Peak accelerations ranged from 100.0 to 408.5 gal. Although high values of peak acceleration were recorded, the duration of the significant portion of the records ( $a_{max} > 50$  gal) did not exceed 4 sec. (Fig. 1). In addition to this, several seismoscope records were obtained, from which the maximum seismic coefficients were computed.

Fig. 1. Strong motion instruments locations within the Gran Mendoza area and accelerograms of the January 26, 1985, Mendoza earthquake

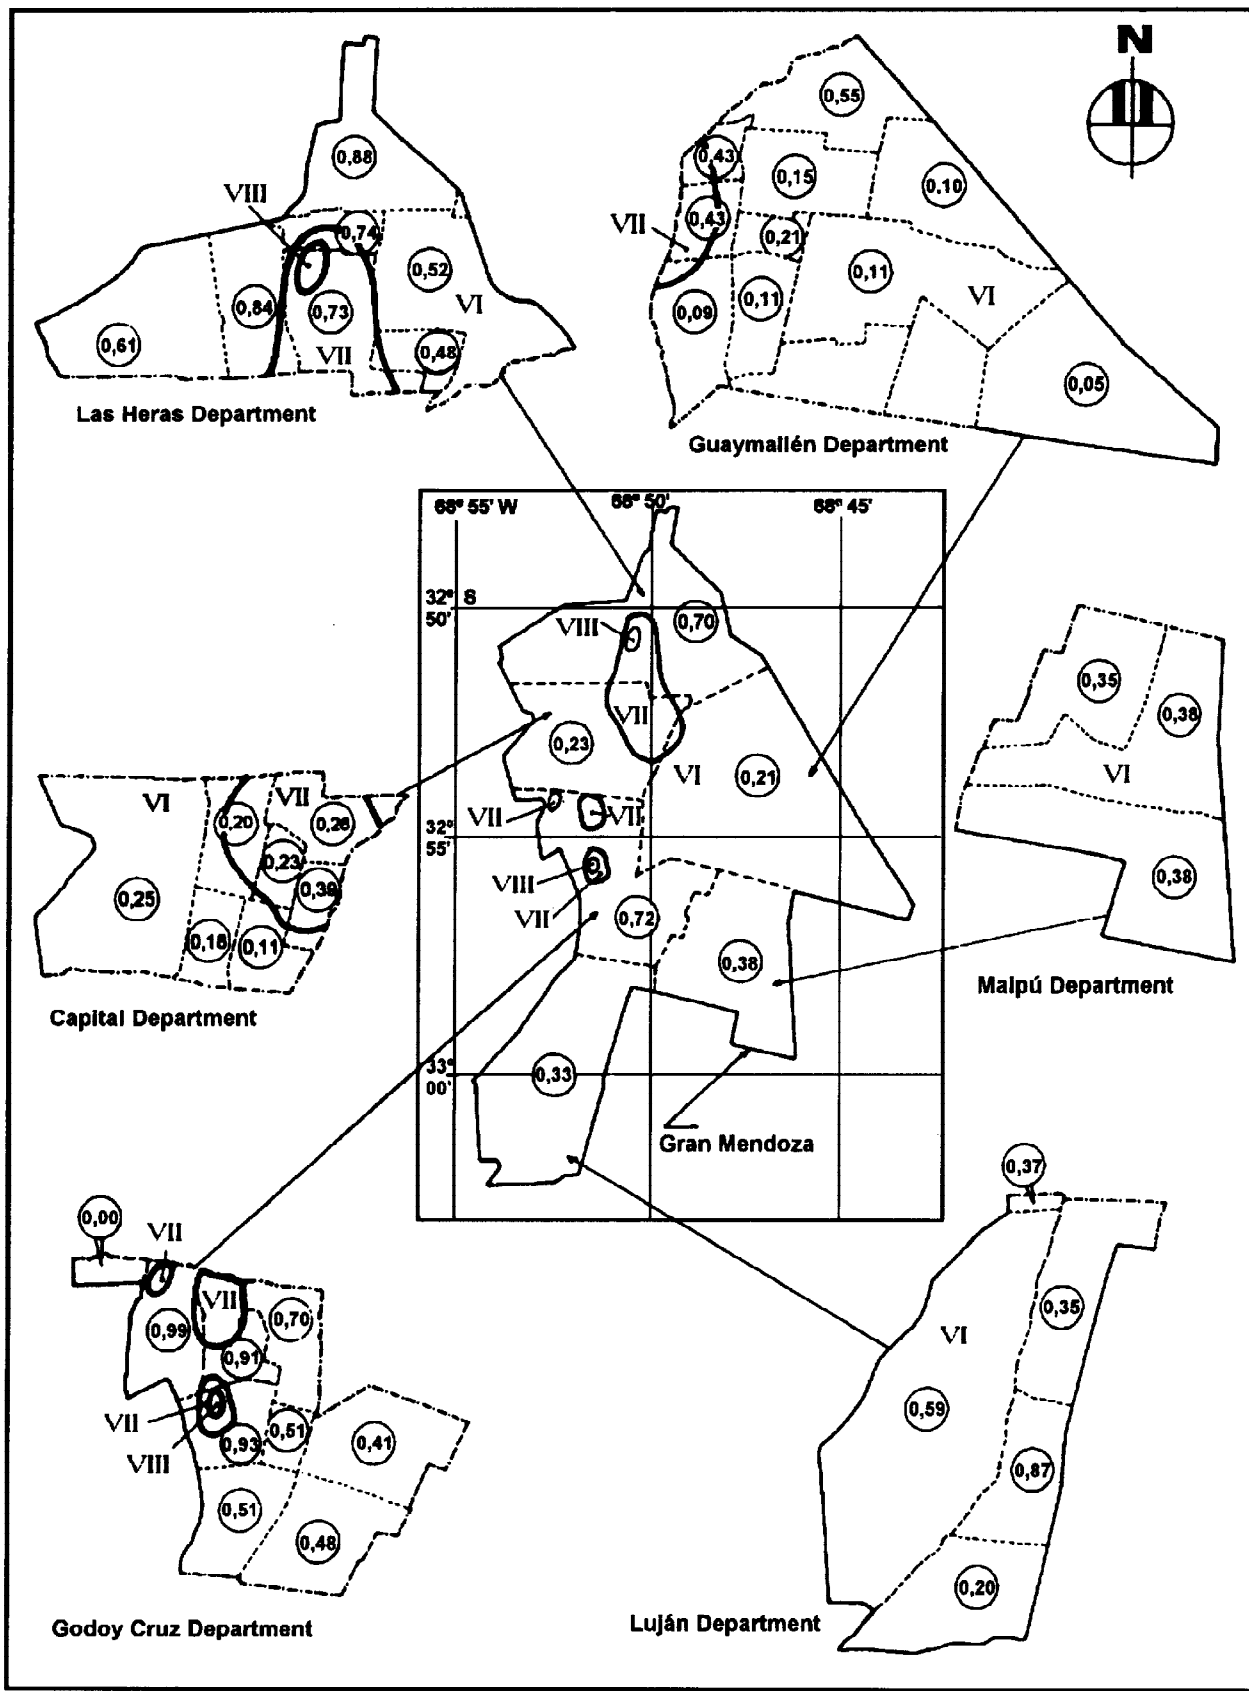
Extensive damage survey questionnaires were analyzed (over 36,000 of them) which show a rather non-uniform pattern of damage. It was assumed that damage to adobe buildings was representative of shaking intensity due to three reasons: the construction types existing in the area under study, the types of damage caused by the earthquake and the earthquake characteristics. Mixed constructions (adobe and bricks) were included in this category. A Damage Index (DI) defined as the number of adobe structures damaged (seriously or totally ruined) to the total number of adobe buildings in the area was calculated for different locations. In Fig. 2 average damage indices for each department of Gran Mendoza and isoseismal for the

Fig. 2. Damage indices and isoseismal curves for the January 26, 1985, Mendoza earthquake.

01-26-85 Mendoza earthquake are presented. Also are shown the damage indices for the different districts of each department. As can be seen, there is a good agreement between the intensity values obtained after quick observations done immediately after the earthquake and the damage indices determined through a detailed analysis of the damages surveyed case by case.

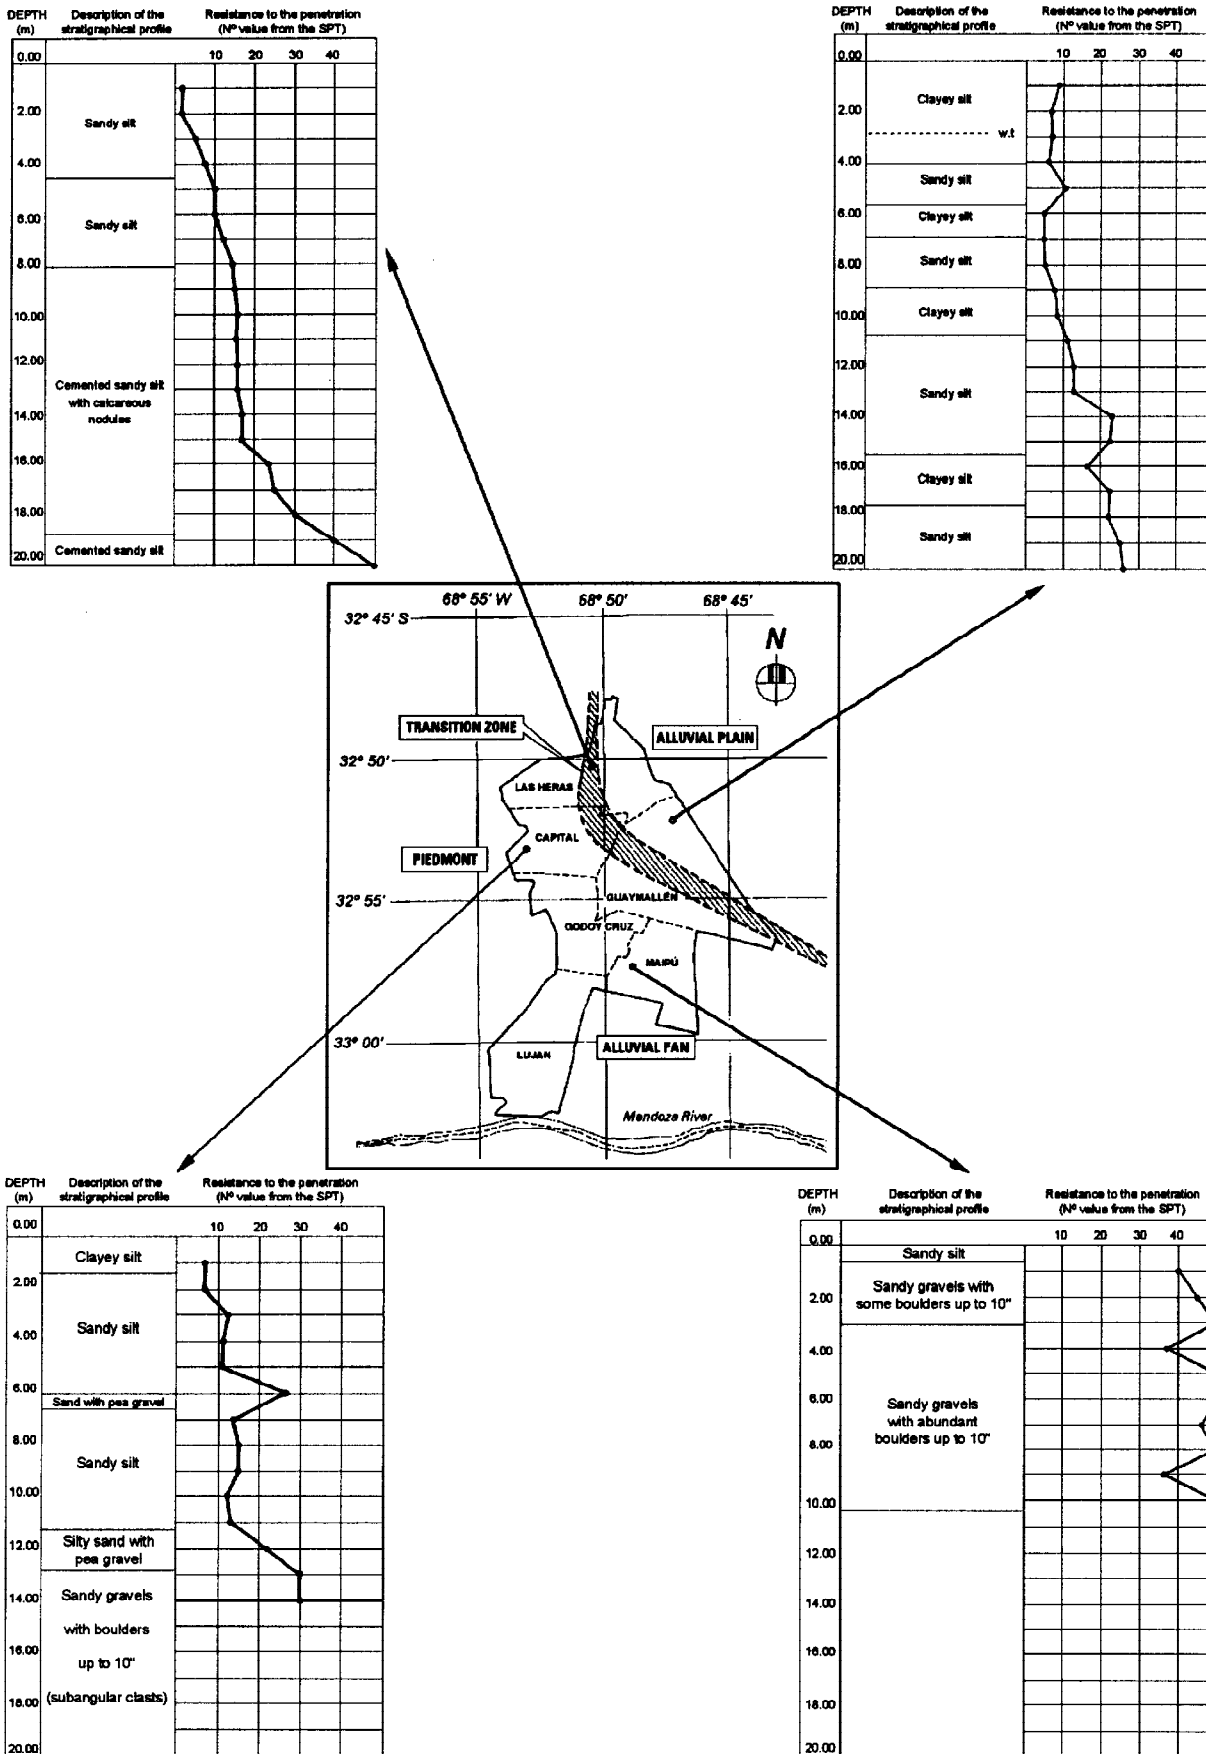
Results of standard penetration tests show, that in general, the alluvial sediments within the area vary in their compaction from dense to loose (Fig. 3), as described below:

- ° The coarse grained deposits of the Mendoza river alluvial fan, show medium degrees of compaction in the first 2 to 3 metres depth, and from these depths downward are dense to very dense. The same situation has been detected in the coarse granular sediments coming from the western Mendoza piedmont.
- ° The fine sediments, such as silts, sandy silts and clayed silts, which cover the pebbles, gravels and sands of the piedmont and the alluvial fan deposits with several thicknesses, show variable degrees of compaction, from very loose to medium.

Fig. 3. Distribution of the subsurface conditions within the Gran Mendoza area and some significant results from standard penetration tests.
