## **DAMAGE OF R/C RESIDENTIAL BUILDINGS IN THE 1995 HYOGOKEN-NANBU EARTHQUAKE**

TAIZO MATSUMORI and SHUNSUKE OTANI

Department of Architecture, School of Engineering, the University of Tokyo,  
7-3-1 Hongo, Bunkyo-ku, Tokyo 113, Japan

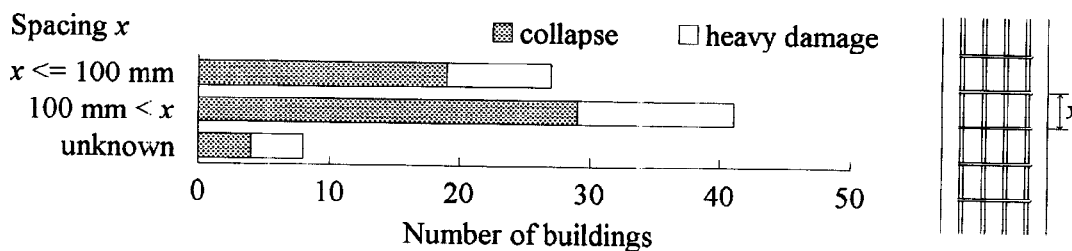
Fig. 6. Vertical spacing of lateral reinforcement

Of the 68 heavily damaged or collapsed buildings where the spacing of lateral reinforcement could be observed, the vertical spacing of lateral reinforcement exceeded 100 mm in 41 buildings (60 %); the vertical spacing of lateral reinforcement was 100 mm or less in 27 buildings (40 %). Statistics show that the quantitative requirement of lateral reinforcement was not sufficient to avoid shear failure of columns.

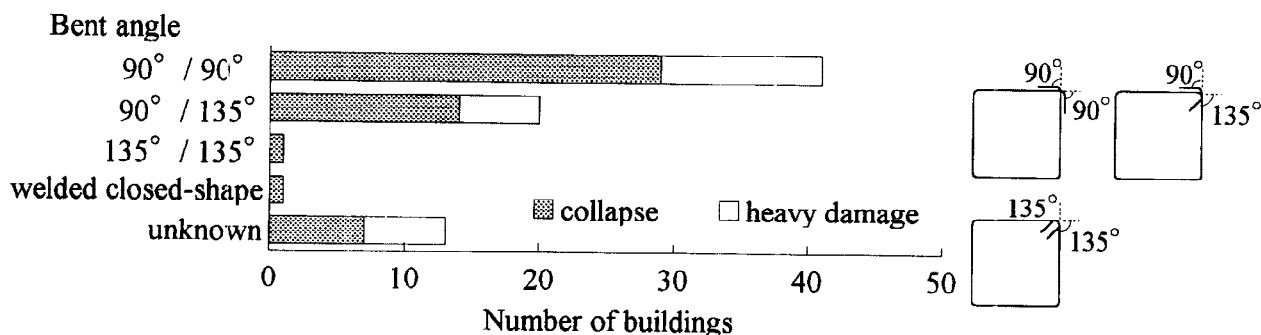
Fig. 7. Bent angle at ends of lateral reinforcement

Of the 63 heavily damaged or collapsed buildings where the ends of the lateral reinforcement in the columns could be observed, 135-degree hooks were found at both ends in one building; welded closed-shape reinforcement was used in one building; the lateral reinforcement was anchored with either both 90-degree hooks or 90-degree and 135-degree hooks at the two ends (Fig. 5(b)) in the other 61 buildings (97 %). Although R/C Standard has recommended the use of 135-degree hooks since 1933, the difficulty in construction did not permit such detailing in construction practice until special devices were developed for the 135-degree bending. The existing buildings are susceptible to the earthquake disaster due to the same inadequate lateral reinforcement workmanship. The importance of reinforcement detailing was reconfirmed.

In the building in which welded closed-shape reinforcement was used, the perimeter hoops were found not sufficient to confine the concrete after shear cracking; supplementary cross ties should be used in a region where large plastic deformation is expected. There was, however, one building in which the first-story columns failed in shear although both perimeter hoops and supplementary cross ties were used and well anchored by 135-deg hooks. Further research is needed to study the cause of the damage and to review the required story shear capacity of the soft first story.
