## A CASE STUDY ON THE COLLAPSE OF A 7-STORY SRC-BUILDING DUE TO THE 1995 HYOGOKEN-NANBU EARTHQUAKE

T. NAGAO, H. TAKAHASHI, K. NISHIKAWA and M. ARAI

A 7-story SRC building collapsed at the 4th story due to the 1995 Hyogoken-nanbu earthquake. A case study was performed using elasto-plastic dynamic response analyses in order to estimate why and how this type of failure has occurred. It can be said that it was the worst earthquake for this building in terms of spectrum shapes, input directions or intensity levels.

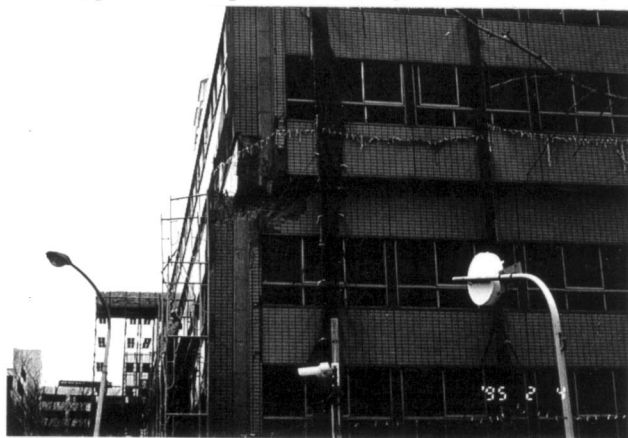
The 7-story SRC building shown in photo. 1 is an example of this type where earthquake damages were concentrated at the 4th story.

Photo. 1 Overall view of collapse

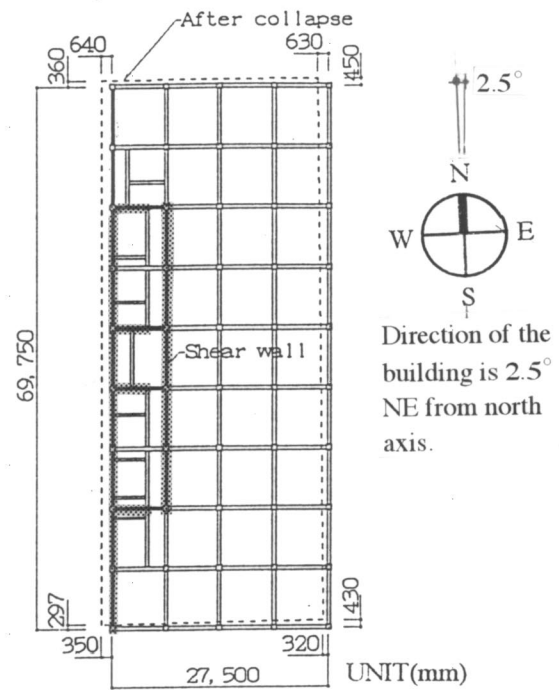
Fig. 2 4th floor plan of the building

The building failure was studied using field data; measurement of residual displacements, material strength tests, or observations of the collapse of each structural member. The structure above the 5th story rotated slightly and displaced maximum 640mm to the west and 450mm to the north as shown in fig. 2, and fell down from 240mm at the south-west corner to 1670mm at the north-east corner.

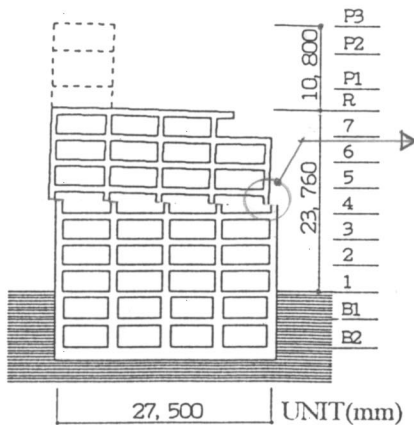
Fig. 3 Elevation of the frame collapse (E-W direction)

It was possible to determine that earthquake damages were concentrated at the top of the 4th story columns and shear walls just under the 5th floor beams, as shown in fig.3 and photo.2. On surfaces of the 5th floor beams and the 5th and 6th story columns, many shear and bending cracks or the falling off of concrete covering were observed, however the concrete failure did not develop within the shear reinforcement zone (the core zone). Other parts of the structure, especially members under the 3rd story, suffered less damages such as falling off of finishing mortars or diagonal crackings on wall surfaces. Results of material strength tests are shown in table 1, they clear the design values.

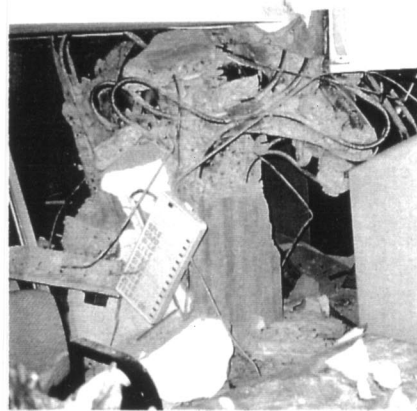
Photo. 2 Damage of the column top of the 4th story

A severe shear failure was observed at the top of all columns. Concrete failure was observed not only in the covering zone but in the core zone. Concrete was broken into small pieces (about 100mm in diameter), which indicated the effect of cyclic dynamic loadings. Some of the encased steels in the column were brittlely broken by tensile stress at the point of the rivet holes, due to that the reduction rate from a gross to an effective sectional area was large in such a small size steel. Longitudinal reinforcements buckled, and shear reinforcements were broken due to tensile stress. Although there were many shear and bending cracks at the surfaces of the bottom of the 4th story columns, cracks did not penetrate into the core zone.

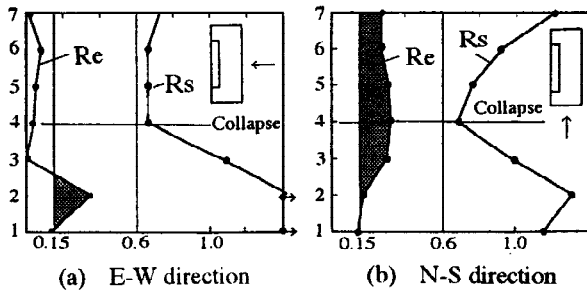
1) The distribution of  $R_s$  was not smooth, and was minimum at the 4th story. This is because the column sizes were abruptly decreased above the 4th story comparing to the 1st to 3rd stories.

Fig. 5 Distribution of stiffness ratio  $R_s$  and eccentricity ratio  $R_e$

The 4th to 6th stories have  $R_s$  close to the minimum recommended value (0.6) in the E-W direction. The earthquake response tends to concentrate to the middle stories, especially by the E-W direction loading.

2)  $R_e$  in the E-W direction (except for the 2nd story because of an eccentrical installation of rigid walls for a safety box of a banking business) satisfied the recommended value (0.15), however,  $R_e$  in the N-S direction are over the recommended value due to the eccentrical arrangement of shear walls. Therefore, torsional movements will occur when the building suffers the N-S direction loading.

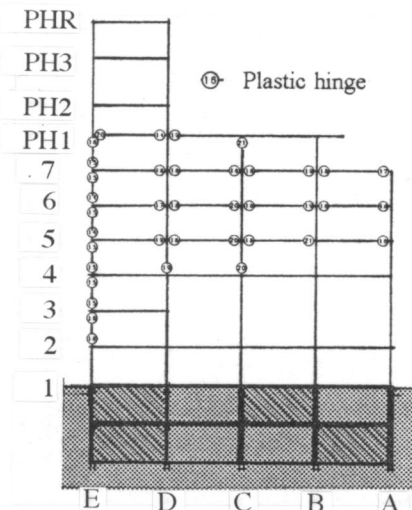
Figure 8 shows a plastic hinge pattern of a typical E-W direction frame. Many plastic hinges are observed at the beam ends (not at the top of the 4th story columns) above the 4th story, and exterior tension-side columns. These results predict that a collapse mechanism is a weak-beam type, however the real damage was a weak-column type.

One of the reasons is the assumption made in the analysis of SRC members that no shearing yield occurs prior to bending yield. The maximum load

Fig. 8 Plastic hinge pattern of a typical frame in the E-W direction

factor decreased to 2.65 in the E-W direction, when considering the shear yielding of the column according to AIJ recommendations\*<sup>1)</sup>, however the collapse mechanism does not change drastically. Therefore, another phenomena might have occurred: an effect of UD (up-down) component in the earthquake or a relative strength decreasing of column due to a 2-direction bending which was produced by the diagonal direction loading.

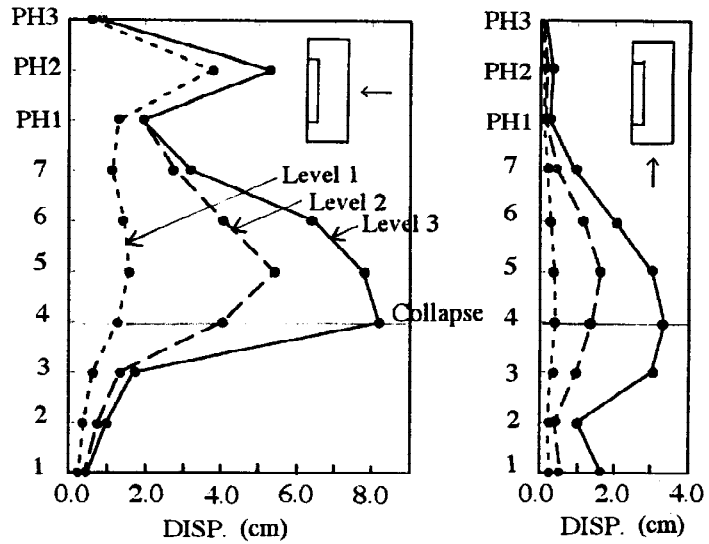
(a) E-W direction (b) N-S direction  
Fig. 11 Maximum inter-story displacement response

The maximum inter-story displacement responses concentrate at 4th and 5th stories especially in the E-W direction, as shown in fig.11. One and a half cycles of drift with more than 1/100 inter-story displacement angle occur at level 2 in the E-W direction, as shown in fig.12, which will be over the deformation capacity of the SRC column with less ductile composition.

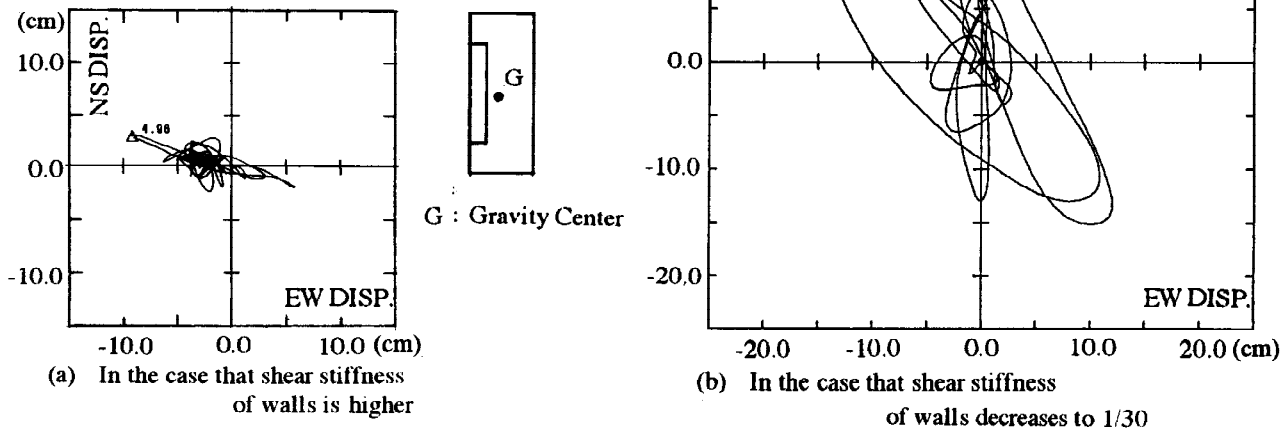
(a) In the case that shear stiffness of walls is higher (b) In the case that shear stiffness of walls decreases to 1/30  
Fig. 13 Orbit of the 4th story drift at the gravity center (at Level 3, time=0~15sec)

1) The building vibrated stronger towards the E-W direction (at level 3, the gravity center displaced max. 3.34cm NS and 8.18cm EW at 4.98sec), as shown in fig.13(a), which is consistent with the damaged direction of the building.

2) If the shear stiffness of walls decreases to 1/30 in the analyses, the building vibrates stronger towards the N-S direction (at level 3, a gravity center displaced max.22.6cm NS and 14.7cm EW at 5.12sec), as shown in fig.13(b), which is consistent with the strongest direction of JMA KOBE.
