## **PERFORMANCE OF RETROFITTED UNREINFORCED MASONRY BUILDINGS**

**BRIAN E. KEHOE**

Wiss, Janney, Elstner Associates, Inc.  
Emeryville, California U.S.A.

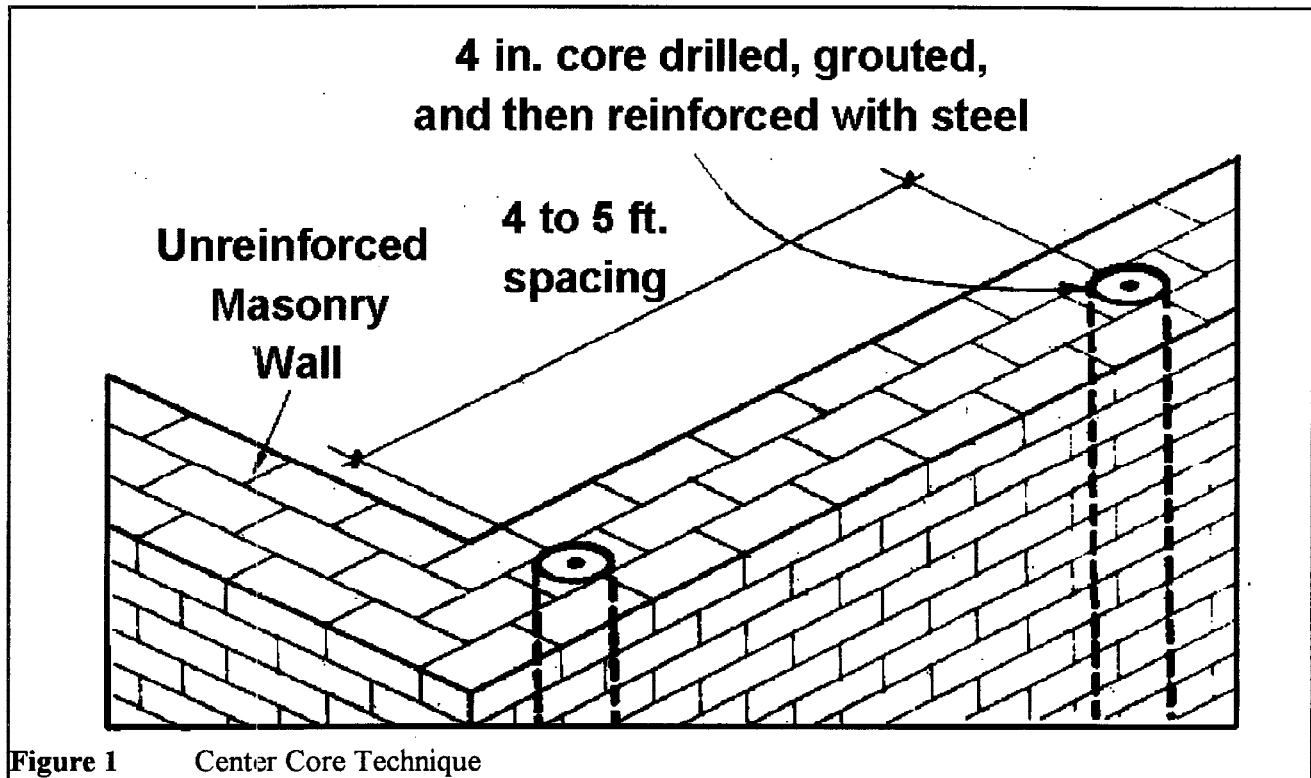
Figure 1 Center Core Technique

Two buildings in the area that experienced strong ground shaking had been rehabilitated using the center core technique were surveyed. In this technique, a core is drilled down through the center of the exterior walls. The coring is spaced regularly along the exterior walls. Reinforcing is placed into the core holes and then the holes are filled with epoxy grout, as shown in Fig. 1. The purpose of the techniques is to provide

out-of-plane strength for the wall without the visual appearance of a new pilaster or strongback. The grouting and reinforcing also provide an increase in the in-plane strength of the wall.

The buildings rehabilitated with the center core technique sustained less damage than other URM buildings located nearby. Both of the buildings strengthened using the center core technique were found to have damage to the exterior walls. The damage included diagonal cracking and falling bricks. The center core technique does not provide anchorage to all of the bricks in the wall, since the core is done at regular spacing along the length of the wall. The damage occurred between the strengthened cores.

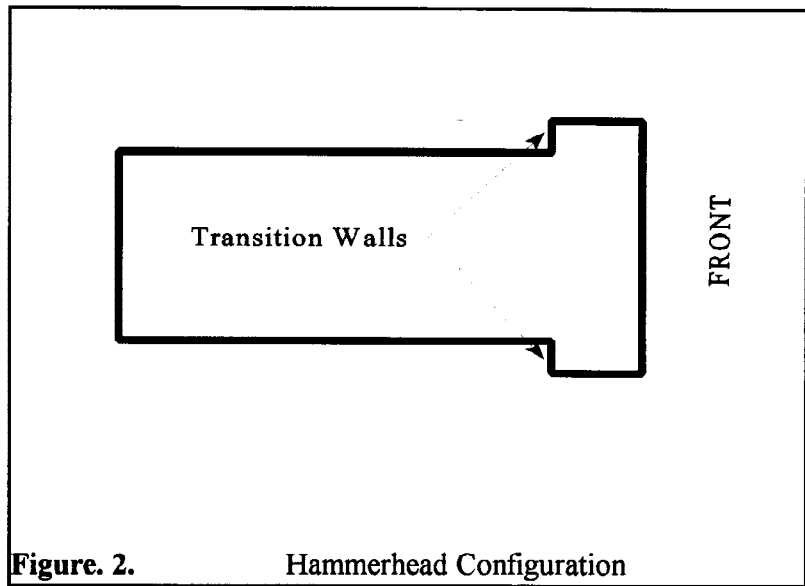
Buildings with configuration problems experienced increased damage. Many apartment buildings in the Los Angeles area are T-shaped in plan, with small projecting ends at the front of the building, as shown in Fig 2. This is referred to as a hammerhead configuration. All of the buildings surveyed with this configuration experienced damage to the small transition wall where the building gets wider.

There are two factors that contribute to this type of damage. One factor is that the transition walls typically have window openings and low dead load compression stresses. This reduces the shear strength of these walls. The other factor is the difference in relative rigidity between the side walls of the front wings and the side walls of the remainder of the building. This causes twisting of the diaphragm in the wings that causes distortion of the transition walls.

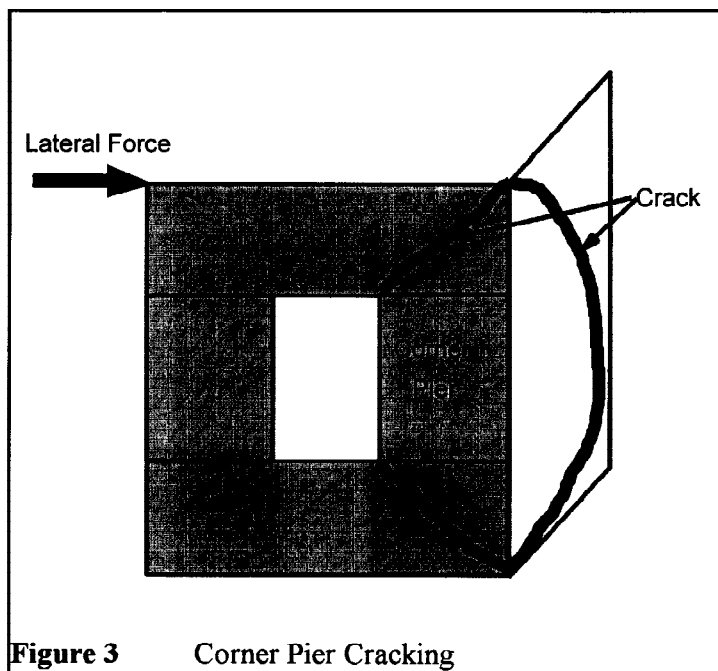
**Figure 3** Corner Pier Cracking

The typical strengthening methods did not prevent damage at the corners of the buildings. Many of the unreinforced masonry buildings that were damaged experienced cracking of the masonry walls at the corners of the building. This usually occurred between a window or door opening and the corner at the top story. In these cases a diagonal crack usually initiates from the top corner of the window to the corner before the end pier can rock, as shown in Fig. 3. In some cases, large portions of the corner fell off of the building.

The rocking block methodology does not appear to adequately address the conditions at the upper story corner piers. For the pier to rock, the lateral force produces a moment at the top of the pier. This moment is resisted by moments in the spandrels on either side of the pier. When the flexural strength of the pier is small compared to the strength of the spandrels, a flexural crack will occur at the top of the pier. Since the pier is unreinforced, the maximum shear force that can be transferred to the pier will have been reached and

a shear crack will not develop in the pier. The dead load on the pier increases the cracking strength, since the dead load stress in the pier must be overcome to develop a net tension in the masonry of the pier. The dead load also helps to provide stability to the block while it rocks.

One of the typical problems observed was cracking at the top corners of the building. Review of the statics at these joints indicates that the corner pier do not always follow the rocking block concept. The flexural strength of the pier can be limited by introducing a saw cut or other artificial joint across the width of the pier. Alternately, the shear strength of the joint at the top corner can be increased by reinforcing the joint with rebar or with concrete applied to the inside of the joint.

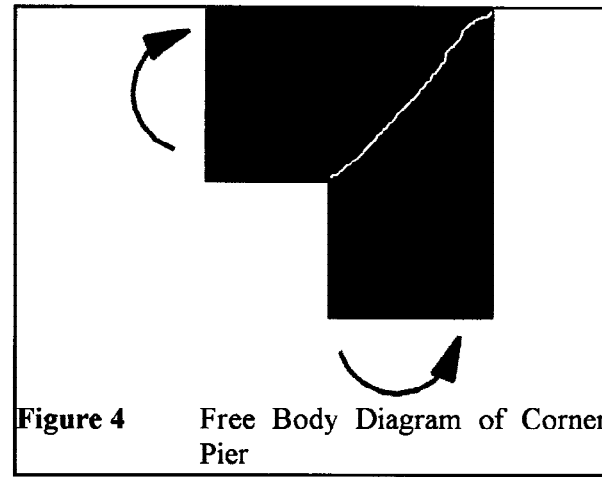
Figure 4 Free Body Diagram of Corner Pier

In the typical areas of most buildings the depth of the spandrel is usually deeper than the width of the pier. Therefore, the moment at the joint will crack the top of the pier. At the top corners of the building, there are three conditions that prevent this theory from working. First, the moment at the top of the pier is resisted by only one spandrel beam. Second, the moment capacity of the pier is enhanced by the masonry around the corner of the wall. Third, at the top of the building, there is little dead load on the pier that needs to be overcome to produce a net tension - and thus cracking - due to the moment. These factors produce a condition where the rocking block cannot occur. A free body diagram at the unreinforced joint at the top corner demonstrates that a diagonal crack will develop, as shown in Fig. 4.

The moment in the pier is resisted by a moment in the spandrel. These moments create diagonal tension through the joint. The strength of the joint to resist the diagonal tension controls the strength at the corner. Without additional strengthening, the joint develops a crack, which can then propagate around the corner of the building.
