PERFORMANCE ANALYSIS OF A DAMAGED 11 STORY STEEL MOMENT FRAME BUILDING DURING THE 1994 NORTHRIDGE EARTHQUAKE

FARZAD NAEIM

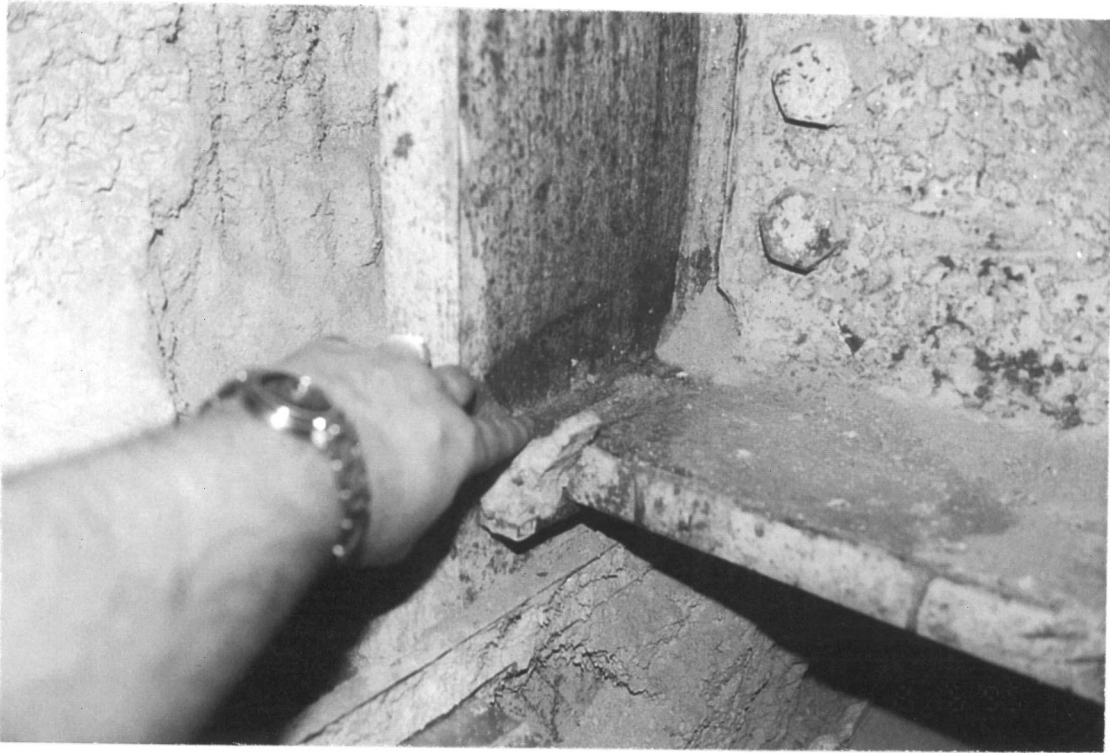
What is particularly interesting about this building is the extent of damage suffered by columns either in the form of torn flange nuggets or complete tearing of the column flanges (Figures 3 and 4). It was the discovery of the extent of column damage which caused inspecting structural engineers to recommend that the building be evacuated. Damage designations as defined by SAC Task 2 were used to identify damage types. The extent of connection damage seriously undermines overall frame integrity at some floors. For at Frame on line "C", all columns oriented in major direction (column lines 3, 4 and 6) have suffered some form of flange damage. Also at levels 10 and 11, two of the three columns show flange damage and one column shows damage propagated to the column web. While damage is spread throughout the height and in both horizontal directions, there is more damage in the upper floors in the North-South direction where the number of bays resisting lateral loads is generally smaller. The density of damage is also high in the connections around the ramp beams.

Figure 3. Beam-column connection damage.

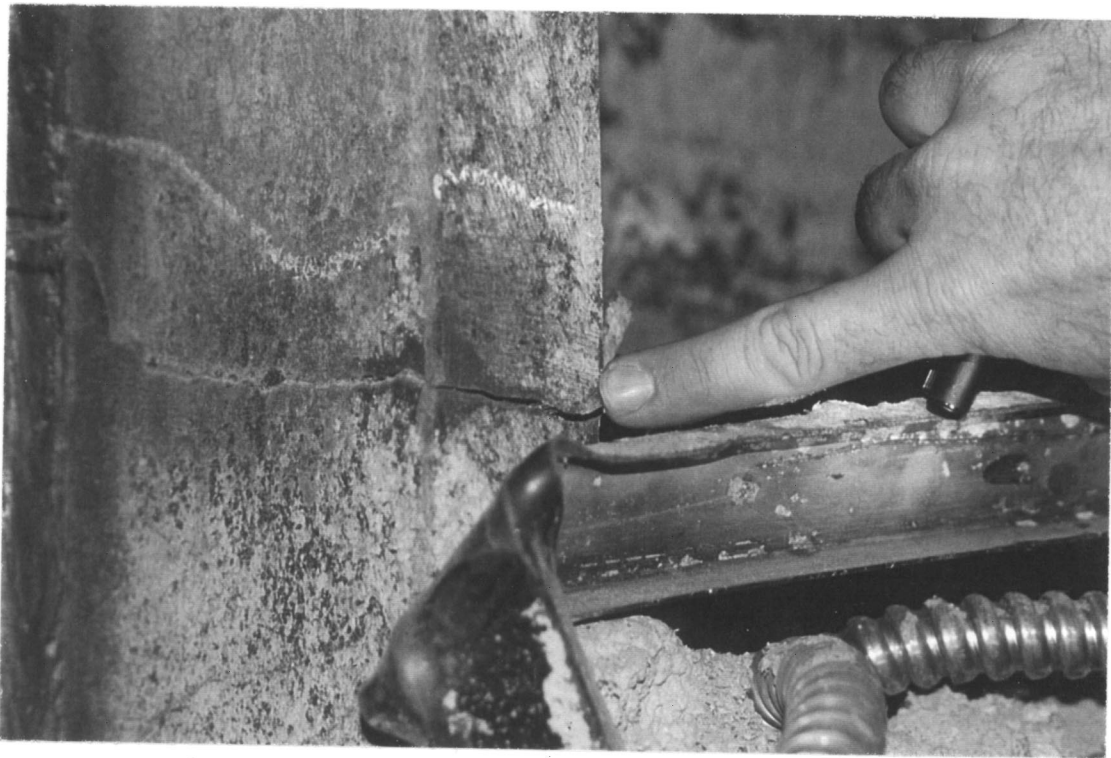
Figure 4. Beam-column connection damage.
