EVALUATION OF THE SEISMIC PERFORMANCE OF AN OLD MASONRY BUILDING IN LISBON

M.S. LOPES

Instituto Superior Técnico, Departamento de Engenharia Civil, Av. Rovisco Pais 1, 1000 Lisboa, Portugal

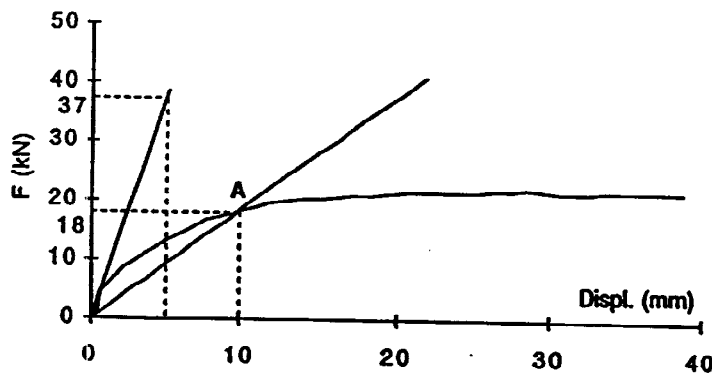
Fig. 6 Test of the facade. Relationship force versus average of top displacements

$$K = \frac{F_A}{\text{Displ}_A} = \frac{18\text{kN}}{10\text{mm}} = 1.8\text{kN} / \text{mm}$$

This value is more than 4 times less than the initial stiffness which is approximately:

$$K_{\text{initial}} = \frac{37\text{kN}}{5\text{mm}} = 7.4\text{kN} / \text{mm}$$

To assess the seismic performance of the building under earthquake loading the value of the acting forces in the elements of the facade tested must be compared with the respective strength. The measured strength of the part of the facade tested can be taken from fig. 6 and is $V_{rd} = 22 \text{ kN}$. The acting shear force on this elements is

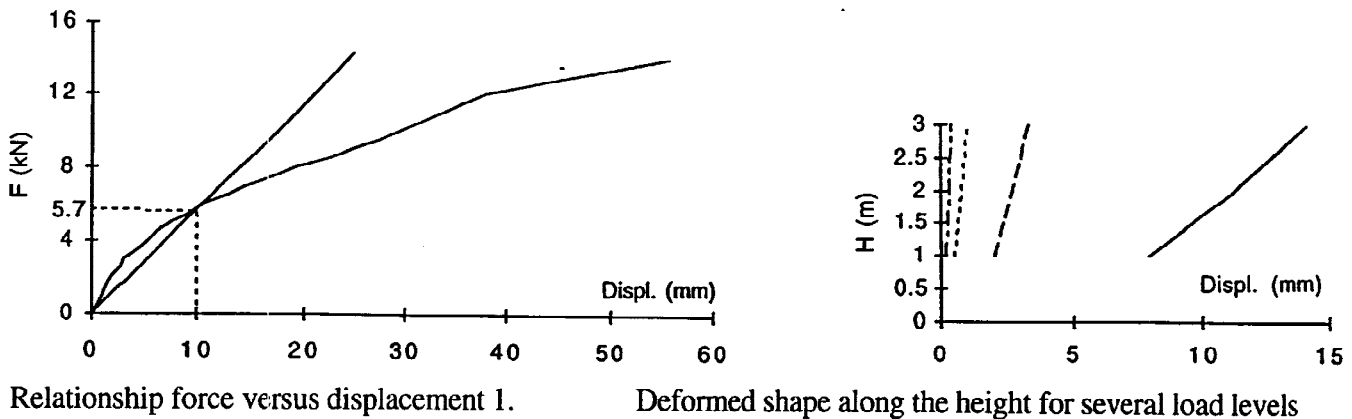
Fig. 8 Test 3 on the interior wood bearing wall.

The mechanical properties of the interior wood bearing walls and the staircase were calibrated by the same method as for the facade. From test 2, performed on a interior bearing wall the experimental stiffness of $K = 570 \text{ kN/m}$ can be obtained (fig. 8). Figure 8 also shows the deformation of this wall along the height, for several load levels.

The fig. indicates that the predominant deformation mode is a shear or a rigid body rotation around the base. In either case the overall behaviour can be simulated by a cantilever with shear deformation only. For a shear cantilever with the dimensions of the element tested (shown in fig. 3) to have the experimentally measured stiffness its shear modulus should be $G=8860\text{kN/m}^2$. However, the tested panel was free at the top what would not be the real situation. This means that if the predominant deformation mode was the rotation at the top and bottom connections, the stiffness could be higher. Therefore, a value of G for the wood panels 4 times higher was also considered and both cases were analysed. The staircase was also considered to have only shear deformation. The experimentally measured stiffness was $K = 300 \text{ kN/m}$, as shown in fig. 9. The corresponding analytical value for G is 4300 kN/m^2 .
