## BEHAVIOR OF LARGE STEEL BEAM-COLUMN CONNECTIONS

Egor P. POPOV and Marcial BLONDET

### ABSTRACT

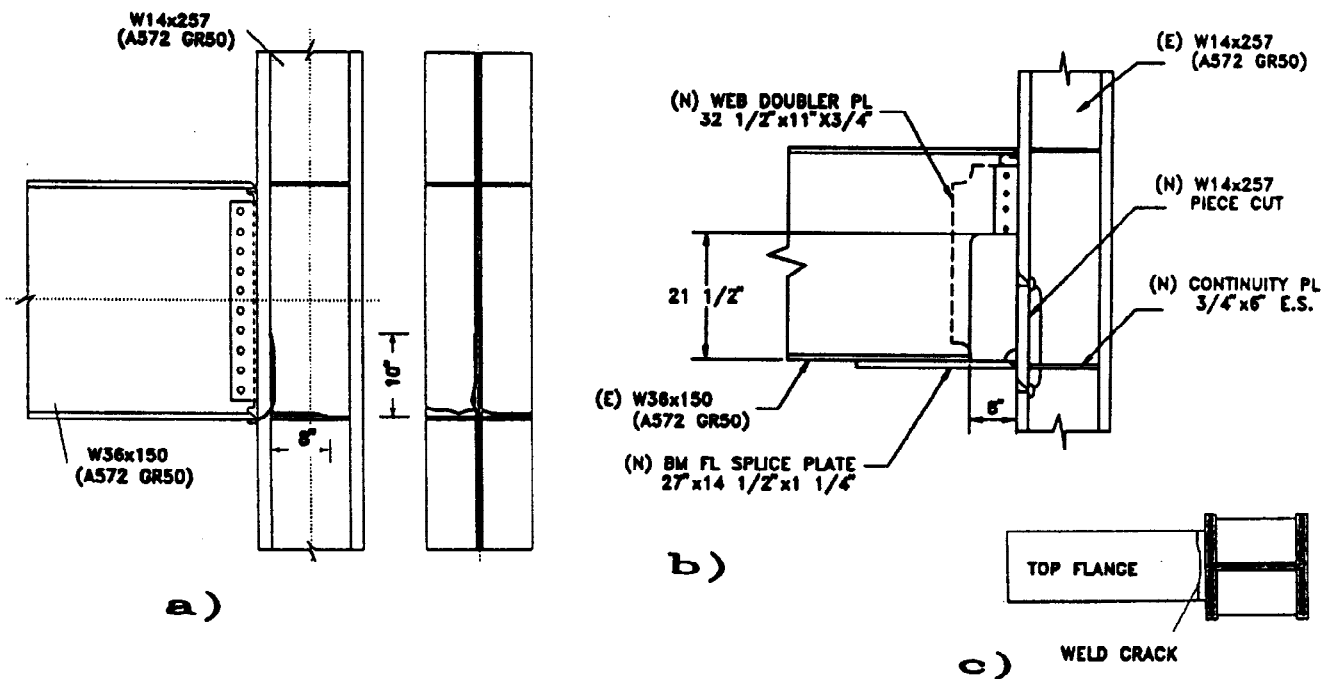
Fig 4. Specimen 1 -- Damage, repair, and damage of repaired connection

the second 3-inch load cycle. The failure load and displacement were 206 kips and 1.62 inches, respectively. One of the column flanges fractured completely, and the crack propagated into the column web, as illustrated in Fig. 4a. This mode of failure was unexpected; analysis predicted failure in the A36 steel beam. Some investigation revealed that the beam was built from Grade 50 steel instead of A36. This error was, in a way, fortunate, because this was the first test where this type of column failure, observed during the Northridge earthquake, was reproduced in the laboratory.

The specimen, now labeled RN1, was retested. Nonlinear response started with the 2-inch cycles. During the 3-inch sequence, significant spalling of the white-wash was observed at the top beam flange and bottom splice plate, at the back column flange, and in the panel zone. RN1 sustained the positive excursion of the first 4-inch cycle with a peak load of 260 kips and 3.54 inch displacement. The specimen failed during the negative excursion of that cycle with a complete fracture of the top flange weld, as shown in Fig. 4c.

The repair procedure consisted of removing the cracked portions of the column flange and web, and welding a new piece made of a Gr. 50, W14 x 257 section. A beam flange splice plate was used to reconnect the beam bottom flange to the repaired column flange and new continuity plates were provided. A beam web doubler plate was welded to the column flange and beam web on the side opposite to the shear tab. Fig. 4b shows a sketch of the repair scheme.

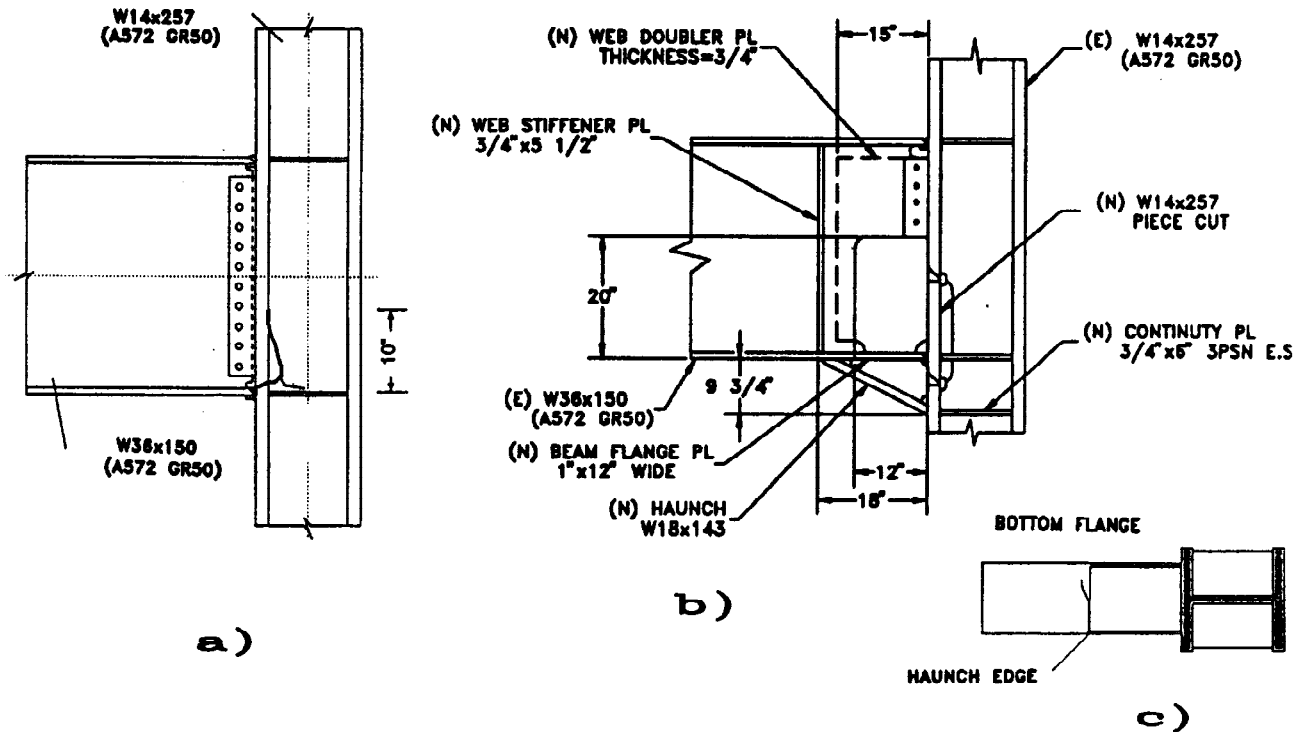
Fig. 5. Specimen 2 -- Damage, repair, and damage of repaired connection

As with PN1, nonlinear response started during the 2-inch cycles. Spalling of the white-wash indicated significant yielding in the panel zone. PN2 failed suddenly during the first leg of the second 2-inch load cycle at 195 kips load and 1.57 inch displacement. The cracking pattern is sketched in Fig. 5a. Cracking started in the beam bottom flange weld, continued diagonally through the column flange, and entered the panel zone, where it extended upwards along the column flange. This column failure was also due to having the beam mistakenly constructed with Grade 50 steel instead of the specified A36 steel.

The repaired and retrofitted specimen, RN2, was able to sustain load up to the 4-inch cycles. First spalling of the white-wash was noted on the bottom beam flange, near the haunch, at the beginning of the 2-inch cycles. Yielding occurred later in the beam top flange, in the column back flange, and in the panel zone. The specimen failed during the first excursion of the first 5-inch cycle. A crack started at the edge of the beam bottom flange between the haunch end and beam stiffener and propagated along the haunch edge up to the beam web, where it branched in two, as shown in Fig. 5c.

Since PN1 and PN2 had similar column failure modes, it was decided to incorporate an improved retrofit scheme by adding a haunch. Damaged portions of the beam and column were removed and replaced with new Grade 50 material. A new A36 plate was used to reconnect the beam bottom flange, and a beam web doubler plate was welded to the column and beam. A tapered haunch made of Grade 50 plate was placed underneath the beam bottom flange. Stiffeners were added to the beam and the column. Figure 5b

summarizes the repair procedure. The haunch and stiffeners were initially fabricated and installed with wrong dimensions and it was necessary to remove them and fabricate and install new material.

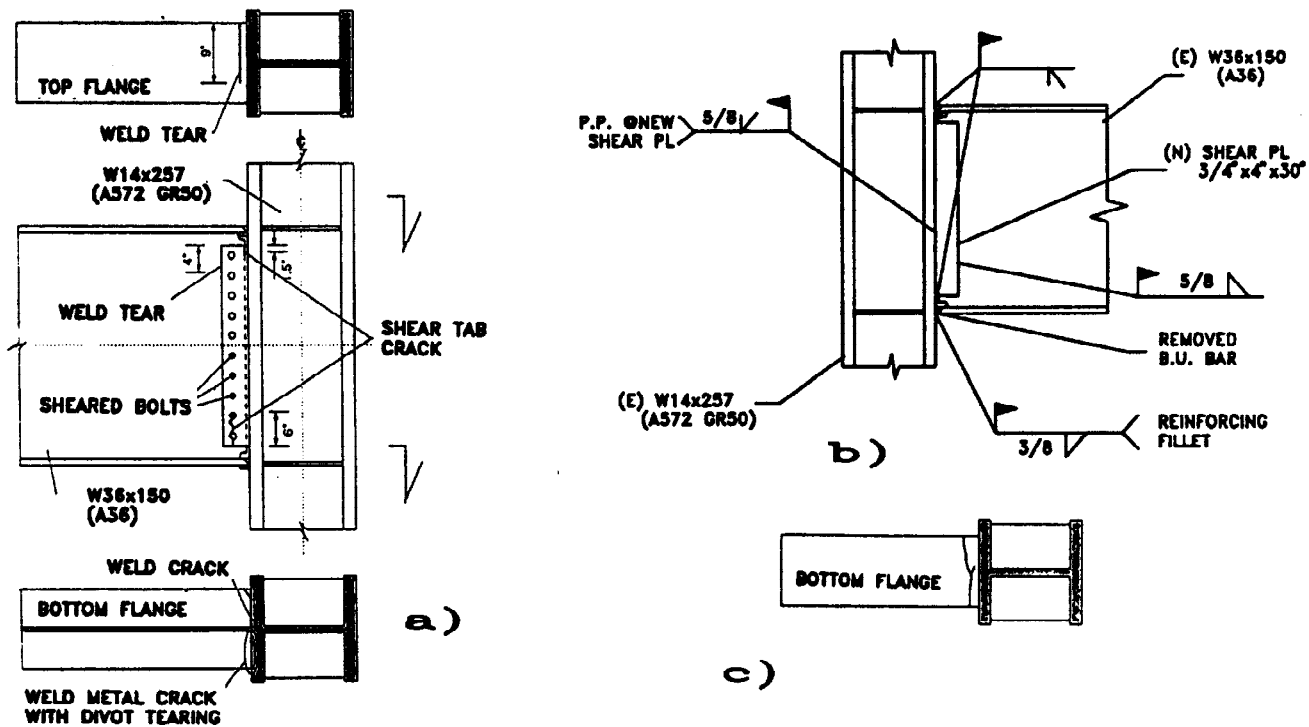
Fig 6. Specimen 3 -- Damage, repair, and damage of repaired connection

PN3 held up to the first 3-inch cycle. Yielding was significant on the beam flanges. The maximum force was equal to 190 kips and the beam end displacement reached during this cycle was 2.67 inches. The specimen failed during the first leg of the second 3-inch load cycle. The bottom beam flange cracked through the weld. Later, some bolts sheared off and the shear tab broke. Loading was continued to finish the cycle. During the negative excursion of the cycle, the beam top flange cracked through approximately 3/4 of its width. This type of beam fracture was expected for all three PN specimens, and occurred only with PN3 which beam was constructed from the correct material, A36 steel. The failure of the specimen is illustrated in Fig. 6a.

The repaired specimen, RN3, withstood up to the first 4-inch cycle. Yielding started during the first 2-inch cycle on the beam flanges and on the beam web. After completion of the first 4-inch cycle considerable white-wash spalling could be observed on both beam flanges and beam web and in the panel zone area. The maximum force was equal to 225 kips at the beam end displacement of 3.60 inches. The specimen failed during the first excursion of the second 4-inch cycle at 196 kips load and 1.48 inch beam end displacement. First crack started at the edge of the beam bottom flange and propagated through the entire flange with a short branch near the flange axis, as shown in Fig. 6c.

The repair of PN3 was achieved by gouging out the cracked welds and placing new complete penetration welds at both flanges. All remaining bolts and the cracked shear plate were removed. A new shear plate was welded on the opposite side from the removed old one. Figure 6b shows the repair details.

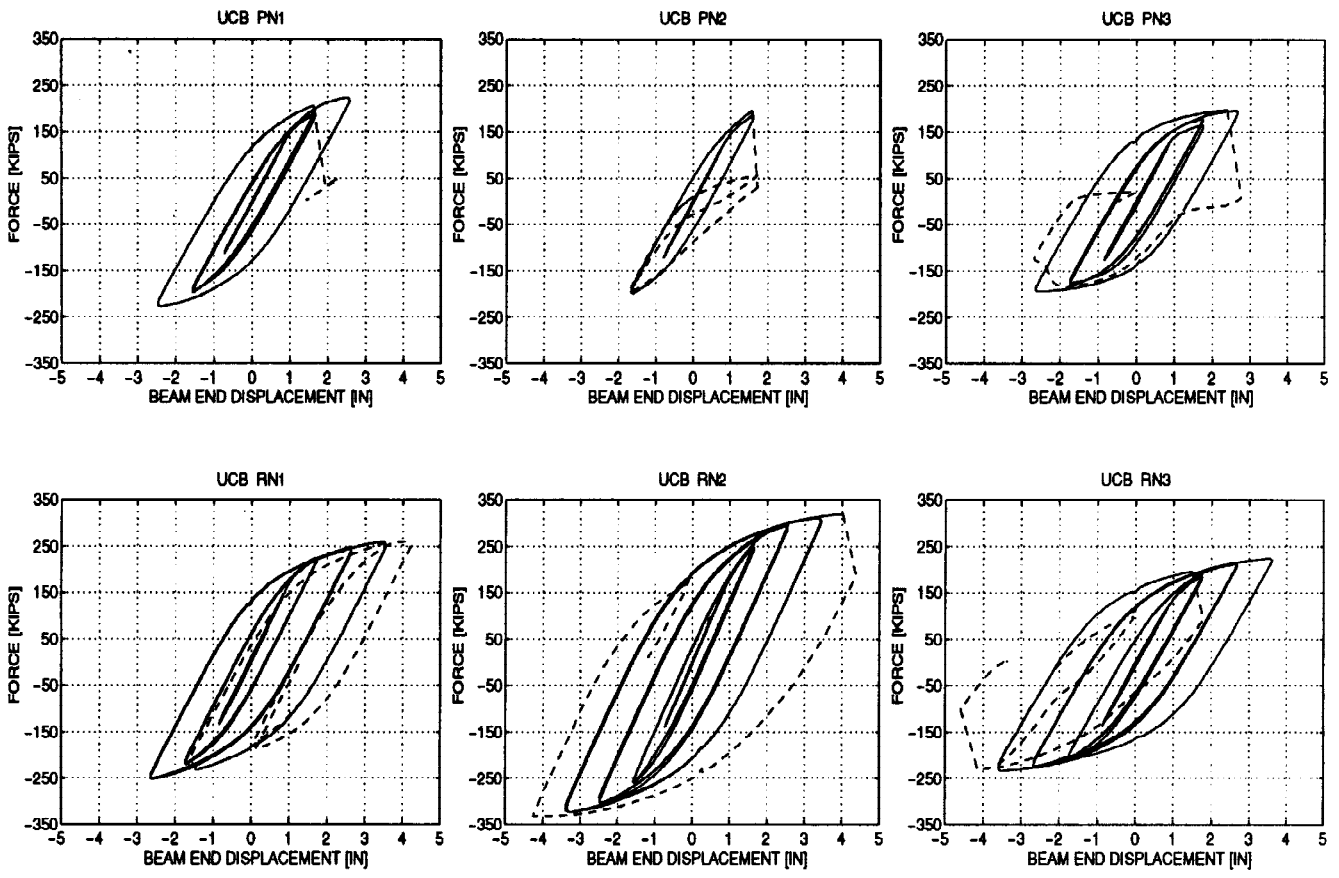
**Fig. 7. Applied Load vs. Beam End Displacement**

The hysteretic response of the specimens can be visualized in Figs. 7 and 8, which provide force versus beam end displacement plots and moment at column face versus plastic rotation plots, respectively. The response of the repaired specimens is shown in the second row.

Clearly, the repair techniques evaluated were successful, in the sense that the repaired specimens were stronger and had significantly better energy dissipation characteristics than the Pre-Northridge connections. The most dramatic improvement was obtained for specimen PN2, which was retrofitted with a haunch. RN1 and RN2 were also stiffer than PN1 and PN2 due to the beam/column joint repair. The reweld repair used for PN3 produced a somewhat softer specimen, with improved strength and ductility. It is important to note, however, that the failure mode of all three repaired specimens was abrupt and without previous warning.
