TESTING OF DAMAGED STEEL MOMENT CONNECTIONS

ABSTRACT

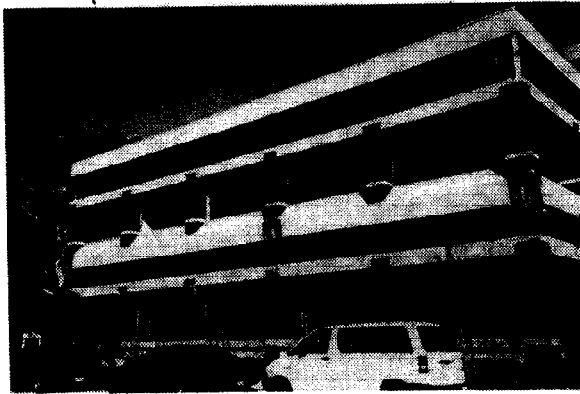
Fig. 1 Two Story Building

The building, shown in Fig. 1, is a two-story office building which was constructed in 1991 and is located about thirteen miles north of the epicenter. Lateral resistance was provided by single bay, ductile steel moment frames on each of the four sides of the approximately square structure. Following the earthquake, it was immediately "red tagged" as being unsafe for occupancy. Field observations indicated that it was out of plumb by four inches to the south and west with three inches of this displacement occurring in the first story. In order to inspect the moment connections, it was necessary to remove the architectural finish on the exterior of the building. Once this was done it was found that nearly all of these connections at the second floor level had major cracks which appeared to start in the weld at the lower beam flange and extend through the adjacent column flange and in many cases into the column panel zone as shown in Fig. 2.

A detailed cost analysis indicated that the estimated cost for the repair of the existing building would be nearly 72% of the replacement cost. Therefore, the owner elected to build a new structure having the same plan as the existing building but incorporating a new facade and a strengthened lateral force system. The decision to replace the existing building presented a unique opportunity to obtain cracked steel connection specimens from a damaged building and take them to the laboratory for additional testing under controlled conditions. Four tee shaped, exterior connection specimens were obtained from two of the moment frames.

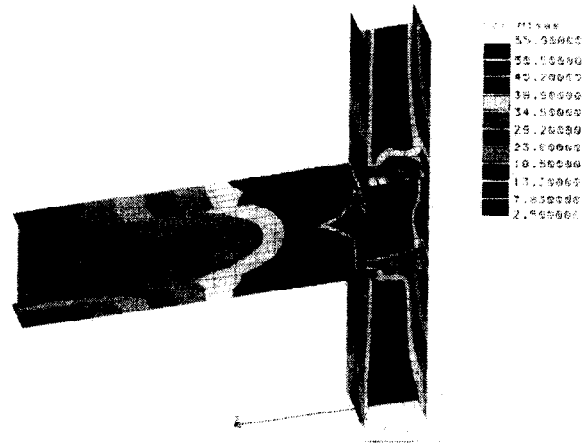
Fig. 4. FEM, Stress Contours

A typical finite element model for a standard connection with continuity plates has 1604 nodes and 967 plate elements. Calculations were done on a Hewlett Packard LM 5/60 computer with a 60 MHz pentium processor using the COSMOS/M program. The load at the end of the beam is plotted versus the calculated beam tip displacement in Fig. 3. For this model, a beam tip force of 130 kips is required to reach a two inch deflection which is representative of 3% rotation. Contours of Von Mises' stress at maximum tip displacement are shown in Fig. 4. The high stress region extends to the beam centerline with the peak stress reaching 55.9 ksi, indicative of a plastic hinge. It can also be seen that the panel zone is a region of high stress suggesting that deformation of the panel zone may be significant for these specimens.
