## MACROSEISMIC SURVEYS AND SOURCE MECHANISM OF LATUR EARTHQUAKE OF 30 SEPTEMBER 1993, PENINSULAR INDIA

P.L. NARULA, P. PANDE, S.K. GUPTA, L. HARENDRANATH and N.V. VENKATARAMAN

Geological Survey of India, Northern Region,  
Sector-E, Aliganj, Lucknow, India

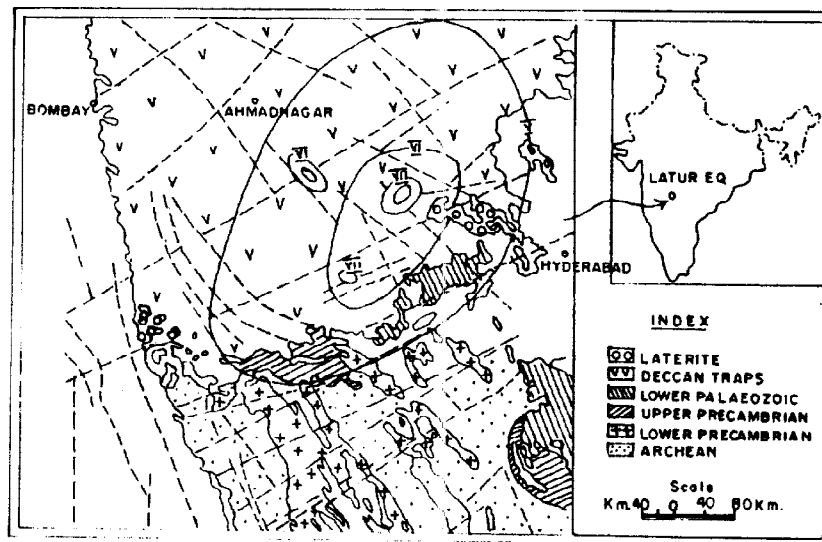
Fig. 1. Isoseismal map of Latur earthquake

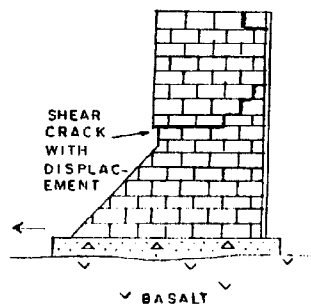
The damage to the engineered structures has been low to moderate. The RCC Water-Tank at Chincholi village was severely damaged by the earthquake and was later pulled down for fear of its impending collapse. A 62 m long and 4.5 m high irrigation barrage (under construction) across Tirna river at Rajegaon developed cracks in 14 out of 18 piers founded on basalt (Fig. 2). There was minor fall of masonry from some of the piers. In the aqueduct of Lower Tirna Project near Talni, the bearing plates of end piers got jammed due to the vibration of the structure. In an RCC bridge near Mangrul, longitudinal cracks, trending in N50°W-S50°E direction appeared in both the abutments and the deck also cracked. The southern masonry parapet of a culvert, located 2 km west of Killari, was completely dislodged by the strong shaking and shear cracks appeared in the culvert masonry, besides development of slump cracks in the rivulet bank (Fig. 3).

Fig. 2. Damage to a masonry pier of a barrage across Tirna river.

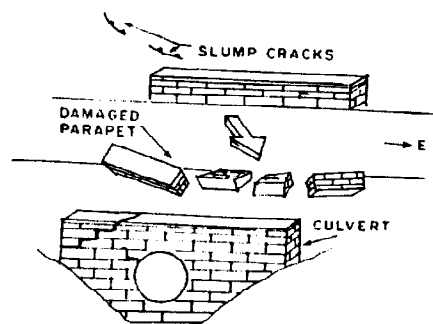
Fig. 3. Collapse of a low parapet, shear cracks in the masonry culvert and cracks in rivulet bank.

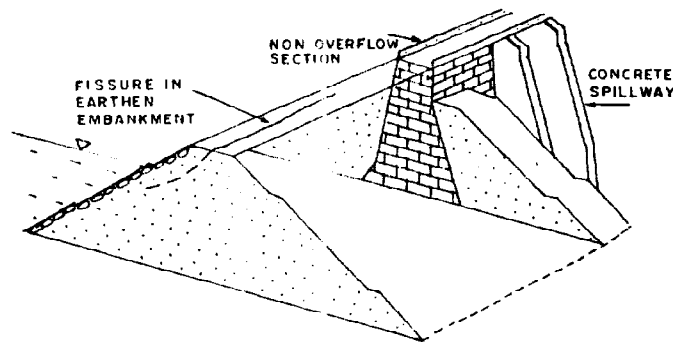
In the 350 sq km cumulative area of this Isoseist, 2.49% of the population has been killed and 70.85% houses badly damaged. There has been development of large and open shear as well as tensional cracks in brick-masonry houses and near total to partial collapses of Type A structures. Yelvat, Kawtha and Makni villages within this Isoseist have shown maximum damage. In Makni village many houses have shown partial collapses and in the well built Irrigation Colony, the brick-cement constructions have got extensively cracked. The Water Tank at Makni has developed wide open cracks along masonry block joints. A longitudinal crack running for over 100 m has appeared in the crest portion of the earthen section of the dam possibly because of the settlement of the earthen fill material (Fig. 4). At Kawtha most of the houses on the northern half of the village collapsed. An eight metre high RCC overhead Water Tank at Kawtha village suffered total collapse under the influence of the strong motions.

Fig. 4. Longitudinal crack in earthen embankment of Makni Dam and slight separation of earthen-masonry section

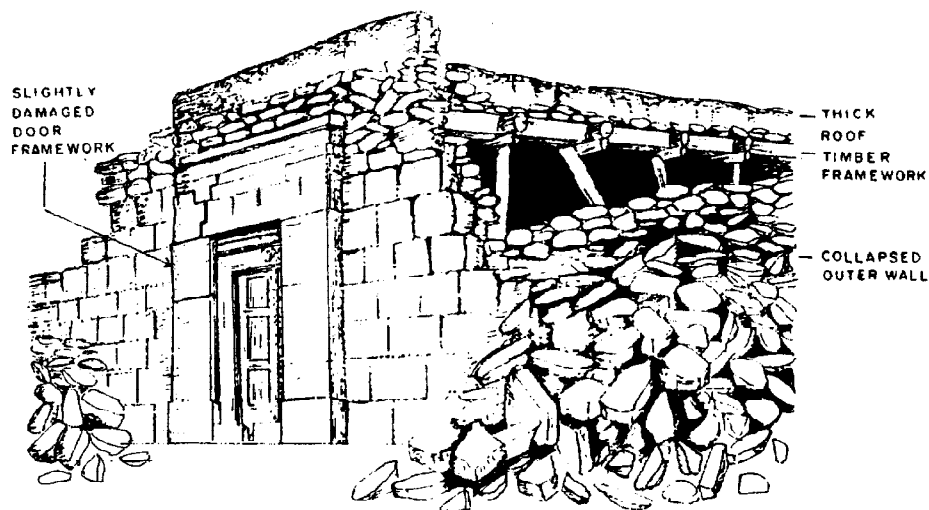
*A. Conventional Houses.* The conventional houses are built of thick mud-masonry walls which have dressed “wythes” of single stones of 20 cm dimensions while the inner portion of the wall is made of random boulder and mud fill. There are no through stones to bind the inner and outer “wythes”. In many cases these thick walls are the load bearing ones whereas in the older constructions the inner portion of the houses is made of timber framework. This practice of using timber framework had been dispensed with in newish constructions. In fact, the houses which have timber framework, have escaped total collapse although the outer walls have been razed to the ground (Fig. 5). The roofs of these constructions are made of thick pile of earth which has made the buildings very heavy thereby adding to the seismic loads. Such buildings have suffered maximum damage.

Fig. 5. Damage to a conventional house in the meizoseist. Provision of timber columns and beams has prevented total collapse of the structure.

There was no strong motion recorder in the area and thus the spectral analyses of the main shock are not available but the aftershocks indicate that maximum of the response spectrum is obtained in the frequency range of 5 to 10 Hz which is close to the eigen frequencies of thick walled conventional constructions in the region (Baumbach et al, 1994). This might have accentuated the damage and collapse of the buildings under resonance.

In the lower intensities, the thick outer walls show typical “wythe” failure in the absence of through stones and in some isolated cases, such damage was noticed even in intensity VI of MSK scale. In the intensities VIII and IX such houses show complete or partial collapses. In many cases the houses were built back to back with common or touching walls on 2 or 3 sides. This caused accentuation of the damage by interactive dynamic loading.

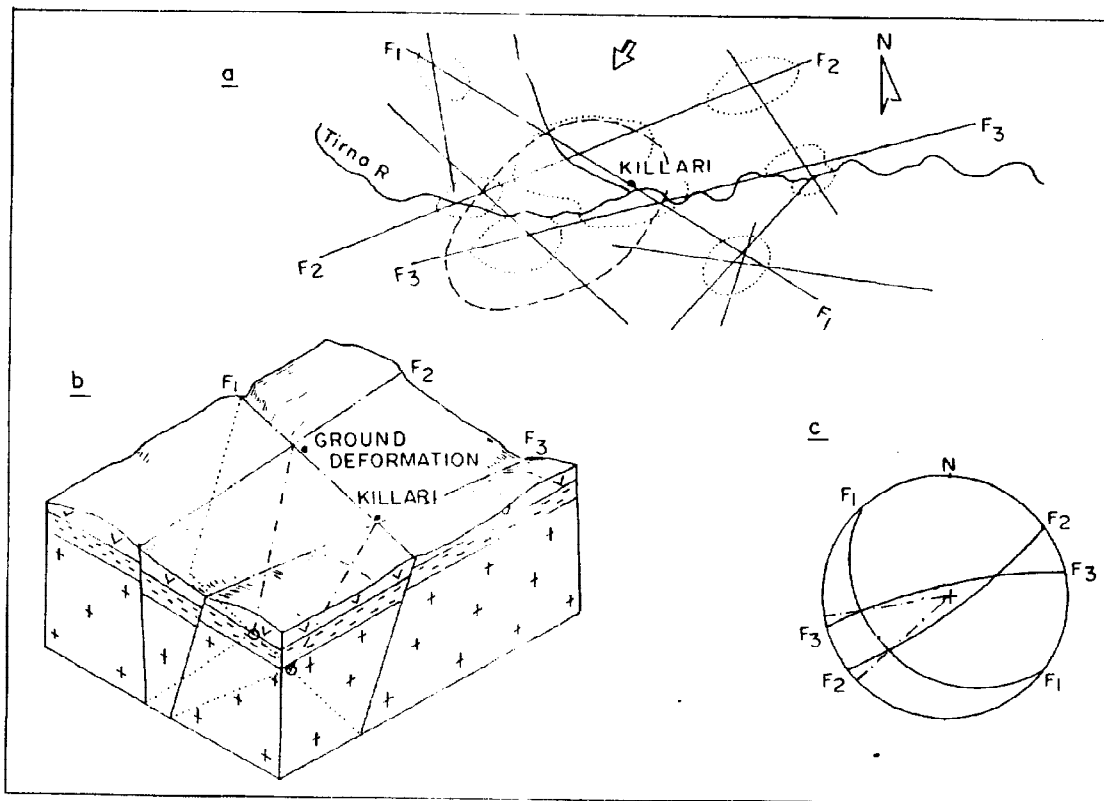
From the above discussions, it emerges that this earthquake has taken place in the vicinity of intersecting pre-existing fault surfaces, concealed under the Deccan Volcanics and the disposition of these tectonic surfaces make an angle of  $120^\circ$  with each other. Fault mechanics-wise, both reverse and strike slip motions on two discrete faults could take place in such a disposition. Generally, the intraplate events do not show surface manifestations but this event, like the one in Australia, has shown these manifestations in the form of upheaval in the WNW-ESE disposition and strike slip in NE-SW direction. Keeping all these parameters in view, the authors have proposed a source model for this event depicted in Fig. 6

Fig. 6. Source mechanism of Latur earthquake (a) Plan showing configuration of faults, zones of strain locking and epicentral tract. (b.) Block diagram explaining intersection model. Main rupture occurring at  $F_1$ - $F_2$  intersection in reverse type motion initiating unlocking at other locked segments and left lateral strike slip motion along  $F_2$ . (c.) Stereonet plot of intersecting fault planes  $F_1$ ,  $F_2$  and  $F_3$ .
