SEISMIC PERFORMANCE OF STEEL PLATE SHEAR WALLS BASED ON A LARGE-SCALE MULTI-STOREY TEST

R.G. DRIVER, G.L. KULAK, D.J.L. KENNEDY AND A.E. ELWI

Department of Civil Engineering, University of Alberta, Edmonton, Alberta, Canada, T6G 2G7

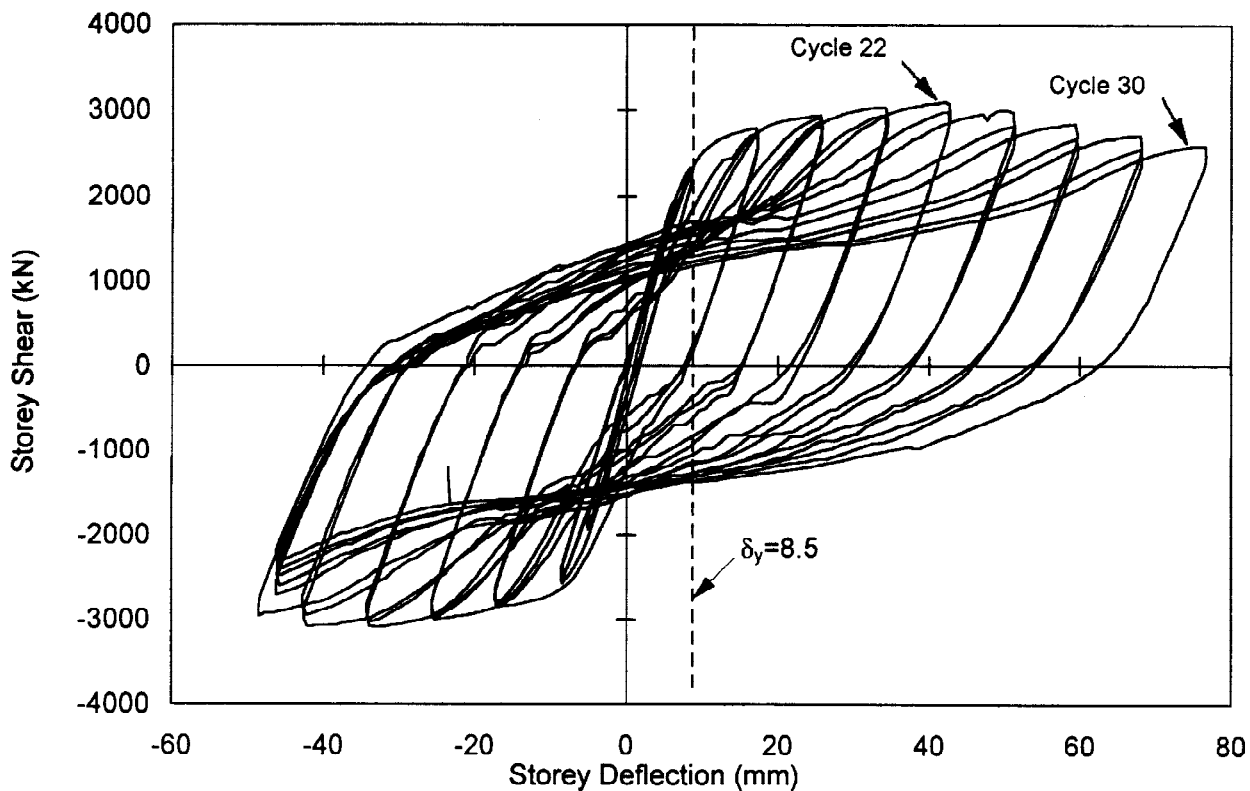
Fig. 4 Storey Shear vs. Storey Deflection - Panel 1

The criterion that was used to control the test, and which is of prime importance for defining the performance of the test specimen, is the storey shear vs. storey deflection behaviour of Panel 1, shown in Fig. 4. This graph clearly demonstrates the significant ductility exhibited by the shear wall during the test. The uniformity of the hysteresis loops implies stability under extreme cyclic loading and, even after the peak load had been reached, deterioration was very slow and controlled. Further, the eventual failure was by fracture at the column base. Had this failure mode been avoided, there is reason to believe that the trend of very gradual deterioration of capacity would have continued. Since the load-carrying capacity of the test specimen had already decreased to 85% of the maximum, no repair of the column was attempted, however.

Figure 4 also shows that the hysteresis loops generated are relatively wide, meaning that there was significant energy absorption during each cycle. The curves flatten in the region where the plate buckles reorient themselves during a load reversal prior to the full development of the tension field. However, the significant stiffness of the moment-resisting boundary frame appears to prevent severe pinching of the hysteresis loops seen in shear walls with frames having simple connections (Kulak, 1991).

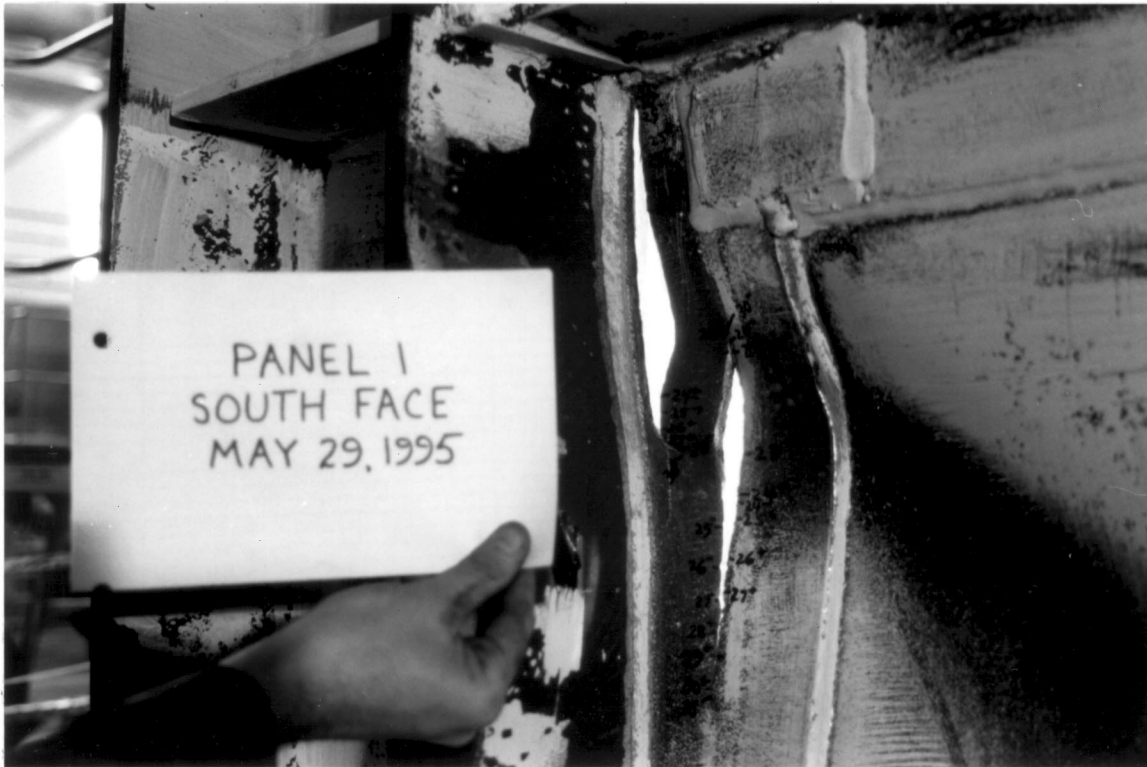
The first tear was detected during Cycle 18 in the top, west corner of the south face of Panel 1. It was 6 mm long and located at the corner of the weld connecting the infill plate to the fish plate, transverse to the weld axis. This crack did not propagate during subsequent cycles and is considered to have had a negligible effect on the behaviour of the test specimen.

In Cycle 22, plate tears were observed at the top corners of Panel 1 at the toe of the fillet weld connecting the fish plate to the columns. The east tear was 120 mm long and the west tear was 80 mm long. In addition, a 50 mm tear formed at the toe of the fillet weld connecting the infill plate to the fish plate at the top, west corner. Figure 5 shows the tears at the top west corner of Panel 1 after they had propagated during subsequent cycles. Also during Cycle 22, at a displacement of $5 \delta_y$ in Panel 1, the maximum base shear of 3080 kN was reached. The load-carrying capacity of the test specimen declined very gradually during each of the remaining cycles of increasing deformations.

Fig. 5 Panel 1 Corner Tears

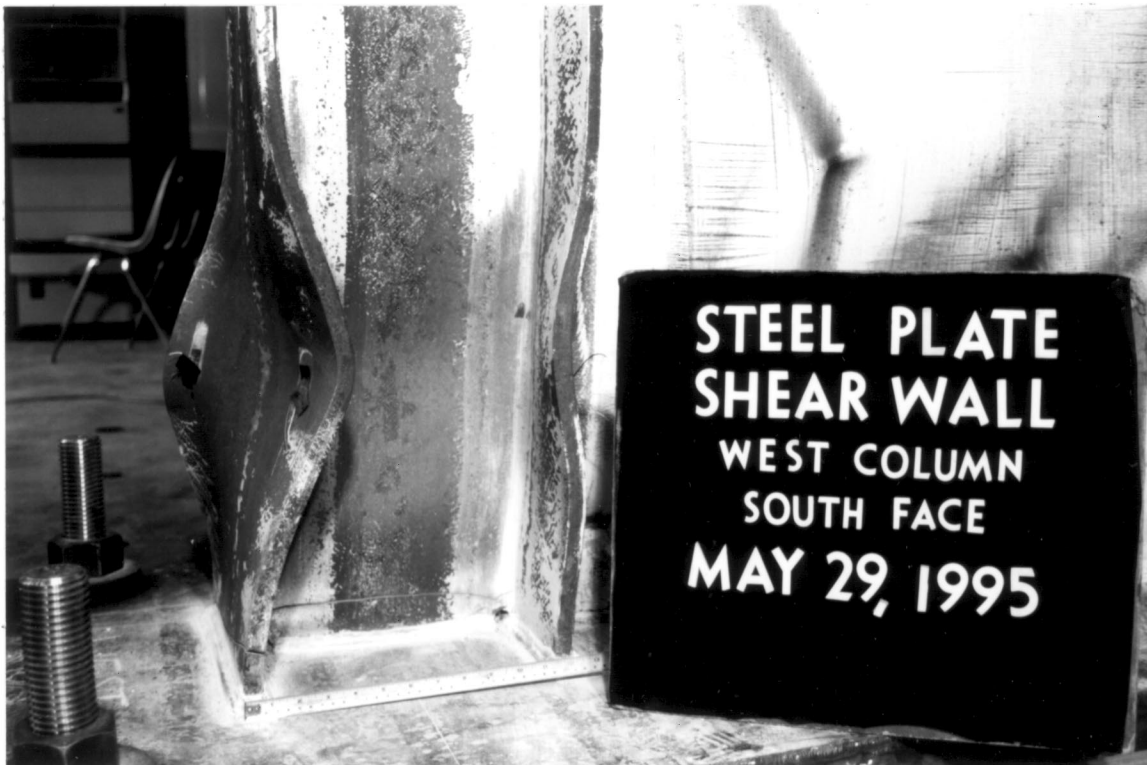
During Cycle 20 ($\delta = 4 \delta_y$), local buckles in the west flange of the east column and the east flange of the west column were discovered immediately below the beam at level 1. These buckles were of relatively small amplitude, but they grew in size during subsequent cycles. After the lateral load had been removed at the end of this cycle, residual amplitudes of 10 mm (west column) and 40 mm (east column) were measured. In addition, a local buckle of 13 mm amplitude was discovered in the east flange of the east column near the base.

Fig. 6 West Column Local Buckles

By Cycle 26 ($\delta = 7 \delta_y$), the column flange distortion in the first storey was extreme. Figure 6 shows the locally buckled flanges at the base of the west column at the end of the test.

The large compressive strains that were present at the column bases caused severe local buckling in the flanges adjacent to the column base connections. Reversing loads tended to repeatedly buckle and straighten these areas. This type of loading leaves the structure vulnerable to failure by propagation of a crack initiating at a flaw in the weld or the parent material. Local buckling can be prevented, however, by the judicious positioning of stiffeners, reducing the susceptibility of the joint to this type of failure.

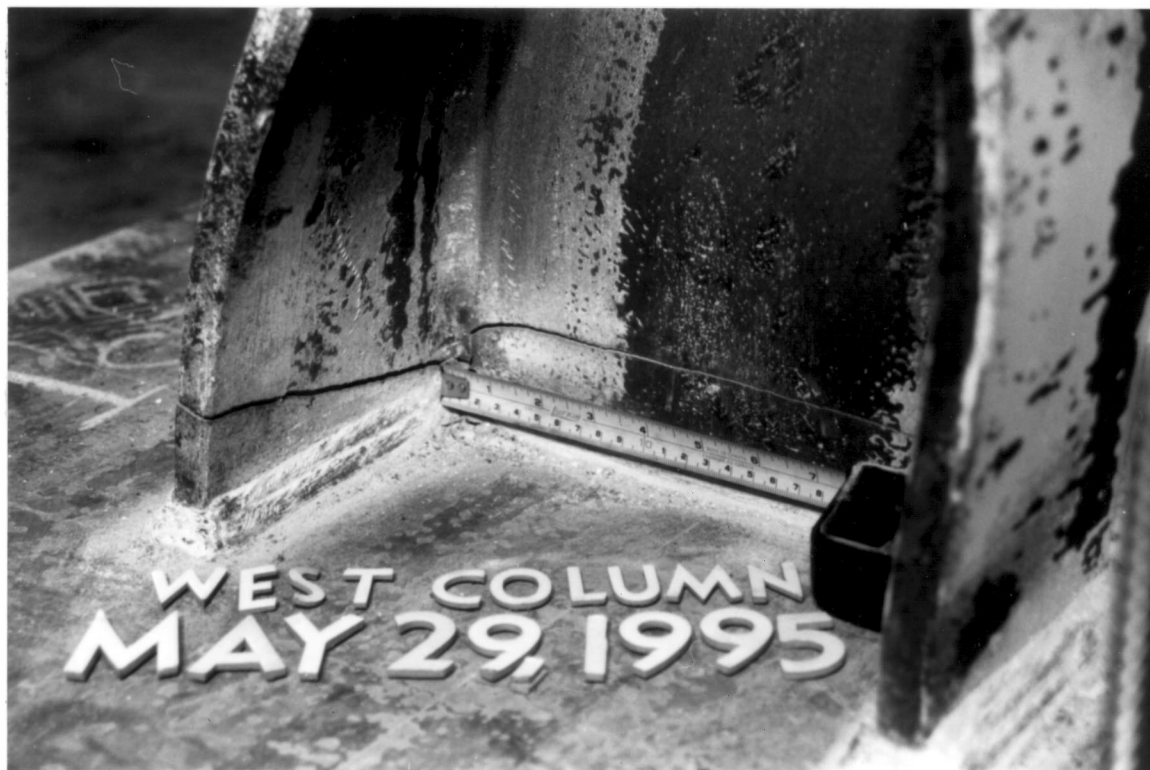
In the first excursion of Cycle 30, a displacement of $9 \delta_y$ was achieved in Panel 1. After the shear wall was unloaded and was in the process of being reloaded in the opposite direction, the west column fractured at its base (at a base shear of approximately 1750 kN). The fracture was sudden and was accompanied by a large release of energy. A metallurgical examination revealed that the fracture began in the heat-affected zone of the base material at the toe of the weld connecting the west flange of the column to the base plate. After growing a distance of about 20 mm prior to the final cycle, the crack extended another 10 mm in the final tensile cycle. Both of these regions showed characteristics indicating that the material behaved in a relatively tough manner. The crack then initiated a brittle cleavage fracture that propagated rapidly through the remainder of the west flange and completely through the web. Figure 7 shows the fractured west column.

Fig. 7 Fractured West Column
