EXPERIENCES ABOUT THE BEHAVIOR OF BUILDINGS DURING THE EARTHQUAKE OF OCTOBER 1995 IN PUERTO VALLARTA AND MANZANILLO, MEXICO.

JOSE LUIS CAMBA C.

ABSTRACT

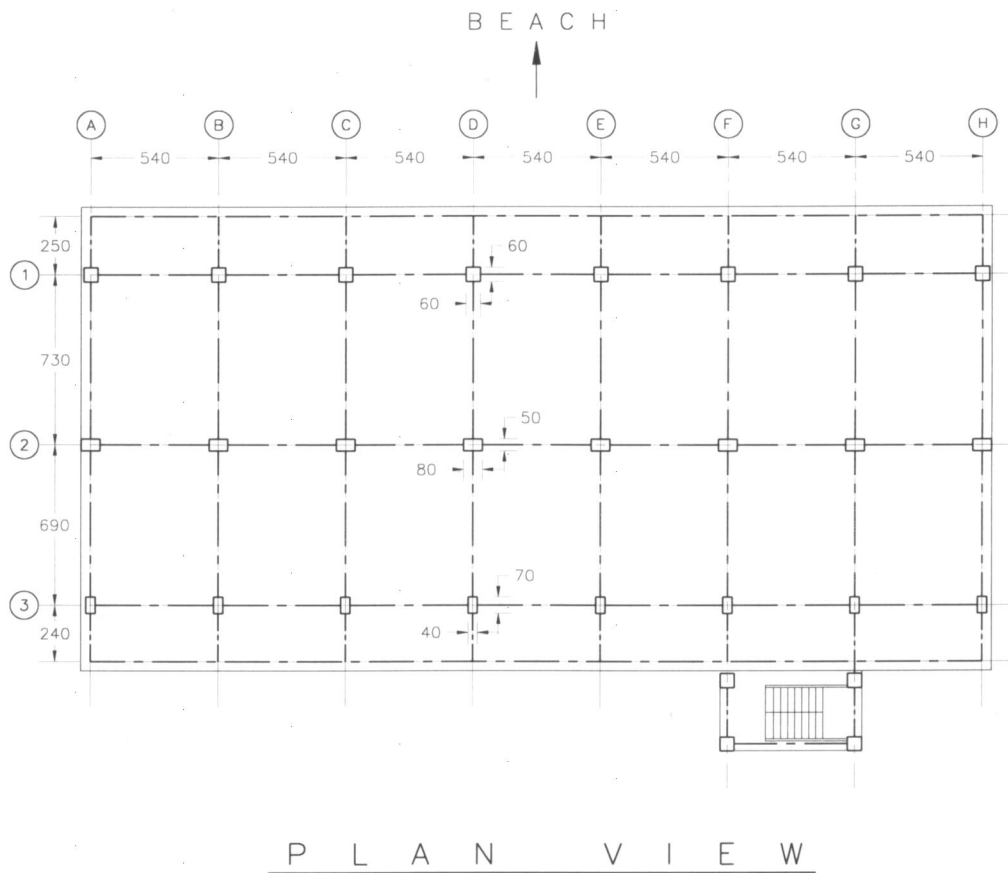
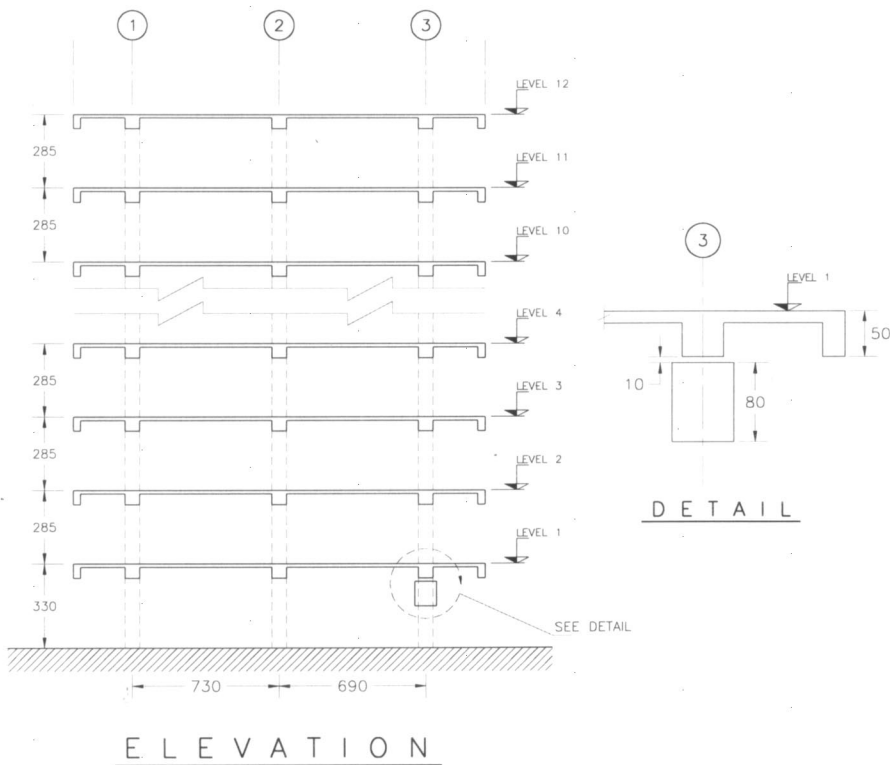
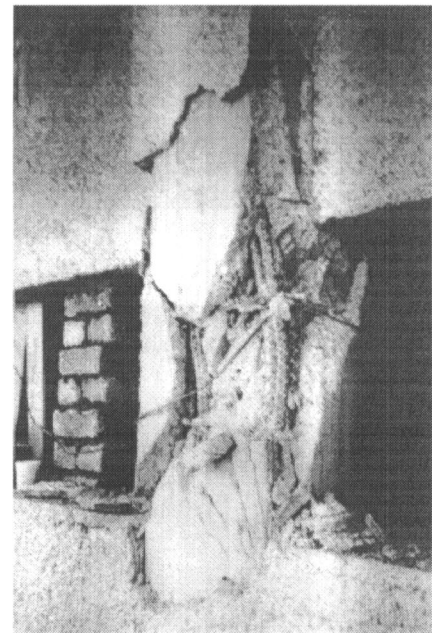
Fig. 1 BPV1 Building

A visual inspection of the building after the earthquake revealed extensive cracking in the masonry walls in the first five levels only in the longitudinal direction and at the connection between the elevator-staircase box and the building.

Most important damage occurred at the first level in four consecutive columns with severe cracking that formed shear plastic hinges (Fig. 1).

The principal cause that provoked the structural damage of the four columns in the lower level was the enormous rigidity of the longitudinal frame No. 3 stemming from the additional beam and the performing as "short columns" due to the infills walls.

It is very reasonable to conclude that if the additional beam were not positioned there and a good separation between the columns and the longitudinal infill walls to avoid their total length, the building really could have had a much better structural behaviour.

The building was closed by the civil authorities and now is being strengthened.

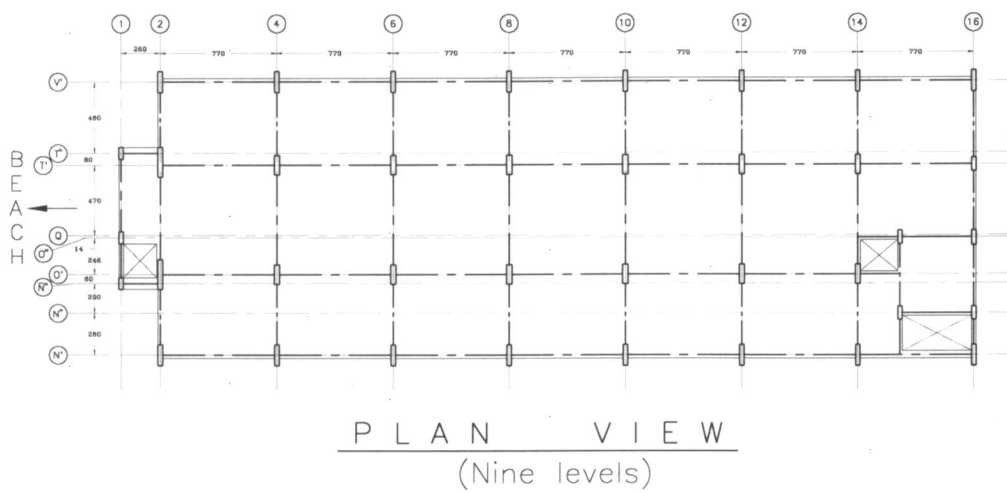
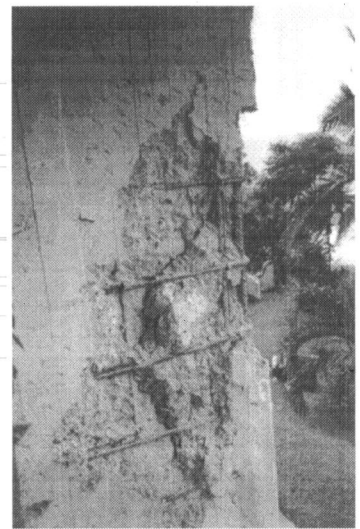
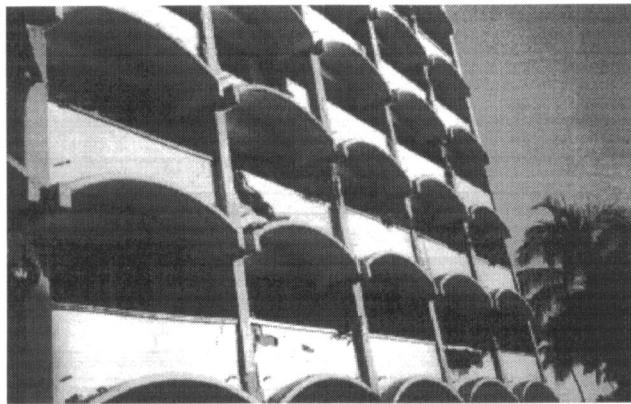
Fig. 2 BPV2 Building

An inspection to the building after the earthquake revealed in the facades full cracking of "false" columns of masonry walls only, because the archs were supporting on the true and false columns. of (See photo in Fig.2) forming a frame with a railing of about 1 m depth. All this happened in the 4 firsts levels.

Two of the north facade columns cracked because the presence of the railing mentioned, which makes the columns work , as "short columns".

Some construction defects were detected at the slab-column connections of the staircase framing because of bad anchored ending bars and the absence of stirrups at the joint.

Because of the orientation of columns and span size in the short direction, it is evident that it is a structure with much more rigidity in the transverse direction than in the longitudinal direction. This has been confirmed, through dynamic analyses were the period of first mode was 1.3s in the short direction and 1.9s in the other, and consequently the computed lateral displacements were extremely larger in the longitudinal direction. This building in now under rehabilitation.

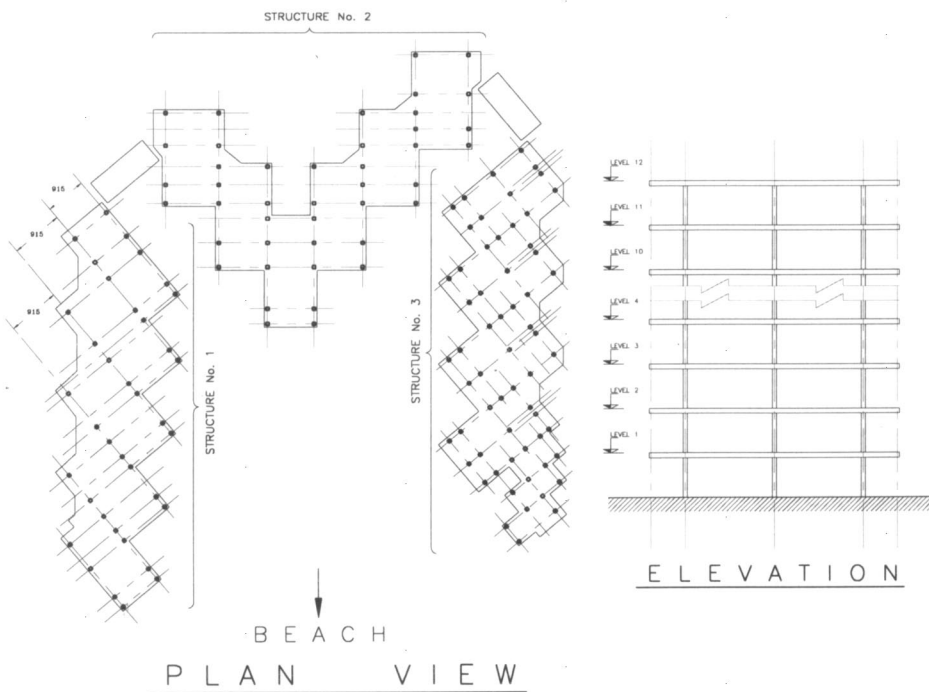
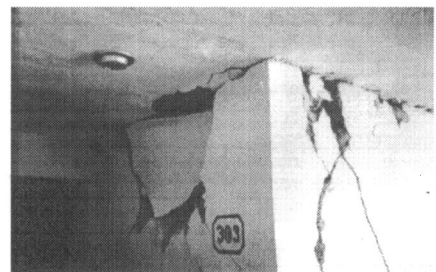
Fig. 3 BPV4 Building

A visual inspection of these buildings, principally number 1, revealed wide and extensive cracking in most of the masonry walls in both directions.

In some cases, large pieces of 1 m² fell to the floor. In others, cracks of 10 cm. wide or pieces of walls were dislodged 15 cm. outside its original plane. (see photo Fig. 3).

Damage on steel column was detected in the second level near the connection to the slab due to local buckling. All this happened in the first five 3 stories.

The enormous lateral flexibility and low torsional stiffness of this kind of structure made by flat waffle slabs and light steel columns, caused a very important interstory drift, which in turn provoked the large cracking in masonry walls. Poor quality material in walls, also contributed to the damage.

CRACKING WALLS
(STRUCTURE No.1)

Now, the structure is on the way of total demolition.

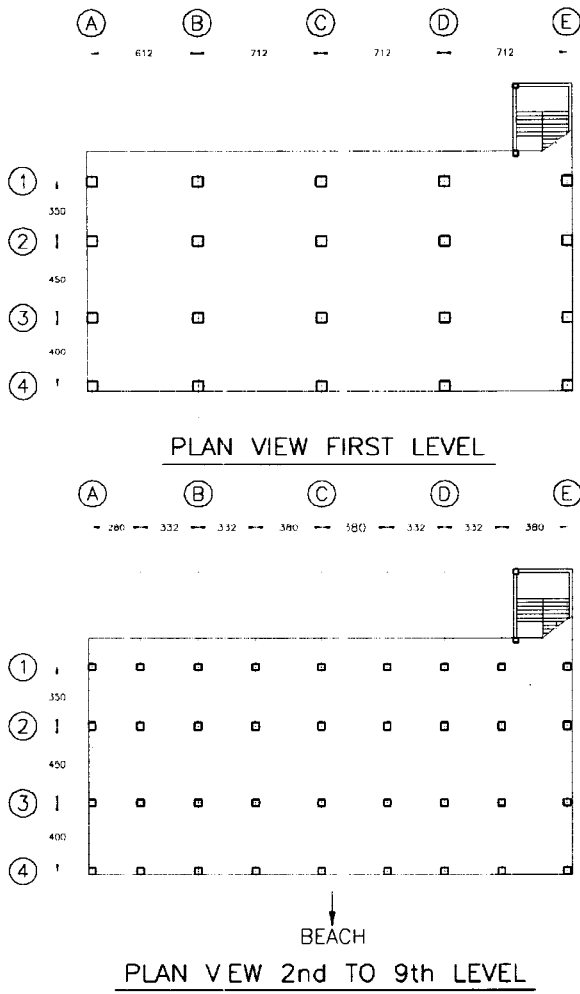
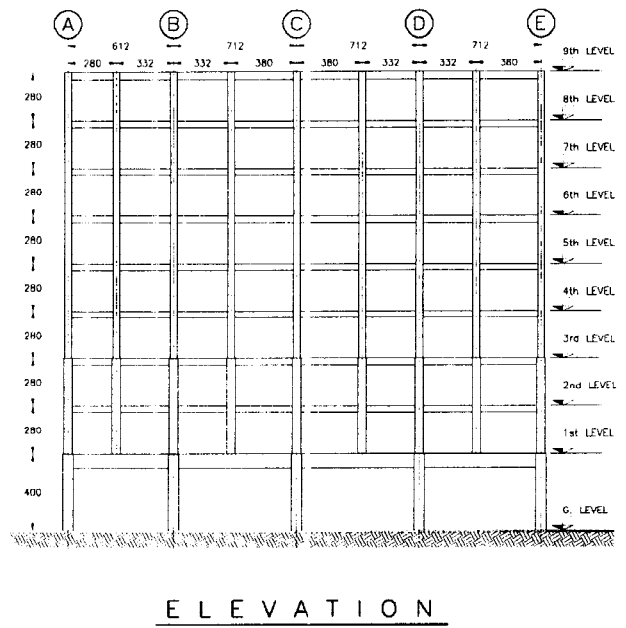
Fig. 4 BM5 Building

The structure completely collapsed during the 1995 earthquake, resulting in at least 30 deaths.

During the visual inspection it was possible to observe a high level of damage in the columns due to the collapse mechanism, forming flexural plastic hinges and almost no damage on the flat slabs.

Longitudinal steel reinforcement in columns, was formed with two bars at each corner and the separation of stirrups (about 25 cm.) showed that was largely insufficient to support the high demands of ductility hence contributed to the formation of plastic hinges at the ends.

First, the large discontinuity between the first and the rest of levels, with columns starting at the middle span of the beams in the longitudinal direction.

And second, consequently the enormous ductility demand for the columns at the ground level and the magnified effects due to the big difference between the presence of masonry walls in the upper levels yielded the structure working with a weak first story.

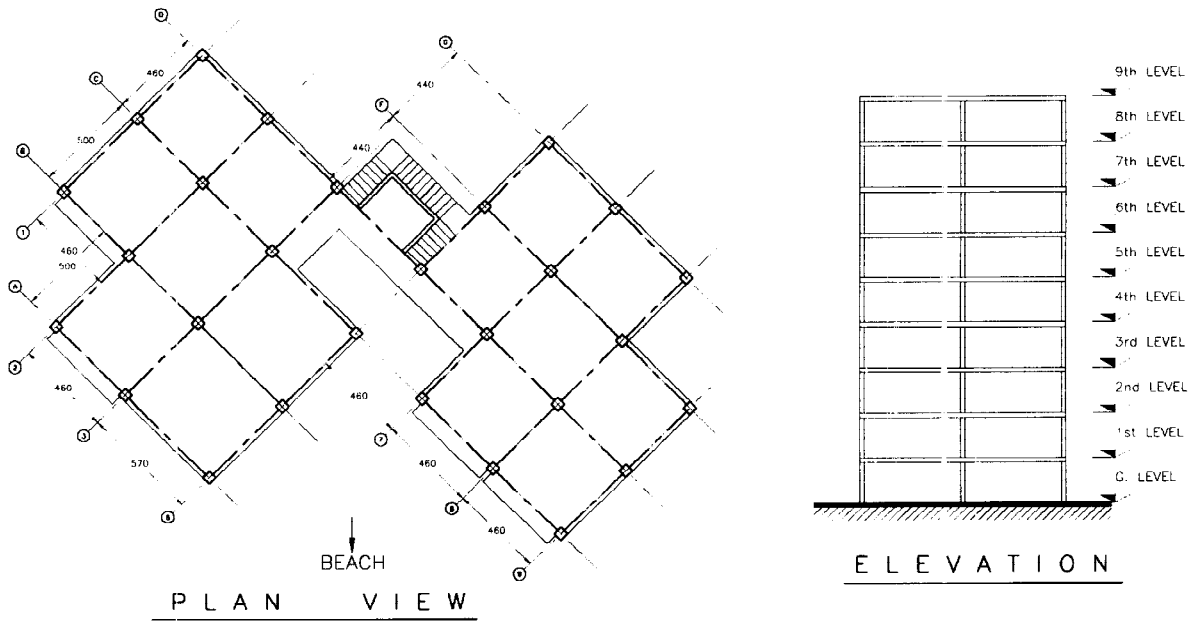
Fig. 5 BM6 Building

A visual inspection of the building after the earthquake, revealed extensive diagonal cracking in the masonry walls in both structures principally in the first five levels. No cracks were found in the main structural members.

Because of the insufficient of the reinforced concrete waffle slabs used (total depth 25 cm.) and the sections and steel of the reinforced concrete columns, it is obvious that lateral displacements were extremely large with a very important interstory drift, but limited because of the masonry walls and for that reason the cracking was very significant.

Another remark is the fact that only one frame connects both structures near the concrete box, with a high probability to crack in the slab, forming a natural separation between these almost different structures. This is a typical case without a good horizontal diaphragm. The building is now closed and will be upgraded.
