FAILURE OF A BURIED CORRUGATED METAL PIPE DURING THE 1994 NORTHRIDGE EARTHQUAKE

Craig A. Davis and J.P. Bardet

Los Angeles Department of Water and Power, Los Angeles, CA 90051
University of Southern California, Los Angeles, CA 90089-2531

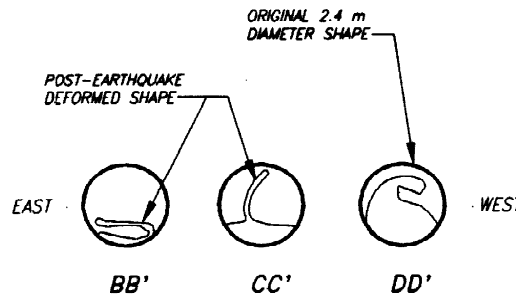
The Lower San Fernando Drain Line No. 1 serves as a storm outlet line for the Lower San Fernando Dam. The 2.4 m diameter, unencased, corrugated metal pipe is 116 m in length. Figure 1 shows a few typical deformed

shapes of this pipe which was extensively crushed during the Northridge Earthquake. Figure 2 summarizes the various major zones of deformation and collapse. More details on the pipe deformations can be found in Bardet and Davis (1995).

Fig. 1. Three typical buckling modes of Drain Line No.1 after the 1994 Northridge Earthquake.

As shown in Figure 2, a sinkhole measuring 6 m in diameter and 3.7 m deep resulted near the south end of the pipe (over pipe segments [1] and [2]). Also shown in Figure 2, subsidence occurred over the collapsed pipe for a distance of 30 m south of the sinkhole. Section BB' of Figure 1 indicates the deformed shape of the pipe below the sinkhole. The northern end of the pipe (segments [1], [2], and [-1] through [-5]) was placed in a trench excavated through bedrock while the center (segments [3] through [7]) was excavated through alluvium. Groundwater was observed to be within 1 m of the bottom of the pipe in the bedrock and alluvium. Section CC' of Figure 1 shows the typical deformed pattern through the center portion of the pipe except for segment [7] which was undeformed.

Since only a small portion of the pipe was located within liquefiable material, it is clear that liquefaction was not the only cause of the pipe collapse. In addition, the deformed shapes shown in Figure 1 indicate that large deformations took place within the firm alluvium soils and bedrock.

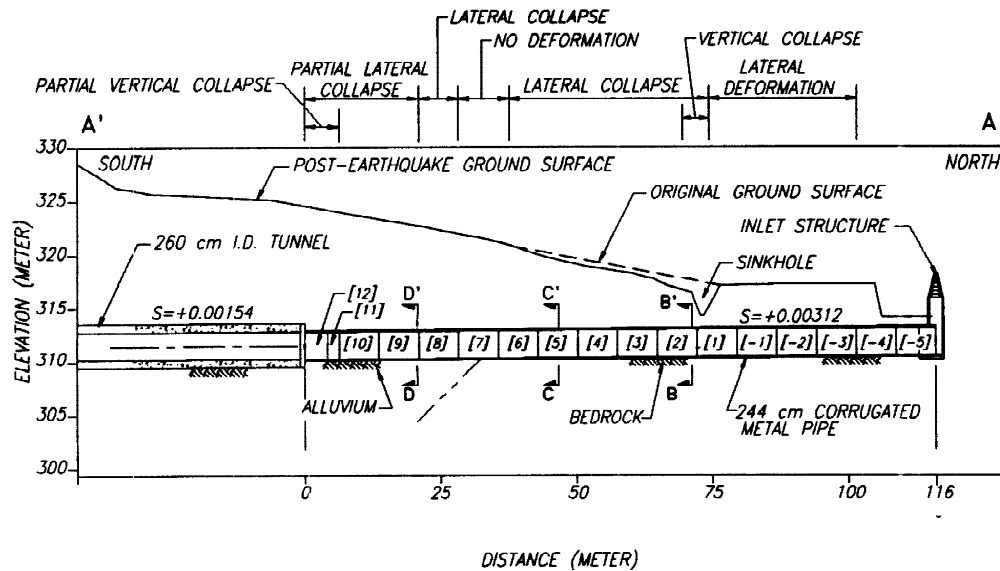
Figure 2 shows a profile of Drain Line No. 1 as it was completed in 1973. Each pipe segment is distinguished by using a number in brackets. The segments are numbered with positive numbers moving south and negative numbers moving north from the sinkhole location. The drain line was constructed with 116 m of 2.4 m nominal inside diameter, 0.43 cm thick, galvanized, corrugated metal pipe placed in 7.3 m sections.

Upstream of the reconstructed berm and east of Drain Line No. 1, the Lower San Fernando Dam spread laterally in the northern direction due to liquefaction, which caused sand boils and ground cracks to form. Liquefaction occurred within the saturated hydraulic fill slide debris which has remained in place since the 1971 San Fernando Earthquake (Bardet and Davis, 1996b). The southern end of the drain line trench (pipe segments [8] through [12] in Figure 2), was placed through the hydraulic fill slide debris during its original construction. This portion of the pipe was founded on alluvium and buried under 12 m of compacted fill encased within the hydraulic fill debris. The eastern side of the slide debris was saturated and ejected substantial volumes of water up to approximately 1 m above the top of pipe. Section DD' of Figure 1 shows the typical lateral pipe deformation located within the saturated hydraulic fill slide debris except for segments [11] and [12] where vertical deformation dominated.

Fig. 2. Profile of Lower San Fernando Drain Line No. 1 corrugated metal pipe.

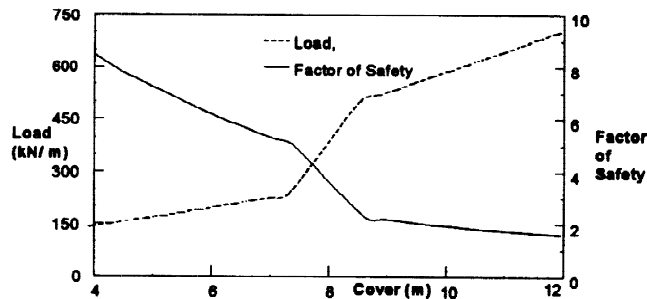
Fig. 3. Graph of static load and factor of safety against buckling for Drain Line No. 1.

Figure 3 shows the static load distribution along the corrugated pipe as a function of the thickness of fill cover. There are two distinct zones in Figure 3 which represent two cases of soil and trench conditions. The first case (4 - 7 m) represents the loads on the pipe segments north of [7] which was installed in a trench excavated through alluvium and bedrock. The second load case (8 - 12 m) denotes forces applied to the pipe in a trench excavated within the softer hydraulic fill slide debris south of pipe segment [7]. The latter condition puts more load on the pipe embedded in soft hydraulic fill. Figure 3 also shows static factors of safety, F_s , calculated according to the methods outlined by ASTM A796 (ASTM, 1990). F_s is defined as the ratio of buckling strength to applied loads.

The lowest value of F_3 (i.e., 1.7) was on the south end where the pipe was placed within the weakest material and the thickest fill cover.

A simplified pseudo-static analysis was performed to evaluate the effect of vertical accelerations recorded near the pipe. As presented in Figure 3, the pseudo-static load was assumed to be proportional to the sum of static and maximum dynamic accelerations. The results indicated that 6.7g was required to cause a failure at the location of the sinkhole and 1.7g at pipe segment [8]. These values indicate that a pseudo-static analysis can not adequately predict the failure of pipe located within bedrock, alluvium, or hydraulic fill. However, an increase of vertical acceleration equal to 0.7g could fail pipe segments [11] and [12], located within the hydraulic fill and having the greatest soil cover. This value of vertical acceleration is consistent with the vertical buckling mode which occurred on these two segments and the peak vertical acceleration of 0.85g recorded at the Rinaldi Receiving Station just south of the pipe.
