SURVEY AND ANALYSIS OF BUILDING POUNDING DURING 1989 LOMA PRIETA EARTHQUAKE

¹KAZUHIKO KASAI, ²ANIL R. JAGIASI, and ³BRUCE F. MAISON

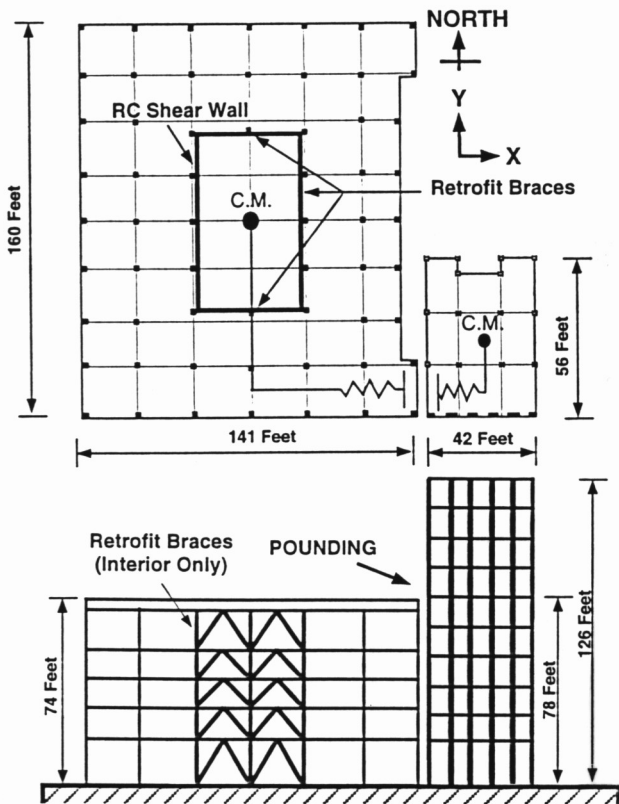
Fig. 1. Typical Framing Plans and Elevations of 10 and 5 Story Buildings.

Buildings and Analytical Modeling. Pounding between 10-story and 5-story buildings located in downtown San Francisco caused severe damage of the 10-story building. The damage of the 5-story building was of minor nature. Fig. 1 shows typical framing plans and elevations of the buildings. Pounding occurred in the vicinity of the 6th level of 10-story building as evidence by the observed local damage (Fig. 2). The 10-story building consists of 13 inches thick exterior masonry wall, with window openings as well as both exterior and interior steel moment resisting frames involving built-up columns. The 5-story building has moment resisting concrete frames and was retrofitted by adding steel concentric braces along three sides and a concrete shear wall on the fourth side of an atrium (Fig. 1). The 5-story building is very massive due to the heavy weight per unit area of the floors and very large plan dimensions compared to the 10-story

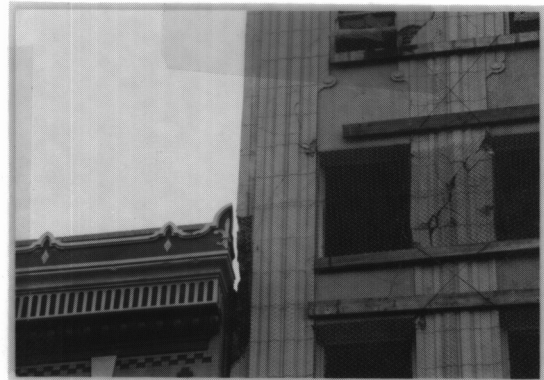
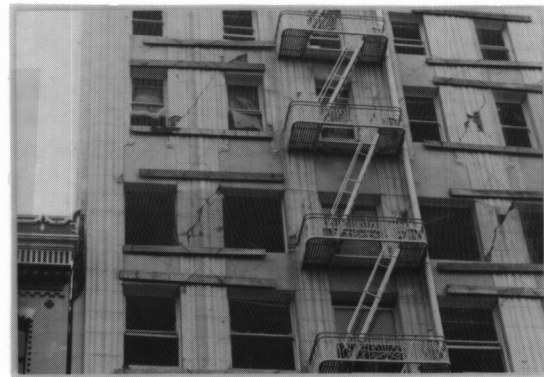
Fig. 2. Damage of Contact Region and Masonry Pier on South Face of 10-Story Building.

building. It has total weight of 18,500 kips which is 4 times the weight of the 10-story building. The buildings are separated by a gap of 1.0 to 1.5 inches. The pounding location is eccentric with respect to the mass centers of the buildings (Fig. 1). As shown in Fig. 2, the masonry piers along south elevation of 10-story building developed large one-directional diagonal shear cracks above the pounding level.

Local Responses and Correlations. Fig. 6 plots the peak shear stresses for damaged masonry pier of the 10-story building. The pier is on the south face, and is the second one from the west edge. This masonry pier as well as the fourth one from west edge do not involve steel columns, and they showed similar stresses, hence the following descriptions apply to these two piers. Additional plots depict the stresses obtained by suppressing the effect of global story rotation (i.e. twisting). The distribution of shear stress is similar to that of the story shear (Fig. 5). Pounding against retrofitted 5-story building increase negative shear stress above the pounding level, and the stress appears to be higher than the failure shear stress of 75 psi suggested by Freeman (1991). The large negative stress is also consistent with the one-directional diagonal cracks observed above the pounding level (Fig. 2).

It should be noted that the stress when suppressing the twisting effect, is smoothly distributed over the story height (Fig. 6). Thus, the twisting promoted the irregular distribution of the shear stresses. As shown earlier in Fig. 3, at the instance of pounding the negative torque developed above the pounding level increased the negative shear stress therein, and the positive torque below the pounding level decreased the negative shear stress therein. Note, however, that when the 5-story building is non-retrofitted, the above mentioned effect of torque is not significant in spite of the large positive torque developed (Fig. 3). This is because such large positive torque did not occur at the same time as the large negative story shear. The significant increase in the story shear directly resulted in extremely large masonry elastic stresses of about 300 psi, 4 times the suggested failure stress.

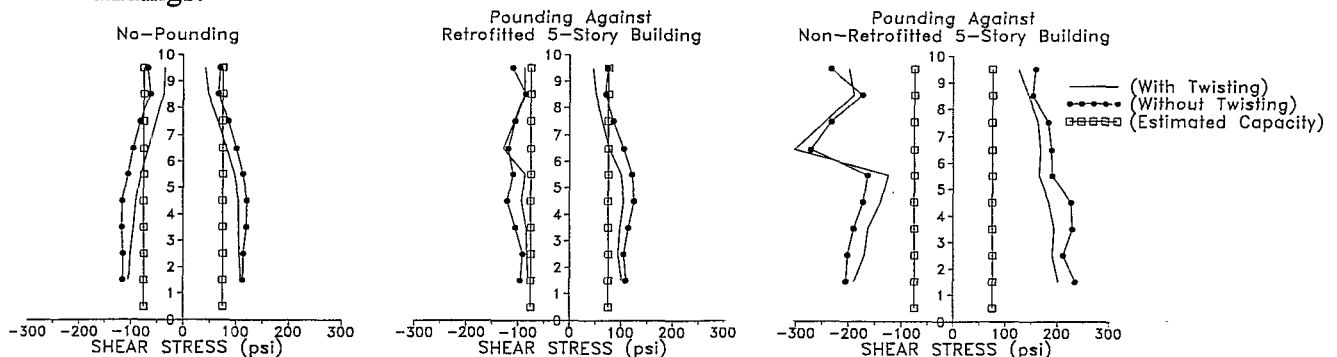
Fig. 6. Envelop of Shear Stresses for Damaged Masonry Pier of 10-Story Building.

Although not shown, study was conducted on the four other south face piers having steel built-up columns. Their masonry shear stresses are about the half of those of the piers discussed above, consistent with only the slight damage of the piers observed. The east edge pier developed the cracks of a different pattern, and it could be due to the combined shear and tension stresses that must have increased due to pounding, as is evident from the overturning moment plots in Fig. 3. Unlike the south face, the north face of the building showed scattered cracks throughout the height. This can be explained by combining the shear stresses created by the story shear and torque in a similar way as explained above. Further analyses results appear to agree well with the observed damage of the 10-story building. They explain the complex mechanism of the pounding as well as its effect on member stresses of the two buildings. The elastic 3D-analysis of the buildings provides important information on the concentration of damage that can develop due to pounding. If the 5-story building had not been stiffened prior to the Loma Prieta event, the consequence of pounding could have been much more severe than the actual damage.

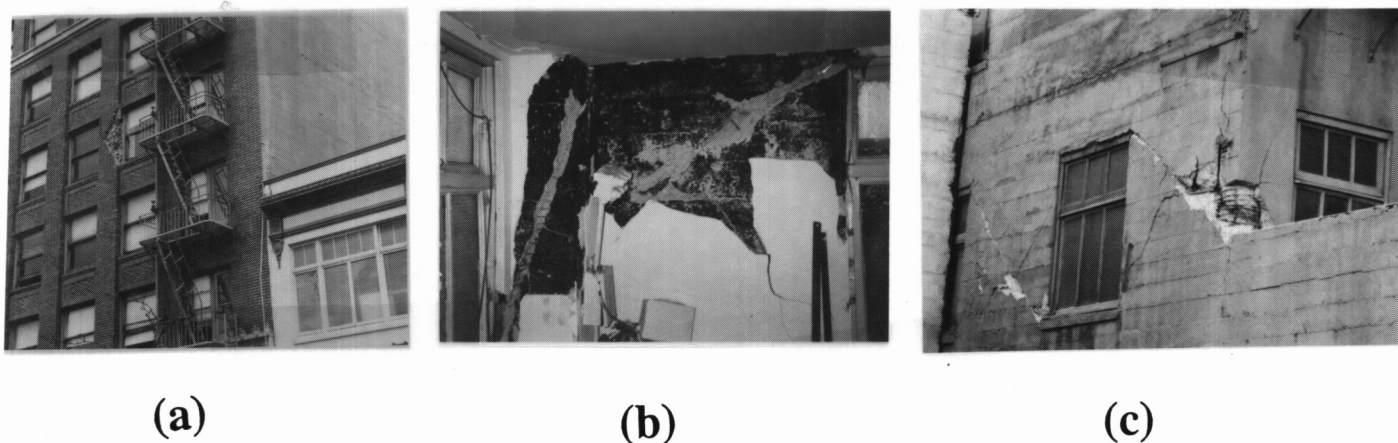
Fig. 8. Damage of 7-Story Building: (a) Brick Facade above Pounding Level, (b) Wall-A and Column-A (Inside View), and (c) Wall-A and Column-A (Exterior View).

Fig. 8 shows the pictures of the damaged elements, and their locations are shown in the typical floor plan (Fig. 7). Fig. 8(a) shows wide classical diagonal shear cracks developed in brick facade above pounding level along the south elevation of the building. The bricks are not structurally integrated into the structural framing. Fig. 8(b) shows the interior view of the damaged wall-A located at the stem of the "T" having the north frame running in east-west direction. The wall developed wide classical one-directional diagonal shear crack below 2nd floor level. The direction of the crack is consistent with the analytically obtained direction of shear stress, as will be explained. Column-A at the west edge of the wall-A suffered severe axial failure, which will be analytically interpreted. The column also failed in shear after the wall-A failed and lost shear resistance.

As interpreted by the inspectors of this building, the failure of the column-A must have occurred soon after the wall-A lost its resistance against the negative shear. The failure of this column is complex, as suggested by the shear cracks developed in interior side of the column and concrete crushing and longitudinal reinforcing bar buckling (Fig. 8(c)). Substantial bending moment, shear, and axial force must have developed in this column. Fig. 10(b) plots axial force envelop for the column-A. It also shows the tensile capacity based on longitudinal reinforcing bar strength, and compression capacity based on the compression strengths of the bars and concrete (ACI 1989). Pounding resulted in significant reduction of both tension and compression axial forces below pounding level. But the tension axial forces are still much higher compared to the column capacity, suggesting significant yielding of the bars. Also, the compression force is almost same as the compression strength. These indicate that the failure of the concrete column was inevitable during the Loma Prieta event. Note, however, that if adjacent buildings had not existed, column-A could have suffered much more significant damage due to much larger compressive and tensile axial forces (Fig. 10(b)) as well as more significant shear and bending demands due to the damage of the adjacent wall-A that could have been more seriously damaged under the no-pounding situation (Fig. 10(a)).

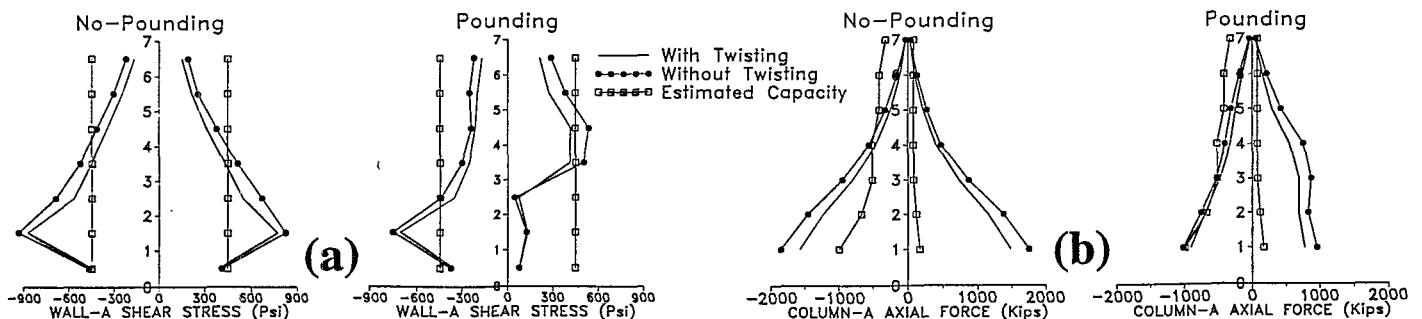
Fig. 10. (a) Shear Stress Envelop for Wall-A, and (b) Axial Force Envelop for Column-A.

Local Responses and Correlations. Fig. 10(a) plots the shear stress envelop for wall-A due to pounding and no-pounding. It also shows the ultimate stress of the reinforced concrete wall, taken as $10(f'_c)^{1/2}$, where f'_c (psi) is the compressive strength of the concrete (ACI 1989). Note that no-pounding case shows very large positive and negative shear stresses between the 1st and 2nd levels, and these stresses exceed the ultimate stress. This is due to the large window opening made at the region (see Fig. 7). In contrast, pounding case shows significantly reduced positive stresses of the wall below pounding level, similar to the distribution of story shear. This is especially beneficial for reducing the shear stresses at the region having the large openings (Fig. 7). On the other hand, negative shear stresses are still significant in pounding case, although they are smaller than those in no-pounding case. Thus, in the pounding case the positive shear stresses are well below the ultimate stress, but negative stress between the 1st and 2nd levels exceed the ultimate stress. This is consistent with the pattern and direction of severe crack developed in wall-A (Figs. 8(b) and (c)). Effect of torsion on the stresses of wall-A appears to be negligible (Fig. 10(a)). Note that, if the adjacent 3-story building had not existed and pounding had not occurred, the damage to the wall-A could have been much more serious as evidenced by the large positive and negative shear stresses shown in Fig. 10(a).
