DAMAGE TO DAIKAI SUBWAY STATION DURING THE 1995 HYOGOKEN-NUNBU EARTHQUAKE AND ITS INVESTIGATION

N. YOSHIDA, and S. NAKAMURA

Engineering Research Institute, Sato Kogyo Co., Ltd.
Nihonbashi-honcho 4-12-20, Chuo-ku, Tokyo 103, Japan

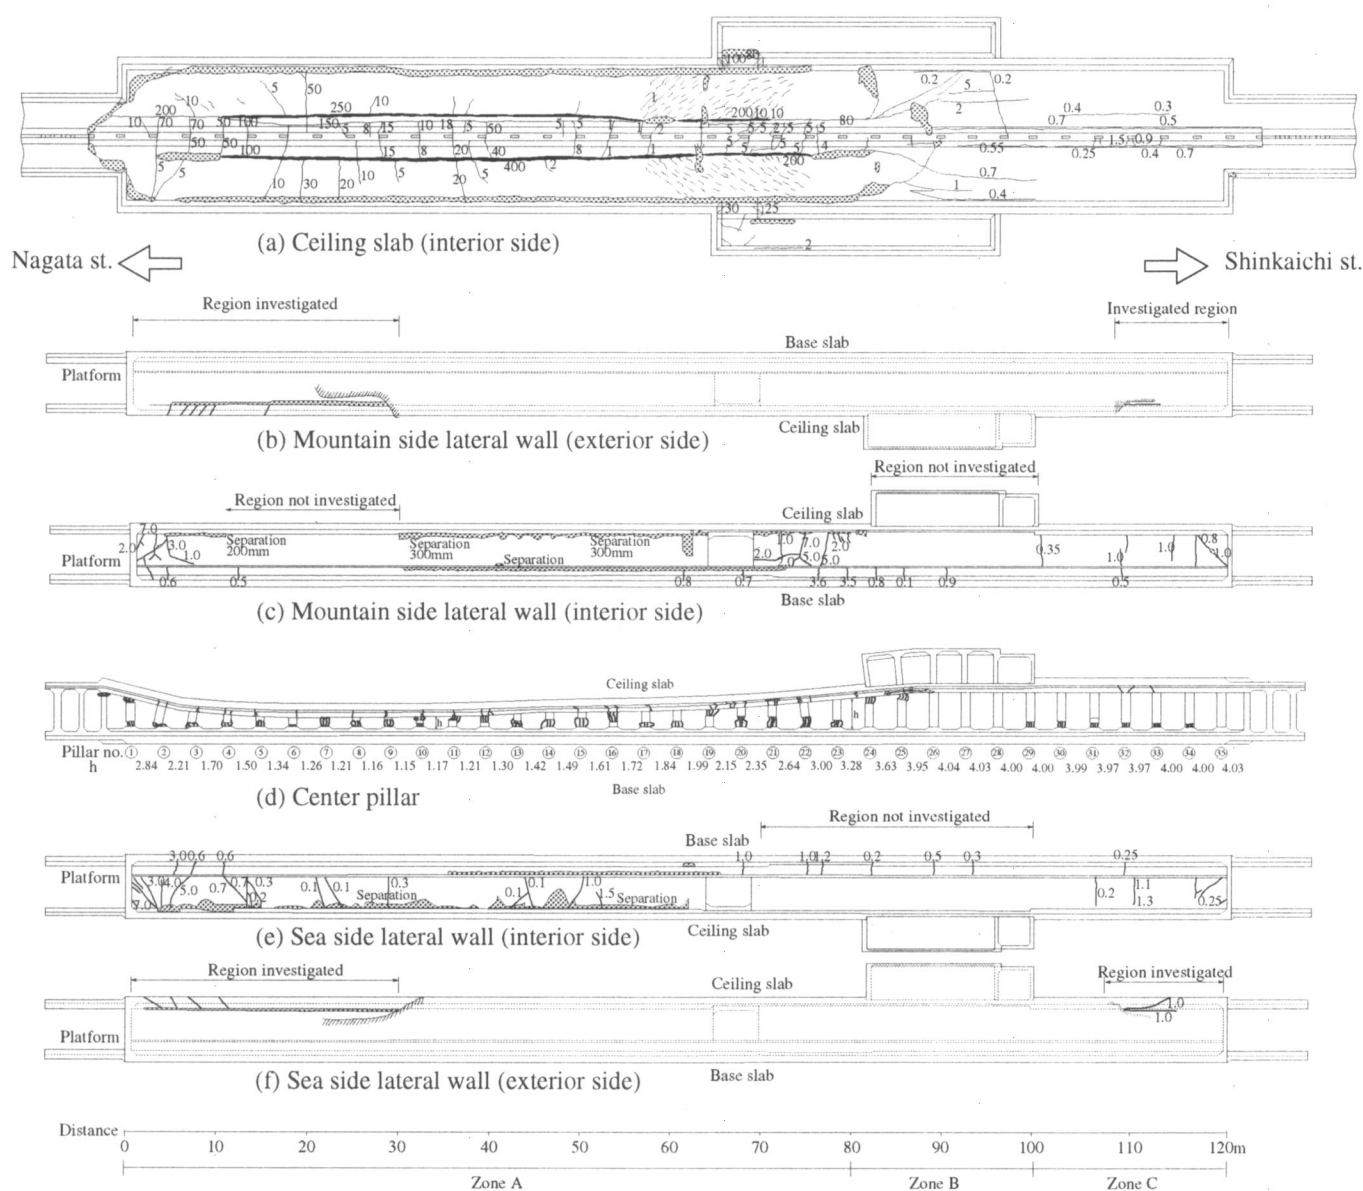
Fig. 8 Schematic figure indicating the damage. Here, h denotes measured clear height, circled number denotes column number. Numeral denotes crack width in mm.

Figure 8 shows schematic diagrams of the damage in the longitudinal direction. The ground of the National road no. 28 for a distance 90 m long and 23 m wide gradually settled up to more than 2.5 m maximum. The contour lines of the settlement of the road surface are shown in Fig. 5, which was measured on January 28. Referring to Figs.2 and 8, the station can be divided into 3 zones in the longitudinal direction along the station depending on the structural system: zones composed of columns 1-23, columns 24-29, and columns 30-35, which are designated zone A, B and C, respectively, hereafter. Zones A and C are a one story box frame structure whereas zone B has utility rooms adjacent to the platform as well as the B2 floor (concourse).

Damage was the most severe at zone A, in the Nagata side zone. Almost all of the center columns completely collapsed and the ceiling slab fell down. As a result, the original box frame structure distorted to an M-shaped section as shown in Fig. 9(a). Typical damage to the center columns is shown in Photo 1. The ceiling slab kinks and cracks 150 to 250 mm wide appeared in the longitudinal direction about 2.15 to 2.40 m from the center line of the columns. In addition, the separation of cover concrete was observed over almost the entire area near the haunch and the intersection between the lateral wall and ceiling slab. In zone B, as shown in Fig. 9(b), the collapse of the column occurred in the upper portion and reinforcing steel buckled into a symmetrical shape for columns 24 and 25. The upper longitudinal beam connecting the center columns was bent at a point between columns 25 and 26. The small separation of the corner concrete of the center columns is observed at the mountain side of upper portion and at sea side of lower portion, in columns 26, 27 and 28. Although the structural system in zone C was the same as that for zone A, damage was less in zone C compared with that in zone A. Figure 9(c) shows the damage to column 31 where the lower part of the center column is damaged and ceiling slab settled about 5cm.

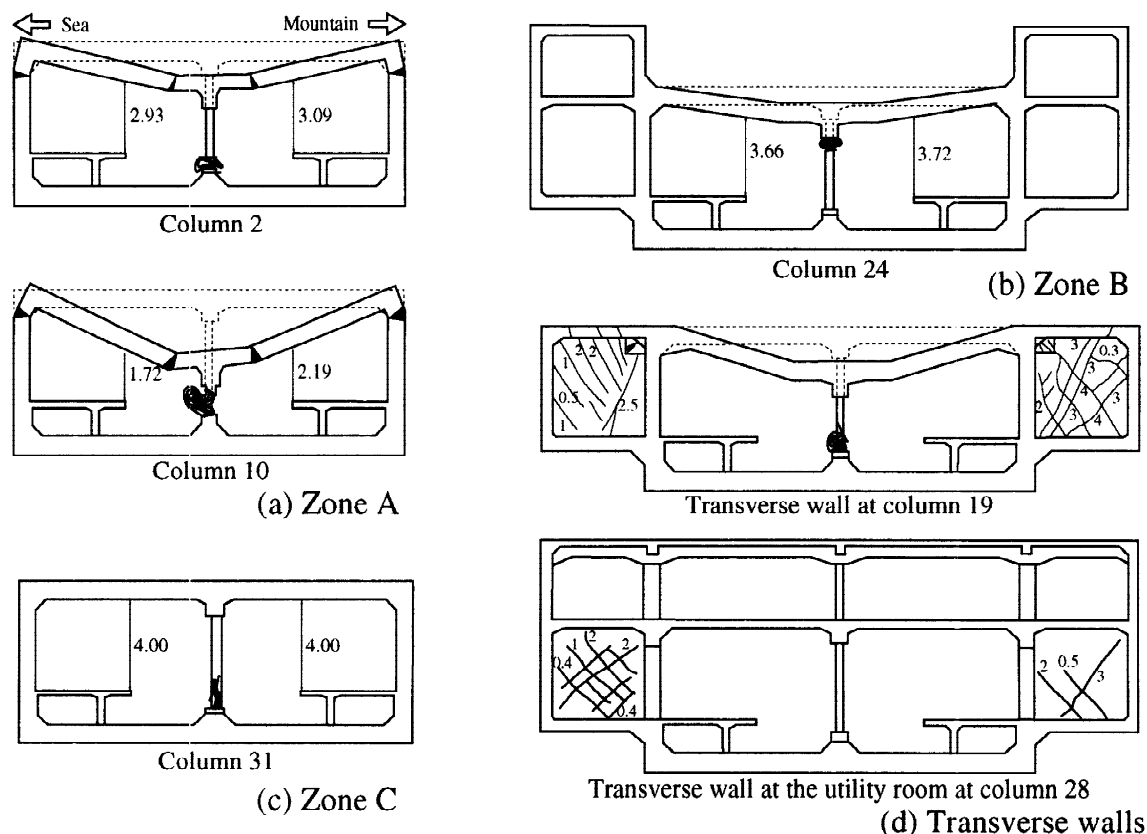
Fig. 9 Schematic figure showing the damage pattern in the transverse direction

In the lateral wall, separation of cover concrete was observed near both the top and bottom haunches. According to the investigation of the exterior surface, wide cracks in the longitudinal direction were observed along the intersection with the haunch. Under the platform, a significant separation of cover concrete was observed on the both side lateral walls. There are several walls in the transverse direction: both ends, electric facility room, switching station room, etc. Diagonal cracks typically shown in Fig. 9(d) and Photo 2 were observed in all the walls in the transverse direction.

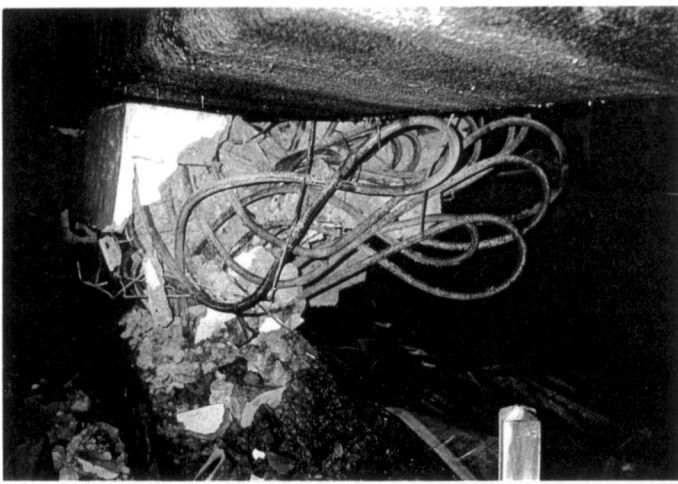
Photo.1 Collapse of no.10 column in Zone A

Based on the observation of the damage to these columns and walls, the mechanism of the damage of the collapsed column in zone A is evaluated to be as follows: 1) Due to strong horizontal force, the member reaches its strength under the combination of bending moment and shear force acting near the end of the column, which resulted in collapse of the end of the column. 2) The load carrying capacity of the box frame was reduced, and therefore excess relative horizontal displacement occurred.

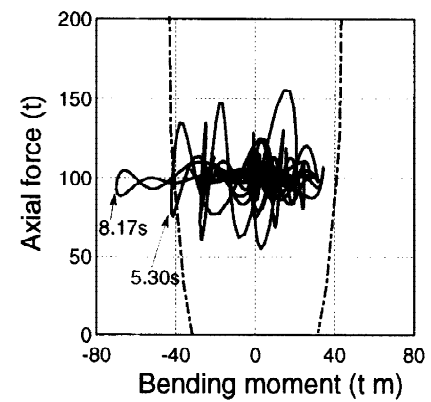
Fig. 12 Bending moment-axial force relationship at the bottom of the center column

axial force and bending moment at the bottom of center column is shown in Fig. 12. Here, axial force is the sum of the dynamic response value and initial force under ordinary load condition. In the figure, the ultimate bending moment under given axial force is shown as a chained line. The maximum axial force (sum of forces under ordinary load and increment due to earthquake) is about 1520 kN (13300 kN/m^2), which is high in comparison with the strength of concrete. The ratio of the axial stress to the strength of concrete is about 0.36. Response bending moment at the bottom of the center column exceed the ultimate bending moment twice, at around 5.3 and 8.13 seconds, respectively. The same tendency is observed at the response of lateral wall, ceiling and base slab. The ductility of the center column is a very small value, 1.3. The ductility is defined as the ratio of the rotational angle of member at the ultimate bending moment to that at the yield of reinforcing bar with respect to the axial force at 5.3 seconds. Therefore, center column was possible to collapse just after the bending moment exceed the yield bending moment. Furthermore, the ratio of the shear strength of center column calculated by the Standard Specification of Reinforced Concrete (JSCE, 1991) to the converted shear force from the ultimate bending moment is less than 1.0. Therefore, center column was also possible to collapse under shear.

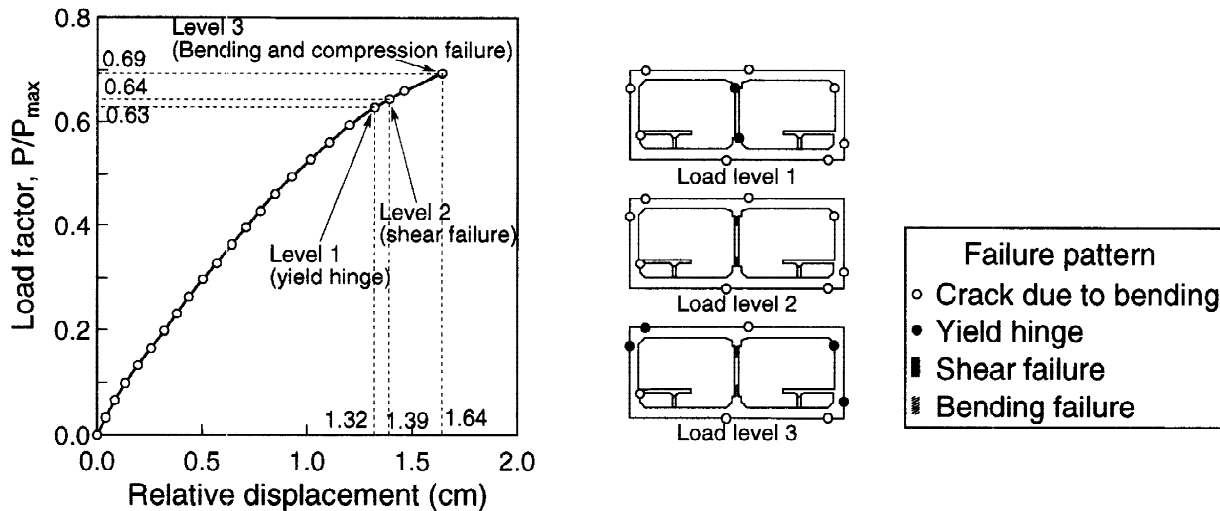
Fig. 14 The relationship between the applied load and the displacement of ceiling relative to base slab

The relationship between the applied load and the displacement of the ceiling slabs relative to base slab are shown in Fig. 14. The vertical axis (sum of the applied forces) is the normalized by the sum of the final force. Shear failure of center column occurred when the relative displacement was 1.39cm, just after the yield. Damages more than crack isn't recognized to the other members. After subsequent loading the load, bending combined with compression failure occurred right after the relative displacement and increase to 1.64 cm where normalized load was 0.69. Therefore, failure mechanism of one story box frame in Zone A is that ceiling slab failed the lack of the load carrying capacity of center column.
