# **“BEHAVIOUR OF MAN-MADE AND NATURAL SYSTEMS DURING 30<sup>th</sup> SEPT 1993 EARTH-QUAKE AT KILLARI, MAHARASHTRA, INDIA”.**

Copyright © 1996 Elsevier Science Ltd  
*Paper No. 433. (quote when citing this article)*  
Eleventh World Conference on Earthquake Engineering  
ISBN: 0 08 042822 3

The survey of earthquake damage was carried out from 3rd November to 9th November 1993 by the authors at and around Killari, Maharashtra, India. Damages to various man-made structures and natural systems are discussed. For a moderate shock of 6.4 magnitude the loss of life and property was very heavy. The reason for this is also analysed. Importance of ductile detailing is explained. The critical nature of role of expert is discussed. In most of the Technical Institutions of India earthquake resistant design is not included in the syllabi of civil engineering courses. The need for introducing it and also educating the masses is stressed.

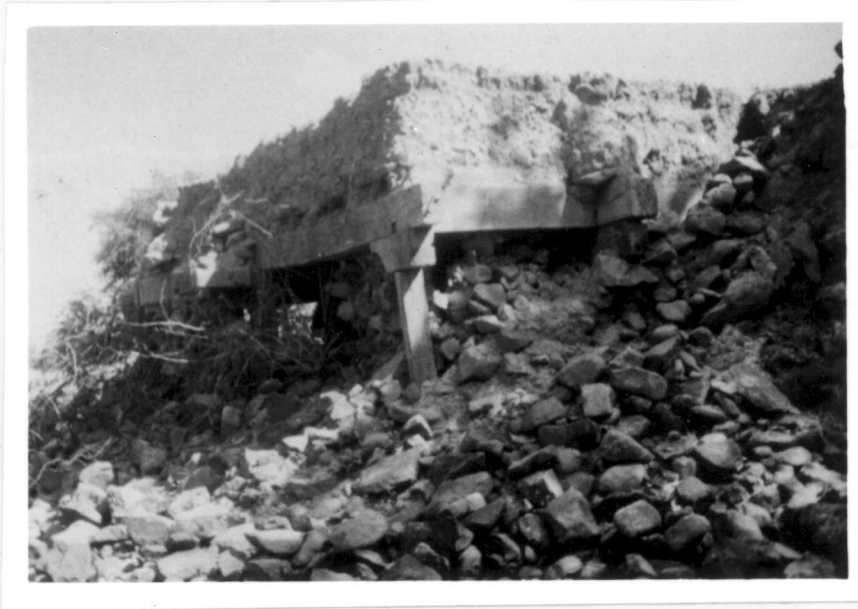
**Reasons of Failure.** Very thick walls generated large inertia forces which led to shattering of walls in most of the cases. (Photograph 1) Thick overburden of soil and impact of heavy walls led to collapse of timber frames at many places.

Photograph 1. Timber frame structure.Thick over burden of soil on top. Shattered walls. These were constructed in non-engineered stone masonry with mud mortar.

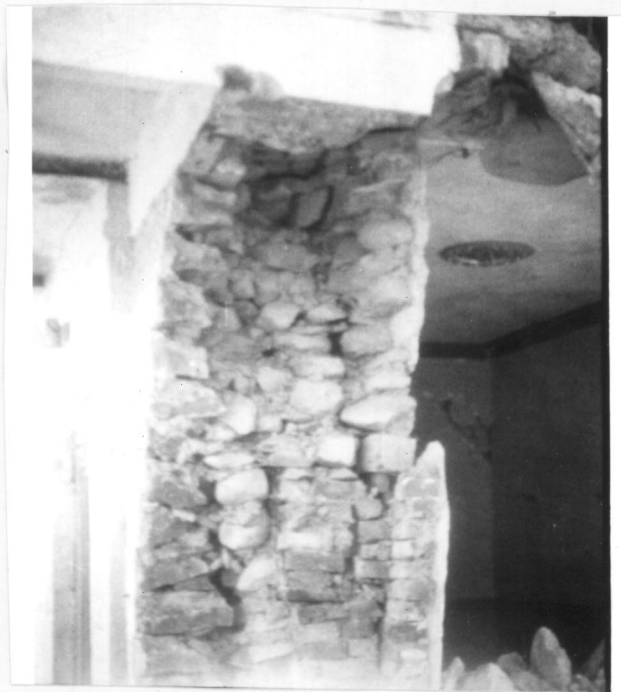
Due to recent increase in cost of timber flooring system people avoided incorporating them and instead used R.C.C. slabs on load bearing masonry walls of same type.(Photograph 2)

Reasons of Failure. Faulty practice of construction of walls led to their shattering, resulting in collapse of slab.

Photograph 2. Typical cross section of wall. Wall constructed in mud mortar. All sorts of stones,brick bats are used. No through stones.

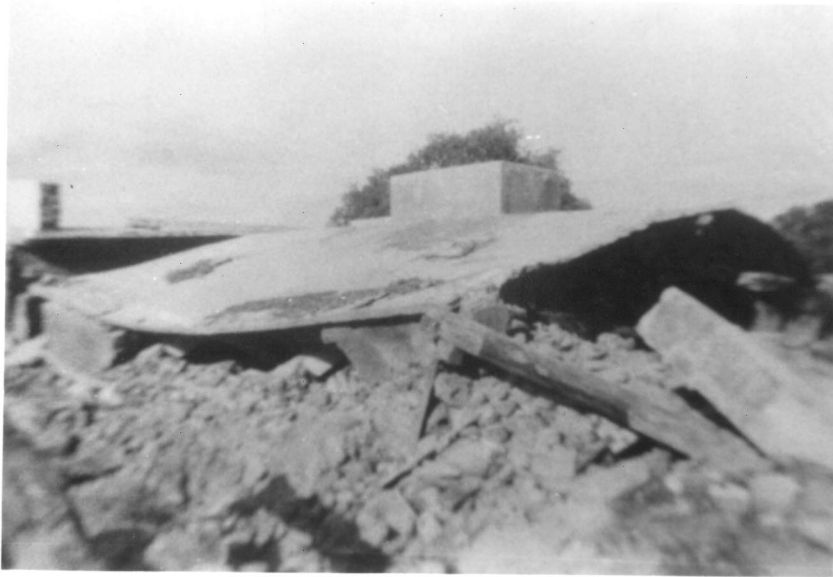
Photograph 3. Collapse of slab due to failure of walling system.

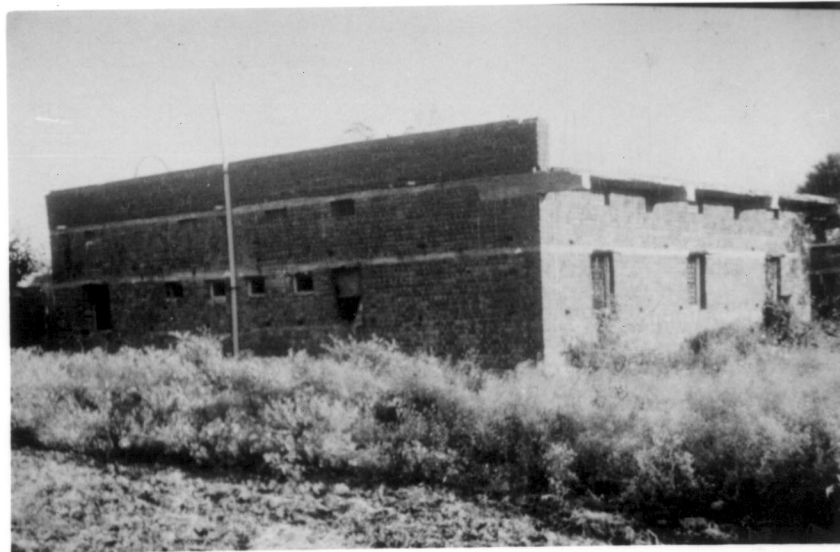
At Killari there was a cluster of 5-6 load bearing brick houses with only R.C.C. lintel bands.These houses suffered no damage,due to tieing effect of lintel band. (Photograph 4)

Photograph 4. Intact house at Killari due to provision of continuous lintel band.

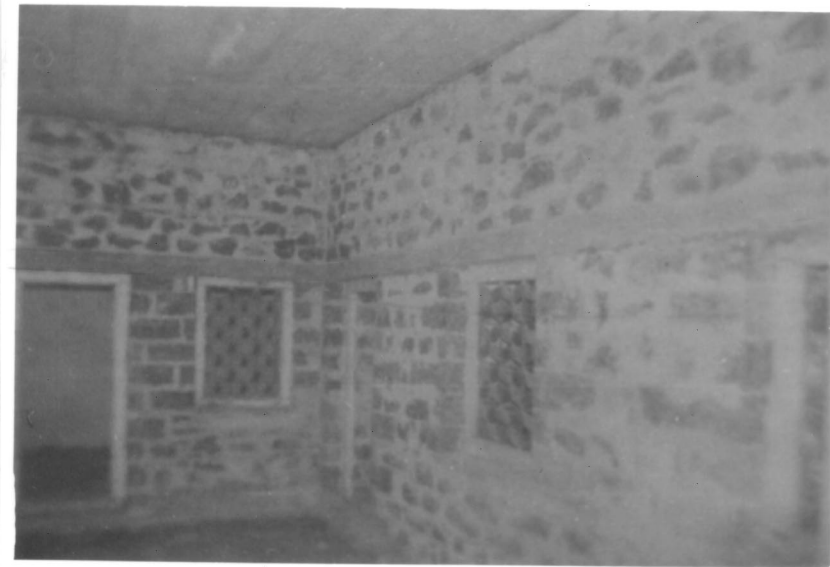
Photograph 5. Inside view of stone masonry house without any damage due to provision of lintel band. (At Petsangvi 5.5 km from epicentre)

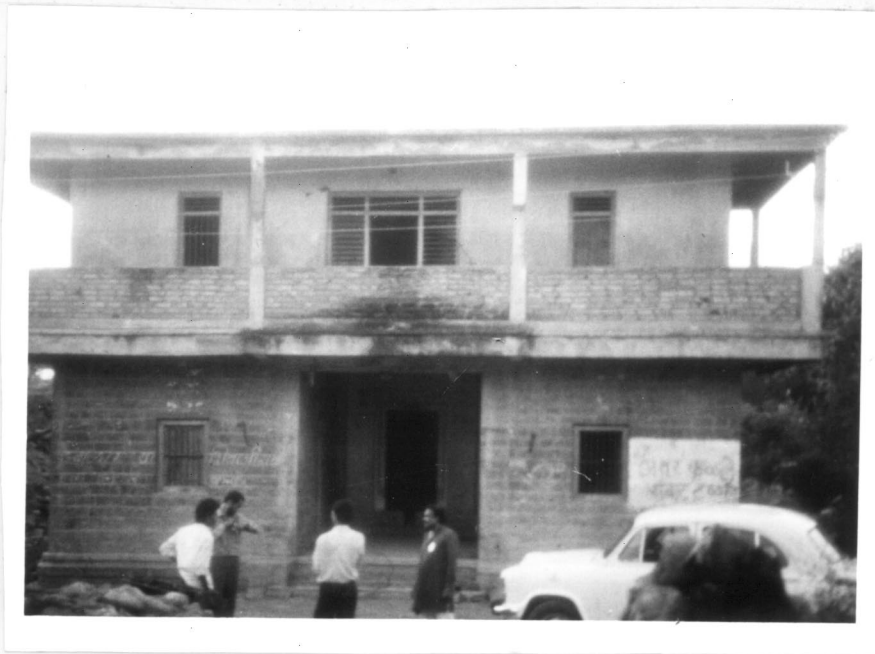
Photograph 6. Two storeyed intact building at Sastur constructed with good quality stone masonry, though no bands were provided. (At 7 km from epicentre)

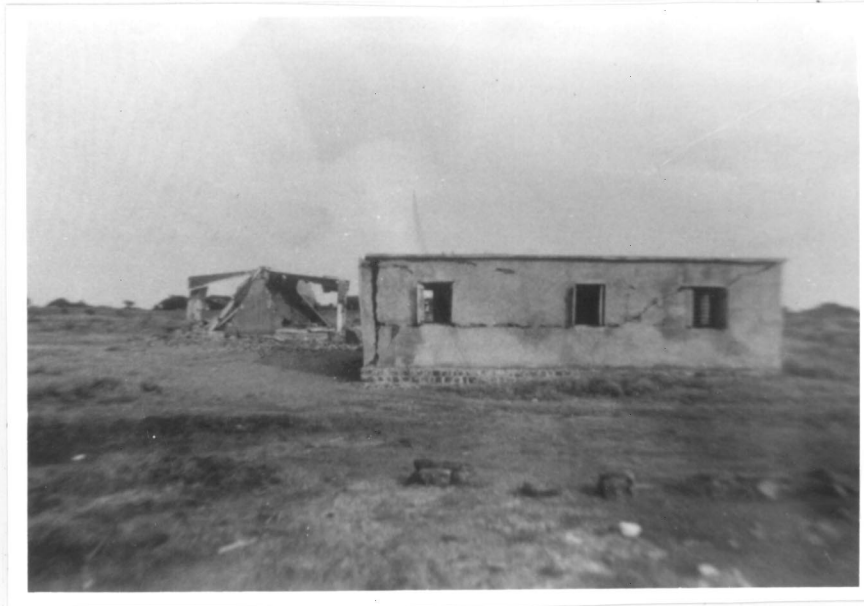
Photograph 7. damage to school building due to long walls without columns & horizontal bands

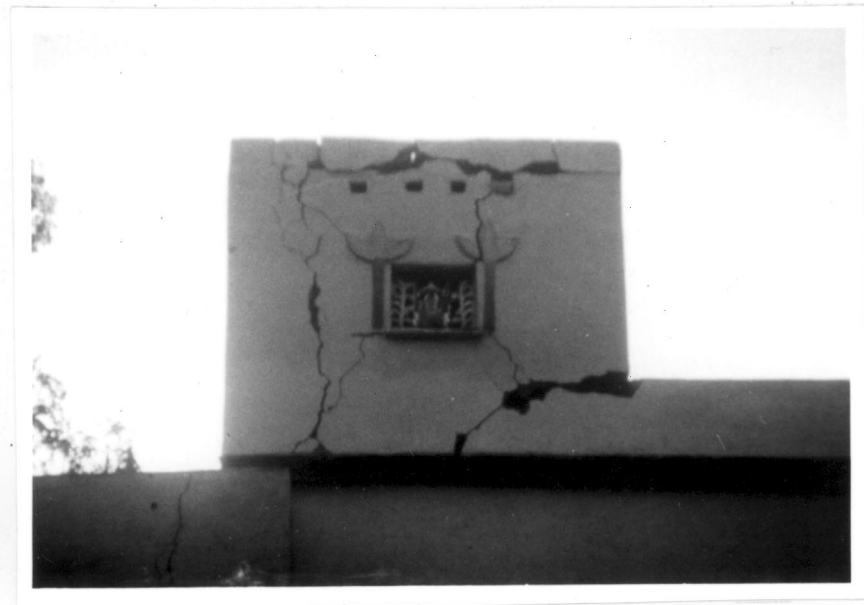
Structures having long walls without lintel bands were badly damaged or collapsed. Small structures on top of bigger structures experience more vibrations and hence these must be designed for large forces. It is called as appendage effect. (Photograph 8) Proper detailing is required for such type of structures, otherwise these will be badly damaged.

Photograph 8. damage to staircase tower. Appendage effect

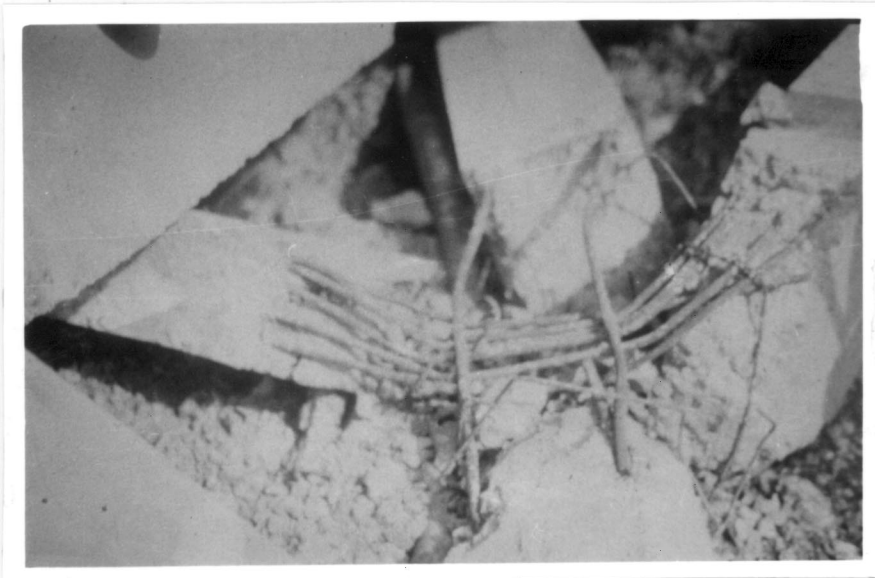
Most of the engineered structures though not designed for seismic forces survived the earthquake. Two number of R.C.C. overhead water tanks collapsed during earthquake, one of which was at Kawatha village. Improper detailing of column reinforcement was visible at this site. The second collapse of water tank was observed at Chincholi (Rebe), which was supported on masonry staging. (Photograph 10) It is suggested that for new constructions in the affected area, Zone IV must be considered as per IS 1893-1984. Analysis was done for this water tank considering forces for zone IV. Theoretically this tank was safe but it collapsed. Codes indicate that structures will normally experience more ground motion than the one envisaged in the specified seismic coefficient. It is assumed that the energy absorbing capacity available in inelastic range of ductile structures will be able to resist such shocks without much damage. As there is no reinforcement in vertical direction, masonry staging of Chincholi (Rebe) water tank became brittle structure and failed. Suitable provision in codes are required for making the structure ductile or higher forces must be recommended for analysis of brittle structure.

Photograph 9. Collapsed R.C.C. water tank at Kawatha. Junction of column & bracing. Absence of confining steel in the column & beams. Improper placement of steel in bracing. (3 km from epicentre)

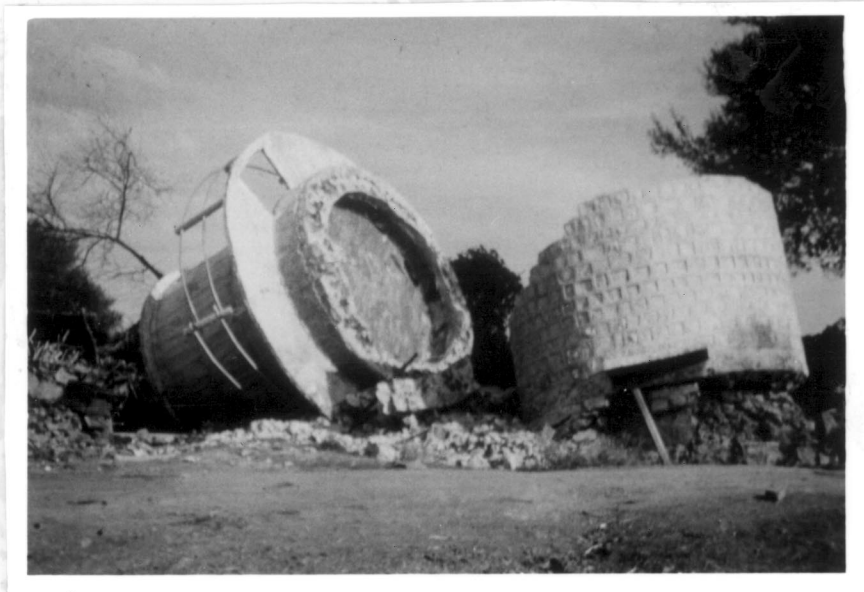
Photograph 10. Collapsed water tank at Chincholi (Rebe) 3 km from epicentre
