## **DAMAGE DETECTION BY MODAL TESTING**

H.G.L. Prion and M. Rezai K.

Department of Civil Engineering, The University of British Columbia  
2324 Main Mall, Vancouver, B.C., Canada, V6T 1Z4

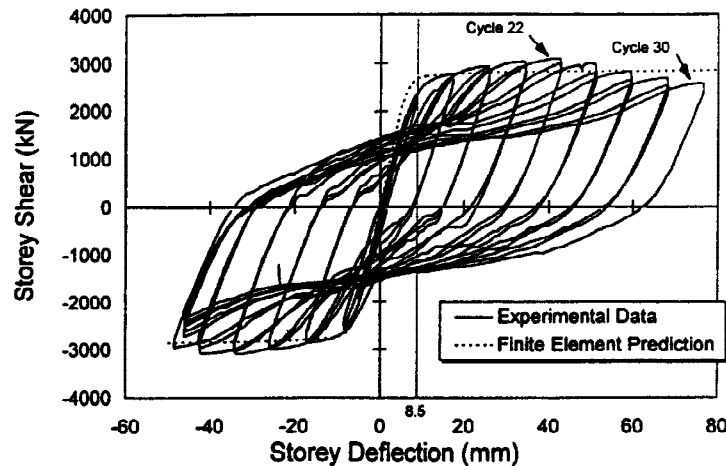
Figure 2: Load-displacement curve of test frame (bottom storey) (Driver *et al.*, 1995)

stiffness with increasing load cycles. Tears also developed in the corners where the shear panels were attached to the beams and columns (Fig. 4). All the tears propagated very slowly as loads were redistributed to adjacent parts of the frame. A crack developed in the west column starting from the weld to the base plate (Fig. 5) during the 30th load cycle, resulting in a sudden load drop and termination of the test. Before this occurrence, the remaining load capacity of the frame was about 85% of the maximum load and the stiffness was about 88% of the initial elastic stiffness (Fig. 2).

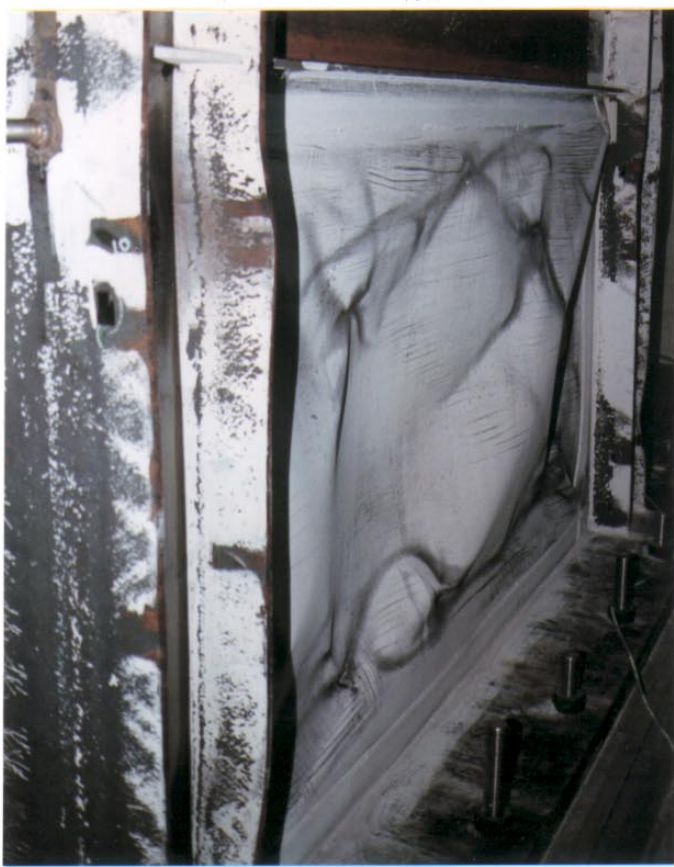
The bottom shear plate sustained the most severe damage from buckling and yielding (Fig. 3). Repeated folding caused several small tears in the plate, which resulted in a gradual degradation of load carrying capacity and

**Figure 3:** Bottom storey of frame showing deformed steel plate and buckled column members

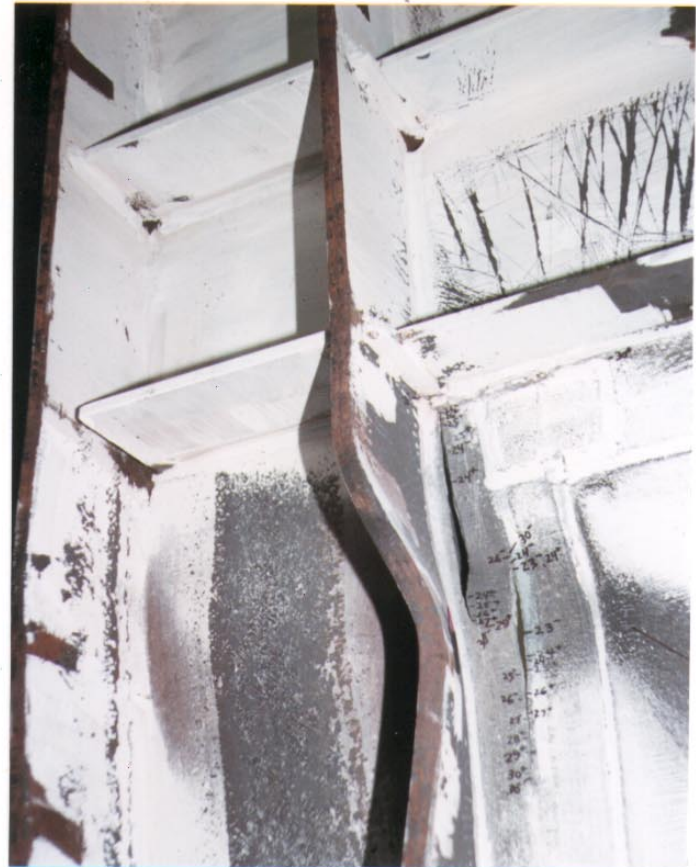
**Figure 4:** Tearing of shear plate at corner locations

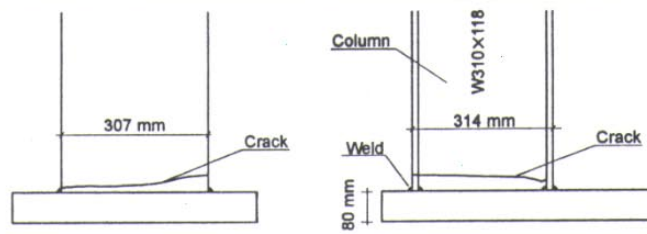
**Figure 5:** Crack pattern in west column

For the purpose of comparison, an elastic dynamic analysis of the frame with the bottom shear panel removed and the column bases pinned, yielded a natural frequency of 15.6 Hz, while the same model with fixed column bases had a natural frequency of 25.4 Hz. This indicates that the damage in the bottom panel and in the column contributed mostly to the decrease in frequency. In the transverse direction the crack in the column was the major cause for the softening effect. Although the crack severely impeded the bending strength, the stiffness was not affected to the same extent.

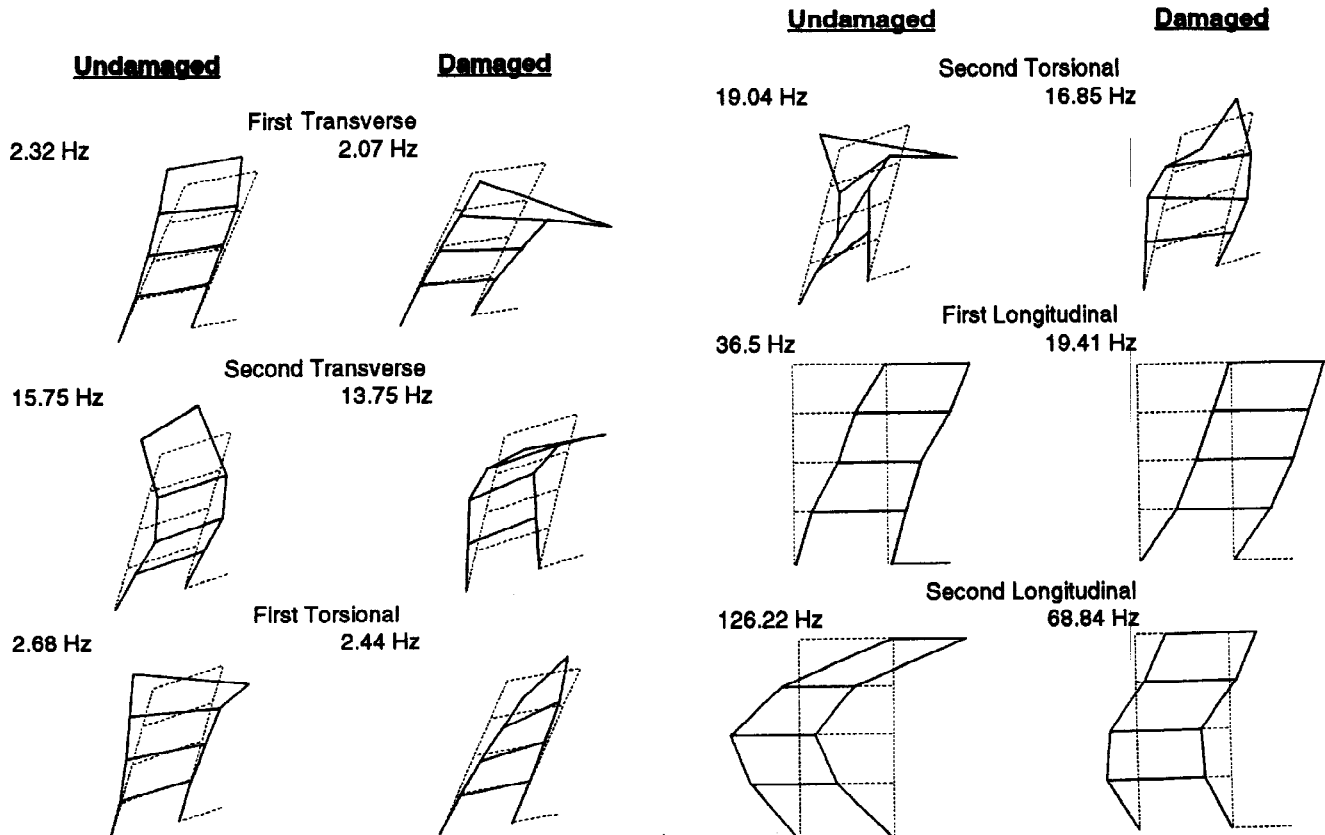
Figure 7: Mode shapes of undamaged and damaged frame

crack in the one column and damage to the shear plate in the bottom storey. The transverse (out-of-plane) mode shapes clearly show a shift from symmetric to unsymmetric motion, accompanied by a moderate decrease in natural frequency. A small decrease in natural frequency of the buckled infill plate in the out-of-plane direction could be attributed to tearing and crumpling of the plate.
