## **SAFETY OF DAMS DURING HYOGOKEN-NAMBU EARTHQUAKE ON JANUARY 17, 1995 IN JAPAN**

**AKIRA NAKAMURA, ISAO NAGAYAMA,  
TAKASHI SASAKI and TOMOYA IWASHITA**

Dam Department, Public Works Research Institute (PWRI), Ministry of Construction, Japan

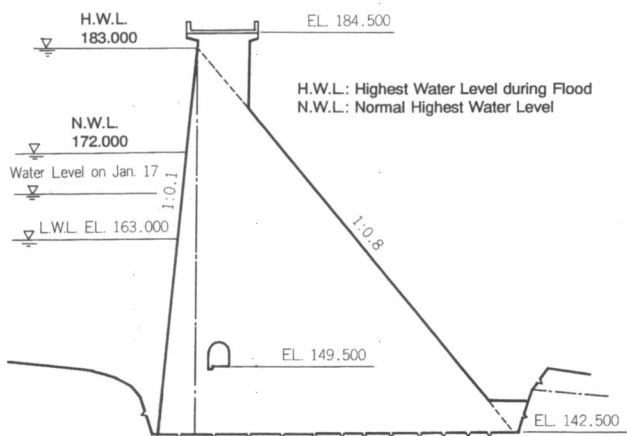
**Figure 3 Cross section of Yuzuruha Dam**

**Yuzuruha Dam** - The Yuzuruha Dam is a 42 m-high concrete gravity dam, located approximately 43 km from the epicenter. Figure 3 shows the cross section of the dam. The special safety inspection by the site office reported slight spalling of the concrete on the upstream face, but the PWRI investigation found that some mortar placed for a surface finish had peeled off, and no damage of the dam body was observed (Photo. 1). Water from the foundation drainage holes became slightly turbid after the earthquake, but the turbidity disappeared after several days. The amount of drainage water and uplift pressure both increased slightly after the earthquake, but stabilized later.

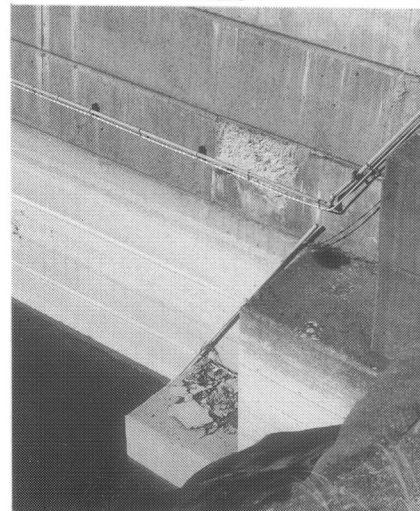
**Photo. 1 Spalling of mortar on the upstream face of Yuzuruha Dam**

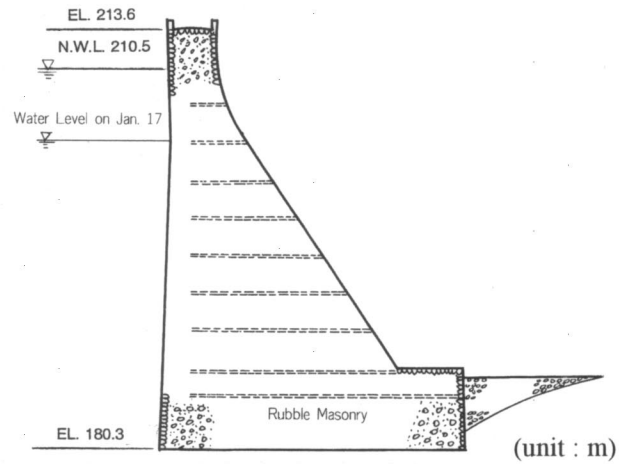
Figure 5 Cross section of Gohonmatsu Dam

Gohonmatsu Dam - Completed in 1900, the Gohonmatsu Dam is a concrete gravity dam (rubble masonry structure) located about 19 km from the epicenter. The height of the dam is 33.3 m. Figure 5 shows the cross section of the dam. Rock fragments at the left abutment fell into the spillway, and hairline cracks were found on the capping concrete on the crest railing, but there were no cracks on the dam.

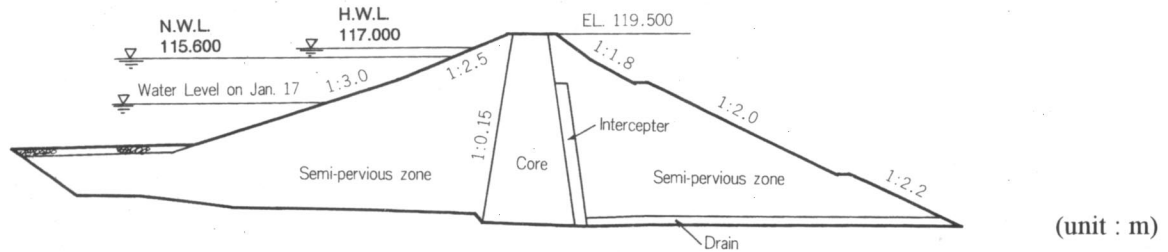
Figure 4 Cross section of Tokiwa Dam

**Tokiwa Dam** - The Tokiwa Dam is a 33.5 m-high zoned earthfill dam, located about 10 km from the epicenter. The dam is as close as 800 m to the Nojima fault, which moved during the earthquake. Figure 4 shows the cross section of the dam. 25 mm wide and 7 m long transverse cracks were observed in the pavement at the end of the crest of the dam near both abutments (Photo. 2). Subsequent excavation by the dam owner showed that one of the cracks reached the top of the core materials, but remained within the freeboard. Rock fragments from the right abutment fell down, but the upstream and downstream slopes of the dam body were not damaged.

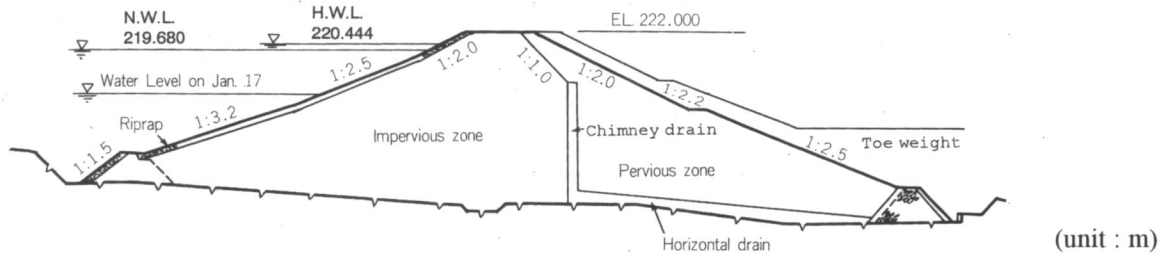
Figure 6 Cross section of Kitayama Dam No.1

Kitayama Dam - The Kitayama Reservoir is formed by five homogeneous earthfill dams — dam No. 1 to No. 5. The reservoir is located about 31 km from the epicenter. Figure 6 shows the cross section of dam No. 1. The dam has a height of 24.5 m with decomposed granite soil used as fill material and is embanked on a foundation of weathered granite. A shallow sliding of the upstream surface of the dam occurred (Photo. 3), but the stability of the dam was not affected.

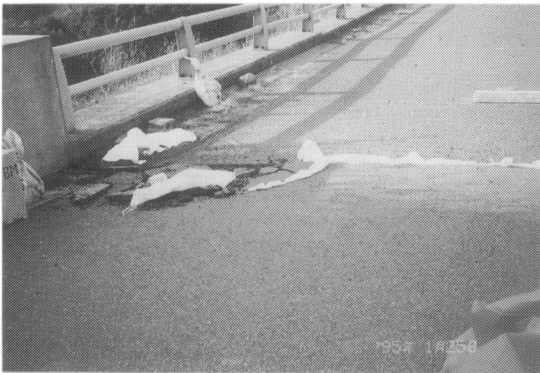
Photo. 2 Cracking at the crest of Tokiwa Dam

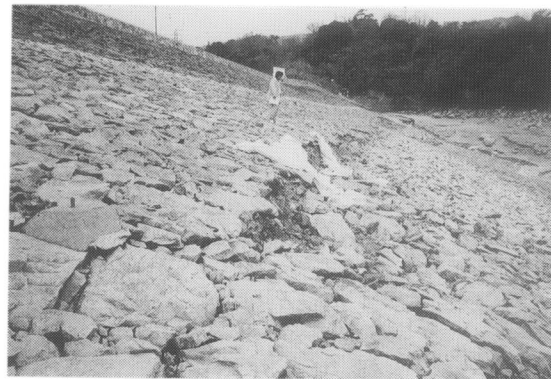
Photo. 3 Shallow sliding at the upstream slope of Kitayama Dam No.1
