EFFECT OF FLOOR SLABS ON THE PERFORMANCE OF SMR CONNECTIONS

JEROME F. HAJJAR and ROBERTO T. LEON

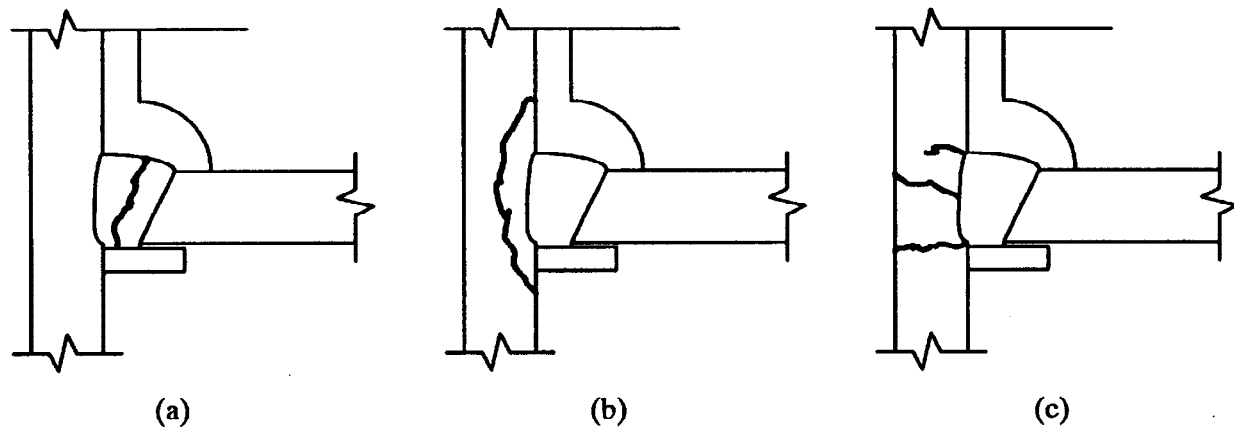
The failures observed occurred in frames with a great variety of geometrical configurations, and often in frames that were only a few years old, indicating unexpected shortcomings in current design and detailing procedures. Much of the damage that was observed in the frames concentrated on brittle failures of the welds, HAZ, or column flanges and webs, with the failures starting at or near the full penetration welds connecting the bottom girder flange to the column (Fig. 1).

Fig. 1. Typical failures for SMR connections: (a) full or partial crack through weld metal or HAZ; (b) flange tear-out or divot; and (c) partial or full column flange or web crack (after (Youssef et al., 1995)).

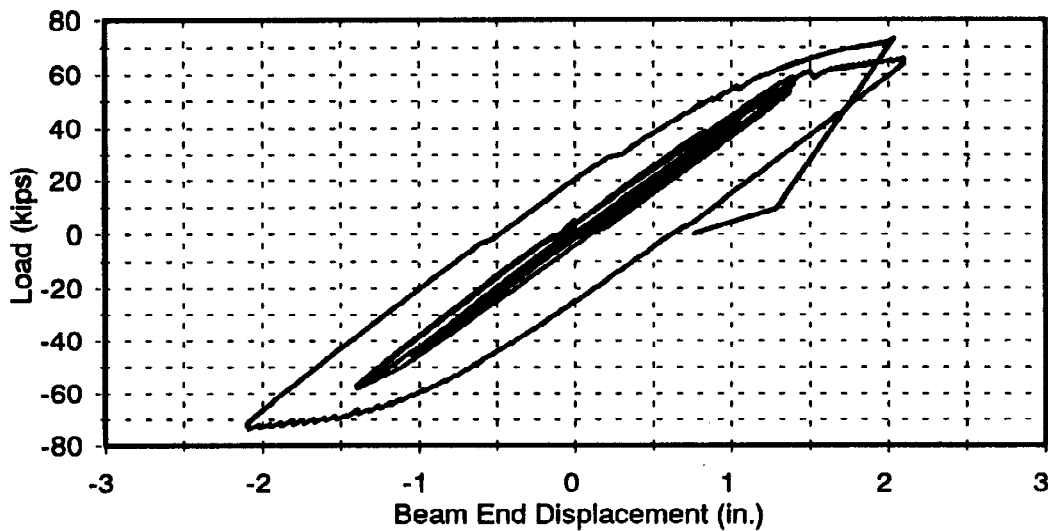
Figure 4 shows the beam end load versus beam end displacement curve for the West beam of Test 1. The bottom weld on this beam, which had a backing bar attached to it, fractured early in the test, during the second full cycle of loading at 1.5% drift (in the figure, 1.4 inches of beam displacement corresponds to 1% interstory drift). The failure was similar to that shown in Fig. 1(a), except that it occurred just outside the weld in the HAZ between the weld and the column flange. The specimen gave very little evidence of the impending failure except for slight bowing of the backup bar, which started at a drift of 1% and probably indicated that a crack had begun to grow at the root of the access (cope) hole. Yielding had begun at the 0.75% story drift level, as evidenced by the flaking of the lime coating applied to the beam and in the strain data, but at 1.5% drift, the only substantial yielding that had taken place was in the flanges, within a few inches of the welds. Thus, the pattern of yielding indicated that the beam had not reached anything near the plastic hinge stage. The West beam only achieved a rotation of 0.0068 radians before failing.

Fig. 4. Load-deflection curve for West Beam (Test 1).

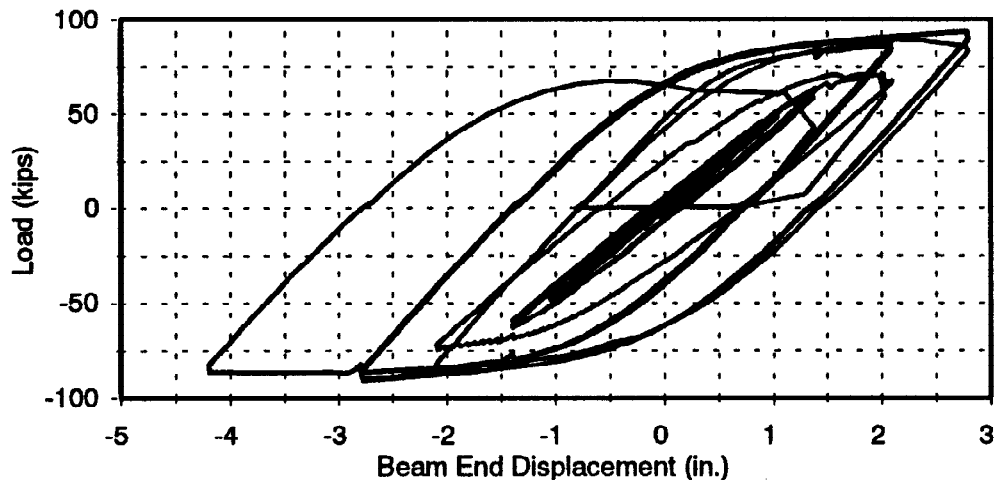
After the failure of the West beam, the actuators on that beam were disconnected and testing was continued on the East beam as a cantilever specimen. Figure 5 shows the behavior of the East beam throughout its displacement history. The connection on the East side had a backing bar on the top but no backing bar on the bottom. As shown by Fig. 5, this connection behaved much better. At the 1.5% and 2.0% drift levels, there was substantial yielding observed in the beams, with some of it propagating into the web and around the bolt holes in the beam web. There was a small buckle that began forming in the bottom connection at the 2% drift level. This buckle grew substantially during the first loading cycle at the 3% drift level and led to the formation of a large crack in the base metal of the girder upon load reversal. The crack initiated in the area of stress concentration on the top side of the bottom flange at the root of the access hole. It propagated predominantly to one edge of the beam flange at the flange-weld intersection. This failure was due primarily to low-cycle fatigue and occurred after the connection had undergone several cycles at rotations of about 0.012 radians, but it only sustained a rotation in excess of 0.025 radians during the first excursion to 3% drift.

Fig. 5. Load-deflection curve for the East beam (Test 1).

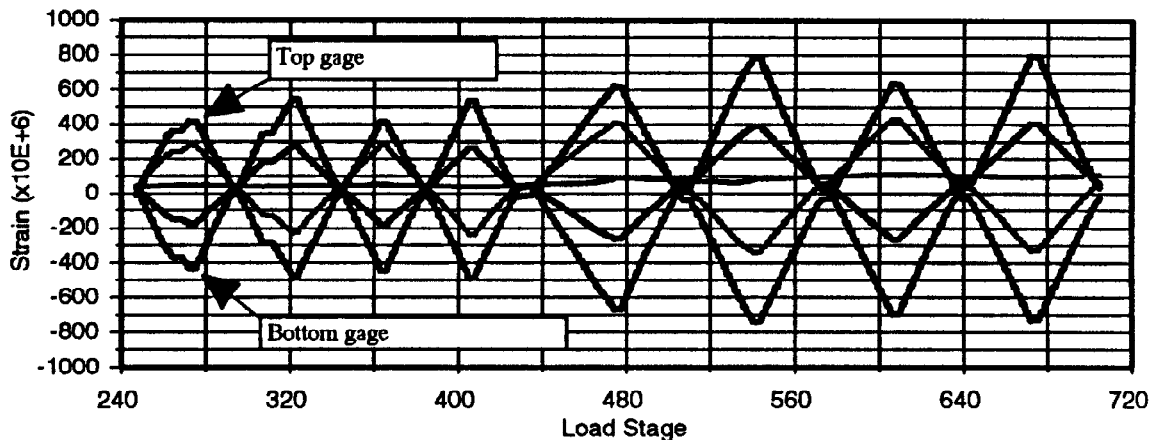
Figure 6 shows the strains measured from five strain gages located at a distance of 13.5 in. (beam depth/2 = $D/2$) from the welded connection. The gages were located at the extreme fibers, at the quarter depths, and at the centerline of the section. The load stages shown correspond to the 0.5% and 0.75% story drift levels.

On a first inspection, the data indicates that at this cross-section an assumption of plane sections remaining plane, such as is made in design for the determination of the connection forces, is reasonable. The calculated strains from an elastic analysis at these stages would have been about $490 \mu\epsilon$ for the 0.5% drift level and $770 \mu\epsilon$ for the 0.75% drift level. A closer inspection reveals subtle but important deviations. The bottom flange shows significantly larger strains when loaded in tension (positive strain) than compression, while the top flange shows larger compressive strains than tensile. However, the largest tensile strain in the bottom flange is consistently larger than any top flange strain. Also, the strain gage at the web centerline, which should remain at zero strain, shows a steady migration towards the tension side of the bottom flange, thus indicating a neutral axis shift. Even in the bare steel specimen, the placement of the shear tab much nearer to the top flange may lead to more excessive straining of the bottom flange.

Figure 6. Strains at D/2 for the East Beam (Test 1).

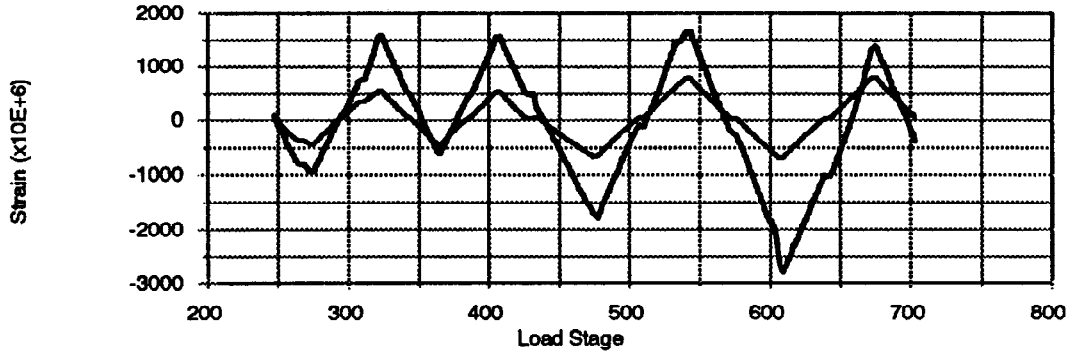
Figure 7 shows a comparison of the strains measured on the bottom flange at D/2 with those measured at a distance of 1.0 in. from the weld utilizing a high elongation strain gage. Linear elastic theory would have predicted that the strains at the weld would have been roughly 11% higher. Figure 7 indicates that they are much higher, on the order of three times larger. This indicates a substantial strain concentration near the weld. Detailed finite element studies (performed at the University of Minnesota as part of this research) utilizing a very fine discretization in this area indicate that stress concentration factors on the order of 2.0 to 2.5 are to be expected in this region, and that larger values (on the order of 3 to 4) can be expected at the weld/column flange interface. The important conclusion from these measurements is that the local ductility demands are very high, since most of the stress concentration occurs within 2 to 3 in. from the weld. From a practical standpoint, these stress concentrations also mean that it is unlikely that the full plastic moment capacity can be reached for beams near the 70% flange moment capacity limit even considering the effect of strain hardening. For the W27x94 beams used in these tests, for a yield strength of 47 ksi, the data indicates that yielding started at a girder tip load of 35 kips rather than the 94 kips calculated from linear elastic theory.

Fig. 7. Comparison of strains at D/2 and at the connection face for the East Beam (Test 1).

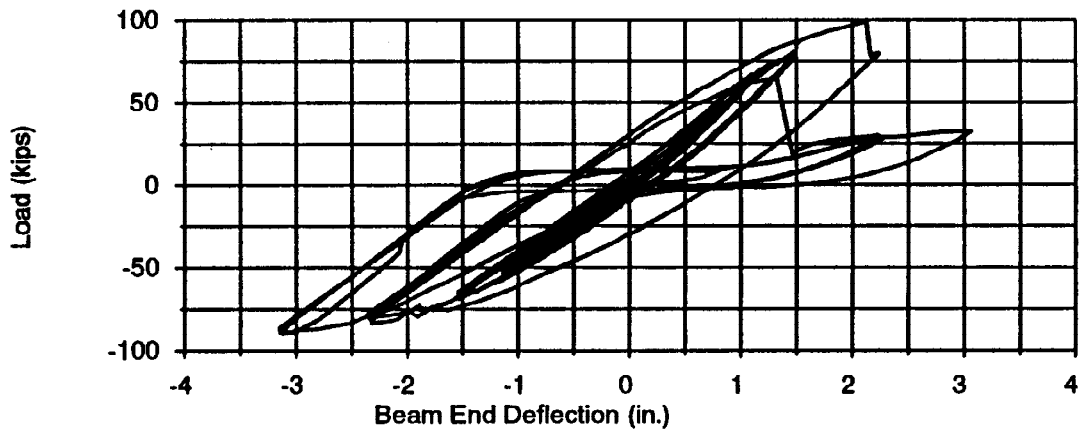
Figures 8 and 9 show the beam end load versus displacement curves for Test 2. In Test 2, the overall behavior was not entirely dissimilar to that of Test 1. One side, the East beam (Fig. 8), again failed brittlely at low levels of drift, but in a two-stage fashion. The first crack, which was initially hard to detect from the surface except for the bowing of the backup bar, originated at the access hole near the top of the first loading cycle to 1.5% drift. The initial crack, which propagated only about halfway to the edge of the flange, resulted in a moderate loss of strength (about 20% of total capacity). Since the crack occurred at about 1.4%

drift, the specimen was displaced further (to 1.5% drift) and the load held for a significant period of time (15 minutes) without the crack propagating further. However, the connection failed completely during the second cycle at this same deflection level. The fracture was very similar to that in Test 1 (West beam -- Fig. 1(a)) and resulted in a decrease in capacity of about 75%. Further cycling of this beam (Fig. 8) resulted in a very unsymmetrical behavior, with the connection exhibiting little strength and stiffness when the bottom flange was subjected to tension, but achieving and maintaining its capacity when loaded in compression. The behavior of the West beam, on the other hand, was satisfactory (Fig. 9) up to the 2% drift cycles. Further loading at 2% drift resulted in a brittle failure in the HAZ of the column (Fig. 1(a)).

Fig. 8. Load-deflection curve for the East beam (Test 2).

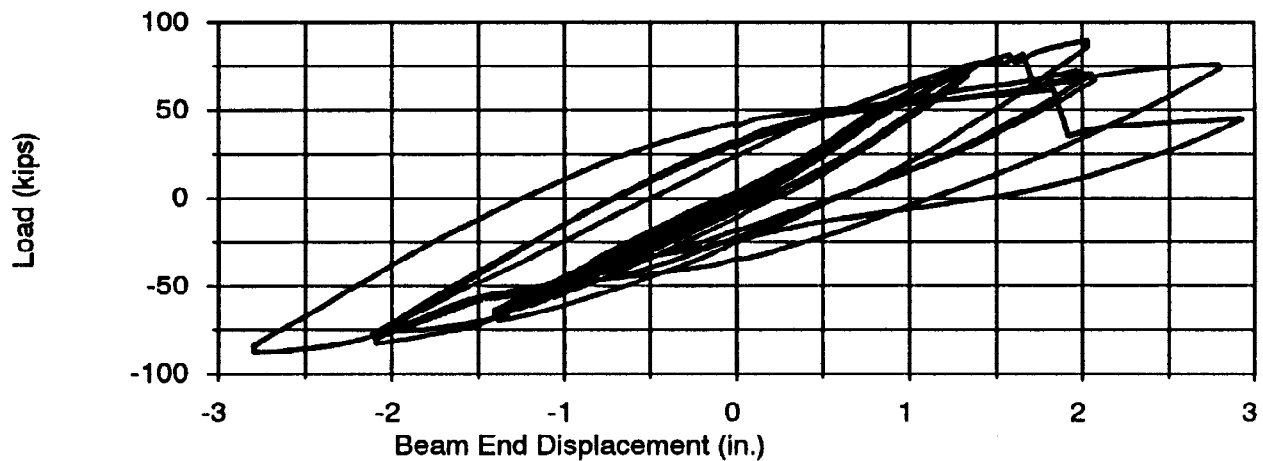
Fig. 9. Load-deflection curve for the West beam (Test 2).

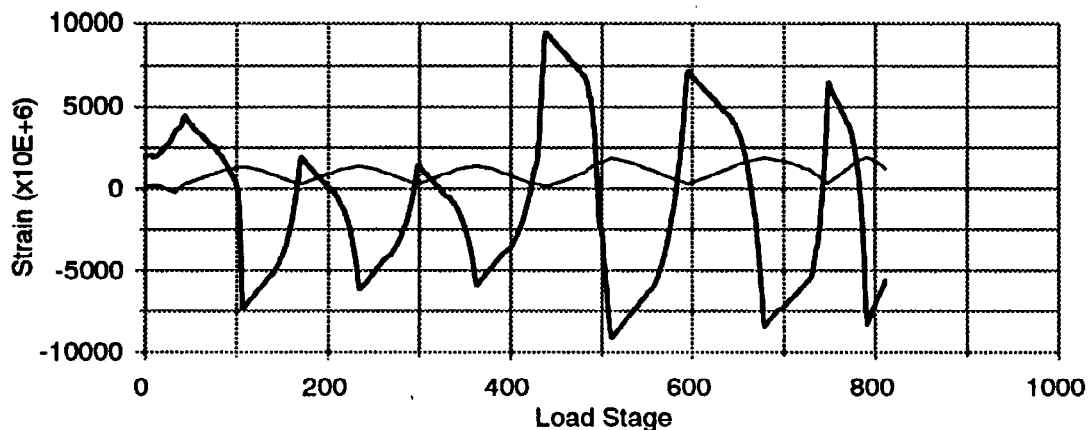
The strain data for Test 2 showed clearly that the neutral axis had migrated several inches upwards when the connections were loaded in positive bending. The neutral axis moved little when loaded in negative moment, indicating that the slab steel was participating little in carrying the loads. A comparison of the strains at the top and bottom flanges of the connection 1 in. from the weld (Fig. 10) shows that there is almost an order of magnitude difference. The data shown is for cycling at 0.75% and 1.0% interstory drift. The strains in the top flange, under the slab, fluctuate by only about 2000 $\mu\epsilon$ during each cycle and indicate essentially elastic performance. The strains in the bottom flange, conversely, are inelastic and show cyclic yielding early in the load history.

Fig. 10. Comparison of strain at the top and bottom of the flange near the connection (Test 2).
