DISTRIBUTION OF STRUCTURAL DAMAGE AROUND THE MUKOGAWA RIVER BASIN
SUFFERED FROM THE GREAT HANSHIN (HYOGOKEN NANBU)
EARTHQUAKE OF JANUARY 17, 1995

Hisanori MORIMOTO, Tadatoshi FURUKAWA and Kensuke BABA

Department of Architectural Engineering, Osaka University,
2-1, Yamada-Oka, Suita, Osaka 565 JAPAN

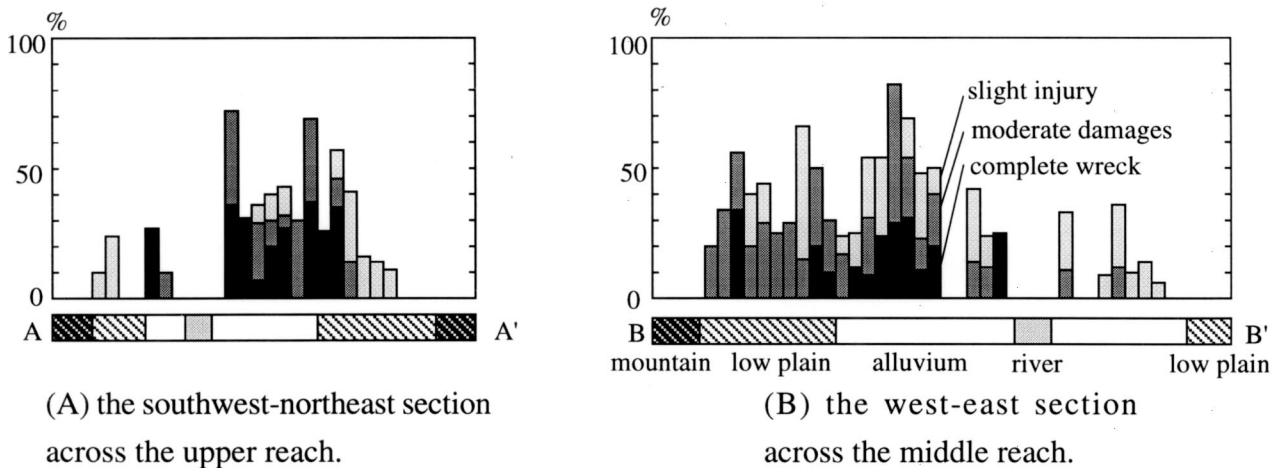
The most severe damage of structures is concentrated within the narrow corridors and extended straight with a little inclination to the north in the coastal alluvium of the west-east stretching Kobe and Ashiya districts along the Osaka bay shore. They are, however, swinging and fragmentary along the Rokko and Hokusetsu Mountains from the cities of Nishinomiya, Takarazuka and its east to the border of the Osaka prefecture, across the alluvial fans stuck on the mountainside as well as the soft deposits of the Mukogawa river basin. In the eastern area stricken by the quake, the swinging corridors are generally divided into three parts. The first, which trends from

west-southwest to east-northeast, passes through the southern portions of Ashiya and Nishinomiya cities and traverses the soft alluvial deposits in the lower reaches of the Mukogawa River. It is interrupted suddenly by the Itami river terrace and relatively under the little damage because these soils are much stiffer than the riverside alluvium. However, the damage associated with the first corridor surfaces again to the east, on the alluvial deposits of the Inagawa River. The second, which runs south-to-north and slightly to the east of the Rokko Mountains, starts from the downtown area of Nishinomiya City by mingling with the first corridor to the riverside zone of Takarazuka City. It is worthy of note that the severe damage is fragmentarily distributed not only on the soft deposits of the Mukogawa River but on the alluvial fans growing firmly along the Rokko mountainsides. While the third stretches west-to-east from the cross point with the second in Takarazuka City toward Kawanishi City, parallel to the southern face of the Arima-Takatsuki tectonic line or the southern foot-line of the Hokusetsu Mountains along which the Nakayama Old Highway is extended. The outward look of damaged structures is researched in the west-east section B-B' across the east end of the rocky Rokko Mountains, the mountainside fan alluvium, the soft deposits in the midstream of the Mukogawa River and the stiffened Itami terrace, as well as in the southwest-northeast section A-A' across the downtown area of Takarazuka City and the upper reaches of the Mukogawa River. As given in Fig.2(B), the severe damage is distributed on the mountainside fan alluviums in the same amount as on the riverside deposits around the western side of the middle reaches. Across the stream to the east, the damage distributions extremely decrease over the riverside formations and almost diminish when arriving at the Itami terrace. On the contrary to the condensed breakage around the westside midstream, the wrecked structures are crowded on the opposite riverbank in the upper reaches because of the winding stretches of the suffering corridors along the foot of the mountains, which is exhibited in Fig.2(A).

Fig.2 Distributions of wrecked structures across the Mukogawa River.
