**STATE-OF-THE-ART SEISMIC EVALUATION OF REINFORCED  
CONCRETE BUILDINGS BASED ON BEAM-COLUMN JOINT CAPACITY.**

***PART 2: Application to Damaged Buildings During the January 17, 1995 Great Hanshin Earthquake***

Tomoaki AKIYAMA, Masaya HIROSAWA and Silvestre BERSO

Structural Investigation Division  
Tokyo Soil Research Co., Ltd.  
2-11-16 Higashigaoka, Meguro-ku, Tokyo 152, JAPAN

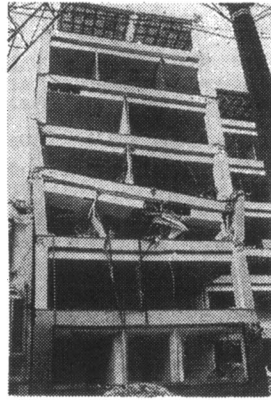
Photo 1. Single span seven-story building showing the heavy damage at the joints of the third floor due to the 1985 Mexico earthquake

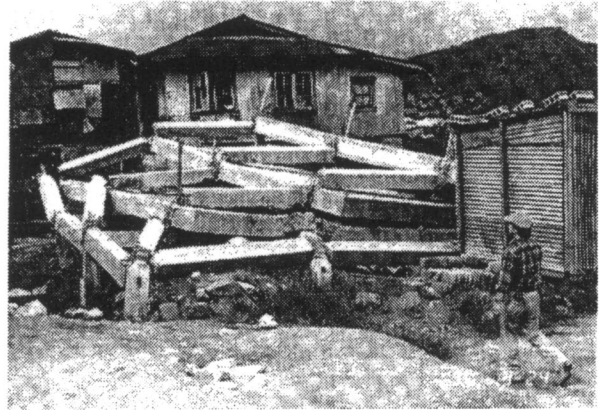
Photo 2. Three-story building with inter-story collapse due to the severe deterioration of the joints during the 1990 Philippine, Luzon earthquake

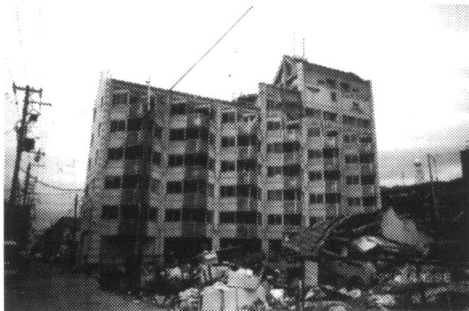
Photo 3.a A panoramic view of an eight-story RC housing building showing the joint damage in different locations Photo 3.b. Close-up view of the damaged joint condition at the reentrant corner

- a) Remarkable failure in (┌) -type joint of single span building [Photo 5].
- b) Remarkable failure in (┐) -type joint of multi-span building [Photo 6].
- c) Many wide diagonal cracks in compressive zone of (┐) -type joint [Photo 3.b].
- d) Visible cracks in compression zone of (┐) -type joint [Photo 7].
- e) Relatively visible cracks pattern.

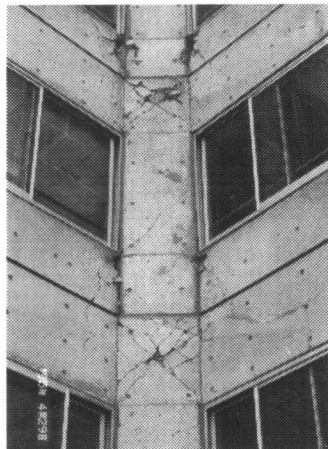
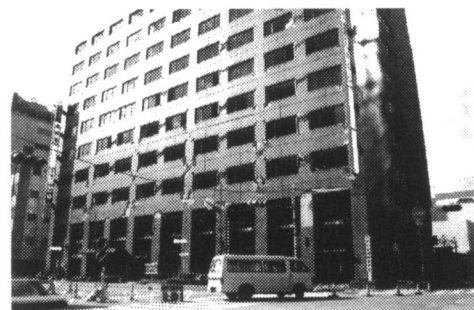
Photo 4. An 11-story SRC City Office building with damaged secondary walls and severe damage of joints

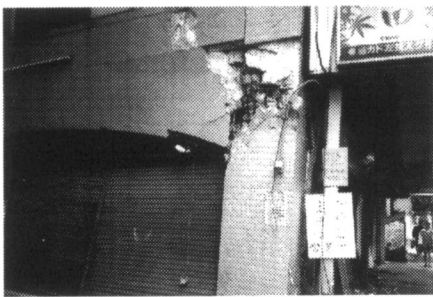
Photo 5. A single span RC building with heavily damaged exterior joint at 2nd floor

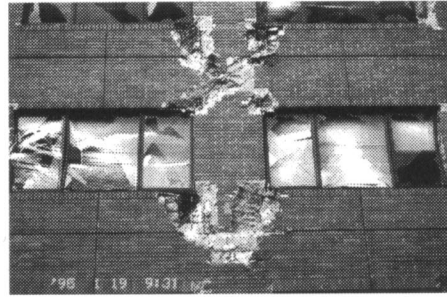
Photo 6. Cross diagonal compression cracks on the interior joint of 11-story SRC building

Moreover, in these joint damage examples as shown in Photo 6, even the frame is infilled by secondary walls on beam and column side, a deterioration of the secondary wall is followed by damage in joint panel. Thus, it can be seen that secondary walls did not have themuch effect to prevent the damage of the joint panel at all.

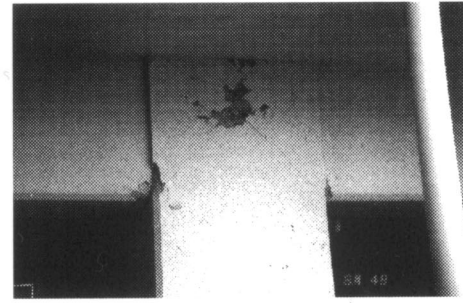
Photo 7. Severe compression failure on the interior joint of an 11-story SRC building at the 3rd floor, although the cracks were not too wide.

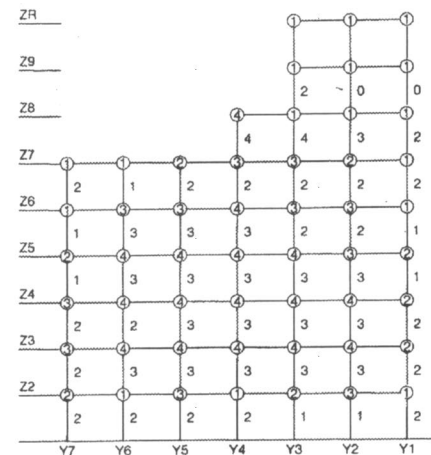
Fig.1 is the damage condition of a nine-story RC building with one by five span in the North-South direction of the longitudinal frame as shown in Photo 3.

- a) The extent of damage of joint panel is relatively extended not only on the horizontal direction but also in the vertical direction.
- b) Severe damage in the interior column than the exterior column.
- c) Very intense damage from the second floor to lower floor
- d) Damage of joint panel on external frames is more apparent than the interior frames

Fig.1. The failure distribution of each joint panel and column of a nine-story RC building in the North-South direction of the longitudinal frame (East side frame of Junes Rokko)

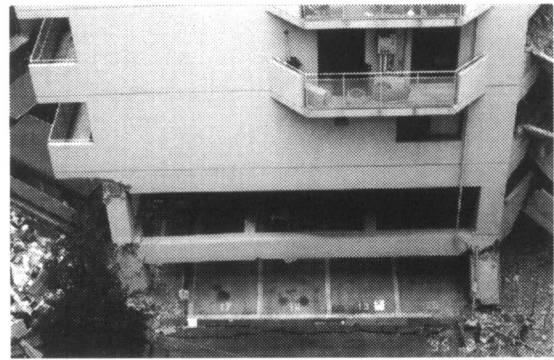
**Damage Description.** The typical damage condition at first floor column and joint panel at second floor are shown in Photo 8. As revealed in this Photo, concrete cover portion of beam-column joint were spalled-off, and critical damage by buckling of main bars was observed. These damage conditions were observed in every direction mainly in Y-direction of first and second floor joint panel. In addition there were several columns at first floor with compression failure on the top of column and base. Based on this damage condition, the damage degree was estimated as "collapse".

Photo 8. Actual damage between the ground and second floor joint and the second and third floor joint

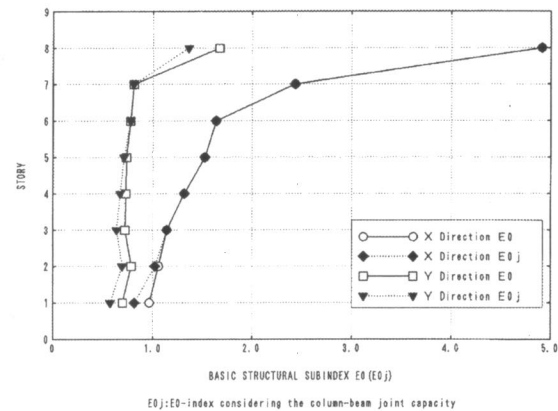
As a result of seismic diagnosis  $E_0$  index distribution is indicated in Fig.3 and  $I_s$  index distribution is shown in Fig.4. As revealed in these figures,  $I_s$  values of each story in each direction are all greater than  $I_{s0} = 0.6$ . With this value, seismic performance based on capacity and ductility ability of vertical members were judged excellent. However, as described in the latter section this building suffered very severe damage mainly in Y-direction at the ground floor. Considering the seismic diagnosis result,  $I_s$  value of the first story in the Y-direction is 0.66. This value is relatively large which means a fairly excellent seismic performance. But if the experienced earthquake motion to this building is stronger than the one considered in the seismic diagnosis, the result of seismic diagnosis and the actual damage condition of the building will not agree with each other. For this reason, seismic performance is judged by the members capacity and deflection ability, but the actual damage is presumed inflicted by the joint panel failure between first story column and second floor beams.

Fig.3. Distribution of  $E_0$ -index and  $E_{0j}$ -index considering the joint panel capacity

The results of seismic diagnosis considering the beam-column joint capacity in which the fundamental index  $E_{oj}$  and structural seismic index  $E_{sj}$  considering the joint panel capacity is shown in Fig.3 and Fig 4. Index  $E_{oj}$  is 0.57 in the first story in the Y-direction which is less than 0.6. Index  $I_{sj}$  are mostly less than  $I_s$  index, resultantly, joint panel capacity is lower than members capacity, especially at the first floor in both directions. Index  $I_{sj}$  is 84% of  $I_s$  in the X-direction and 82% in Y-direction, consequently, damage degree at first floor in the Y-direction is estimated to have a satisfying seismic performance with  $I_s = 0.66$ , is modified to  $I_{sj} = 0.57$  which means "poor seismic performance".

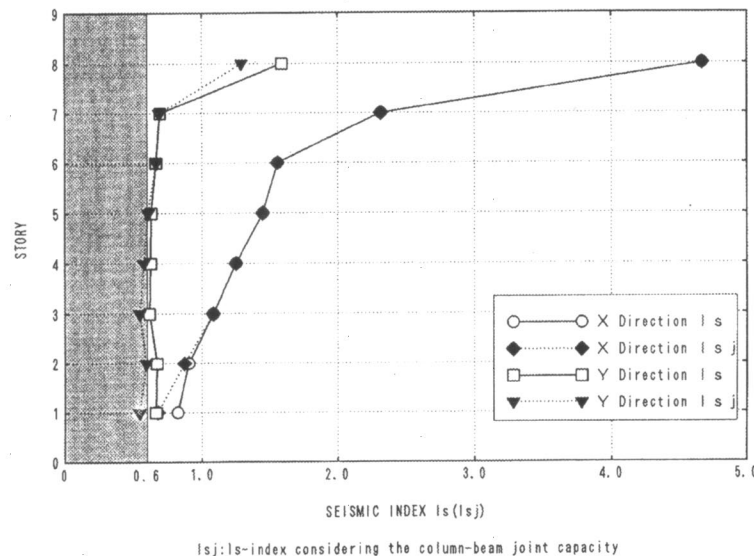
Fig.4. Distribution of  $I_s$ -index and  $I_{sj}$ -index considering the joint panel capacity
