## SEISMIC PERFORMANCE OF WOODEN DETACHED HOUSES SUBJECTED TO THE 1995 HYOGO-KEN NANBU EARTHQUAKE

YOSHIMITSU OHASHI and ISAO SAKAMOTO

### ABSTRACT

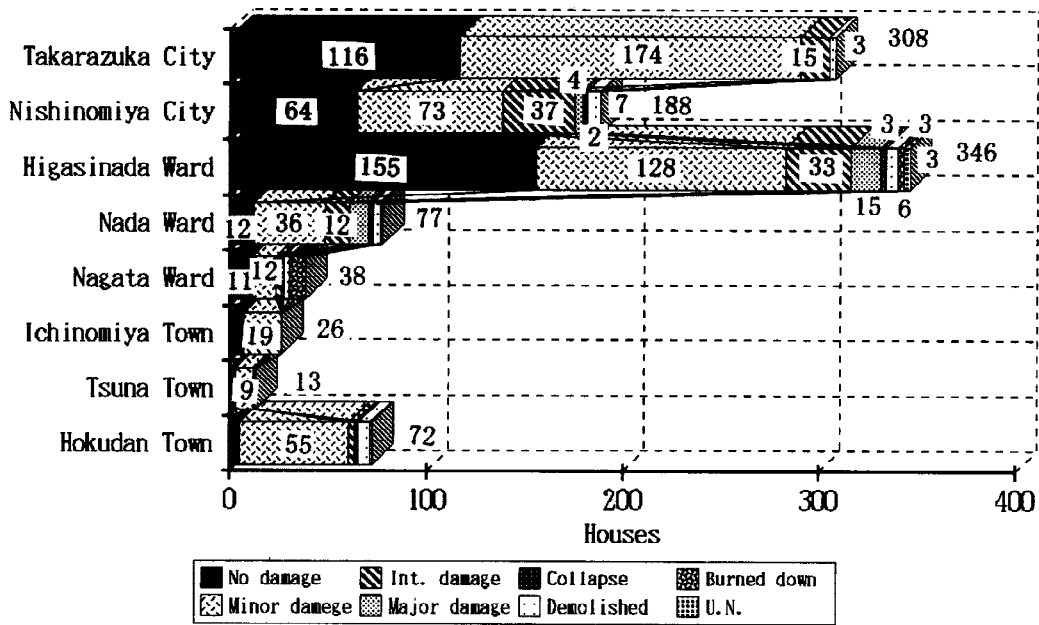
FIG. 2 NUMBER OF DAMAGED HOUSES SUBJECTED TO AREA

Damage Ratio. Figure 2. shows the damage grade of 1068 houses, financed by the G.H.L.C.J. Of the 1068 houses there were 104(9.7%) houses of intermediate damage, 31(2.9%) major damage, and 8(0.7%) collapse. There were also 29(2.7%)houses already demolished at the time of the survey, and 11(1.0%) were burned. The ratio of intermediate damages was approximately 10%, and the damage ratio of major or more severely damaged houses was 3 - 4%.
