# THE RESTORATION OF THE IKUTA SHRINE DESTROYED BY THE GREAT HANSHIN EARTHOUAKE USING ULTRA HIGH STRENGTH COMPOSITE COLUMN

TOSHIHARU HISATOKU<sup>1)</sup>, TERUO SEGAWA<sup>2)</sup>, TATSUO OKAMOTO<sup>2)</sup>
1)Takenaka Corporation, 8-21-1, Ginza, Chuo-ku, Tokyo, Japan
2)Structural Engineering Section, Building Design Department, Takenaka Corporation,
2-3-10, Nishi Hom-machi, Nishi-ku, Osaka, Japan

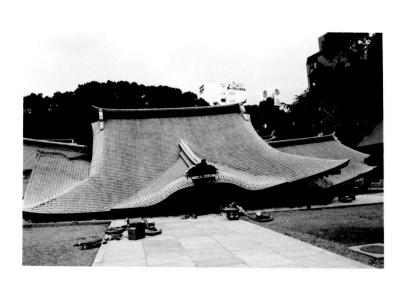
The earthquake also attacked a lot of shrines. The IKUTA shrine which is located in the central part of Kobe, also received a great damage. Especially, the Hall of Worship fell down to the ground (Photo. 1).

The IKUTA shrine initially opened about 1,800 years ago, and it worships the Wakahirume-no-mikoto, who is the infant princess of Japanese mythology. The collapsed Hall of Worship is a wooden structure, and it was reconstructed in 1957 because it had been burned down by fire. The structure was composed of semi-rigid frame and the bottom part of the column is flexibly connected to the foundation, fixed only by steel bar (Photo 2). It did not have sufficient resistant capability to the strong seismic motion.

Photo.1 Collapsed Hall of Worship

The superior priest requested us to restore the shrine as soon as possible to be the first re-constructed building in Kobe and to encourage citizens. Then, re-construction of the shrine started 5 days after the earthquake. For the restoration, we intend to serve in honor of the mythological princess by using the most progressive technology and giving the building sufficient seismic resistant capability.
