## SEISMIC DAMAGE TO CIVIL ENGINEERING STRUCTURES BY THE 1994 FAR-OFF SANRIKU EARTHQUAKE

Y.SHIOI and N.SAKAJIRI

Department of Civil Engineering, Faculty of Engineering  
Hachinohe Institute of Technology ( HIT )  
88-1, Ohbiraki, Myou, Hachinohe, Aomori, Japan

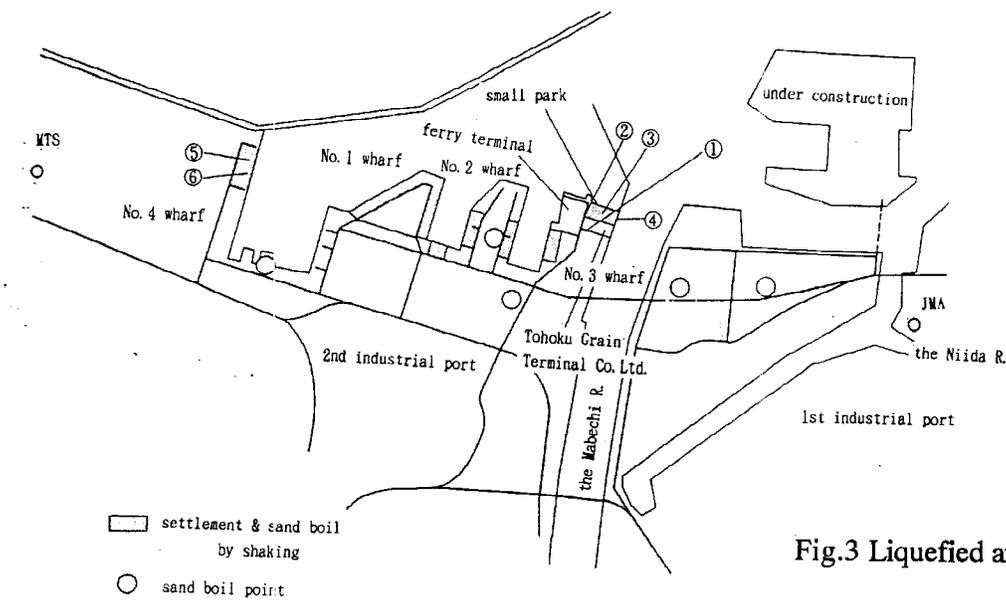
Fig.3 Liquefied area at Hachinohe Port

Although the phenomenon of liquefaction due to this earthquake was observed at some places, as shown in Fig.3, the one at Hachinohe Port was generated over a wide area and on a large scale, mainly at the 2nd industrial port which was newly reclaimed after the 1968 Off Tokachi Earthquake( hereinafter Tokachi Eq.). The bedrock at the 2nd port submerges at a steep angle from the old coastline to the north-west offshore, shown in Fig.2(Sakajiri and Sasatani,1994). The liquefaction caused small movement forward of quays, settlement of aprons, sand boil and so on, from No.1 to No.4 wharf.At the 1st port and the fishery port, the influence of liquefaction was relatively small and sand boil, fissures of pavement,etc.were observed in places.

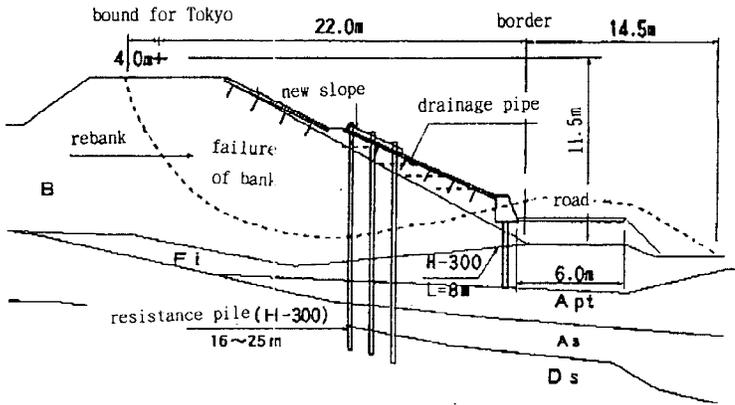
second for the horizontal direction. But for the vertical direction, it is difficult to determine the predominant period since high acceleration was distributed up to 8 Hz. Therefore, we cannot neglect the influence of the vertical component of this earthquake motion in order to analyze the damage to structures. Photo.4 shows cracks in some intermediate columns of the city hall, with heavier loads than edge columns. Photo.5 shows a big shear crack in a column on the porch of a high school, sustaining the overhanged portion of the building. Figure 7 shows failure and rehabilitation of the bank of railway, where another type of failure, slope sliding, occurred due to the Tokachi Eq. and had been repaired.

Fig.9 Failure & rehabilitation of bank of railway

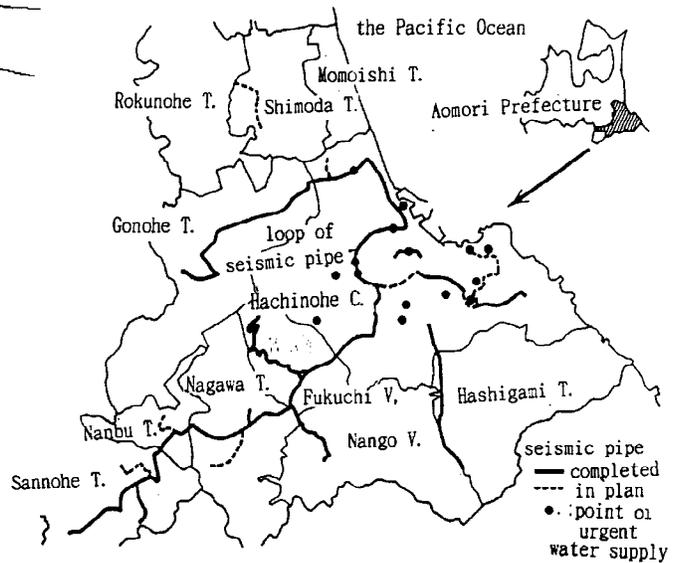
Fig.10 Seismic pipe in the main trunk line of HRWWE

The water supply facilities in Hachinohe City were severely damaged by the Tokachi Eq. in 1968. Hachinohe Regional Water Works Enterprise (hereinafter HRWWE) has been making efforts to take seismic measures for their facilities based on this bitter experience. HRWWE devised an iron pipe with a new joint system shown in Fig. 7, called a "seismic pipe". The seismic pipes are used for the trunk lines in the network 124km long (Fig. 8) and received no damage from the 2 big earthquakes. HRWWE is building a loop circuit of the trunk line surrounding the center of the city. Furthermore, HRWWE took several seismic measures for purification and pumping stations such as strengthening of instruments, fixation of equipments and tool shelves, chemicals, protection of computers and so on.

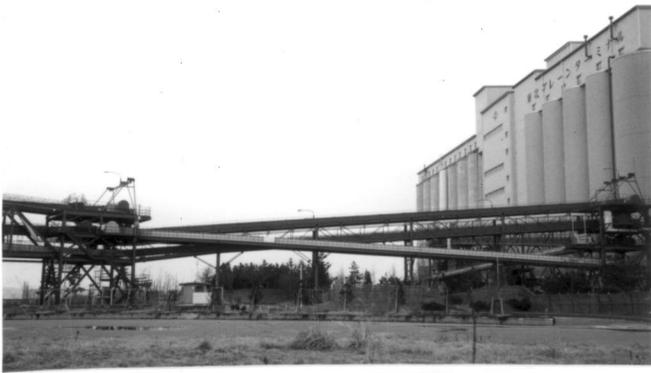
Photo.1 Silos, plant & conveyer of TGT

Among the liquefaction phenomena at the 2nd port, several noteworthy facts were found at No.3 wharf. On the top of wharf, big silos and a plant of Tohoku Grain Terminal Co.Ltd.(TGT)(Photo.1) and a small park are situated along the Mabechi River(Fig.3). The ground of the silos and the plant was improved 10m below with sand compaction method in the 1st construction stage and with gravel drain method in the 2nd stage. The improved ground of the plant was quite sound except for a slight settlement (Photo.2), though a bit of boiled sand on the natural ground of the same area was observed. At the small park and its parking area neighboring to the plant a lot of boiled sand was found throughout the site (Photo.3), contrasting the other side of a fence. From a series of phenomena including other examples, it was confirmed that ground improvements with dewatering can be effective in preventing soil liquefaction or reducing its influence,

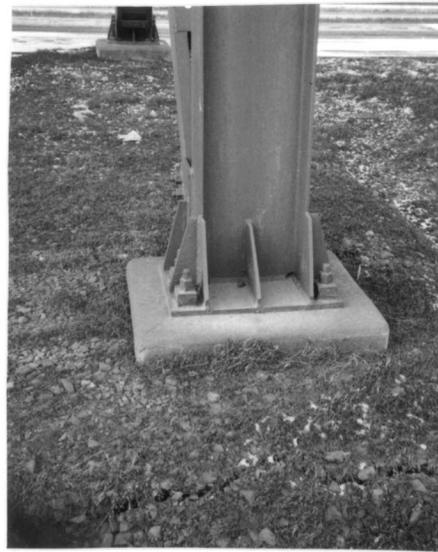
Photo.2 Improved ground & column of conveyer

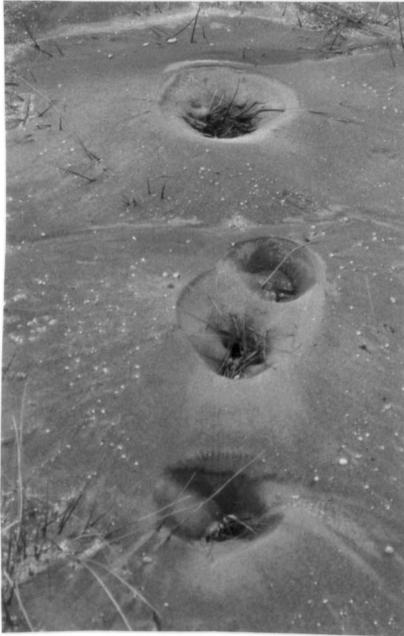
Photo,3 Boiled sand covering lawn

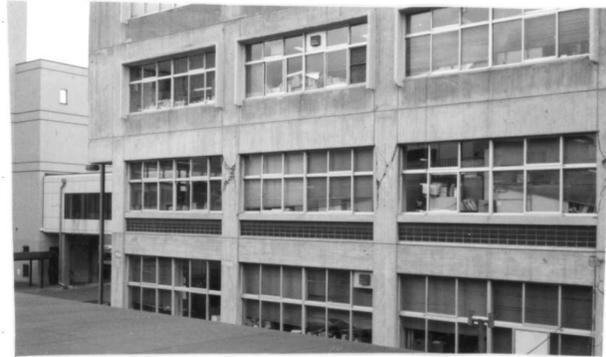
Photo.4 Conjugated failures on intermediate columns

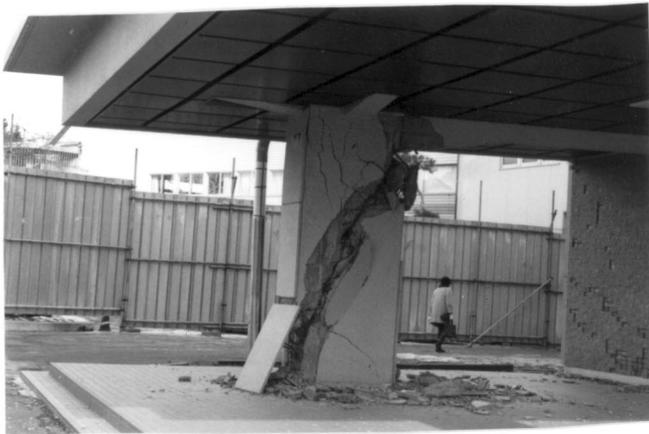
Photo.5 Shear crack of portal column of high school

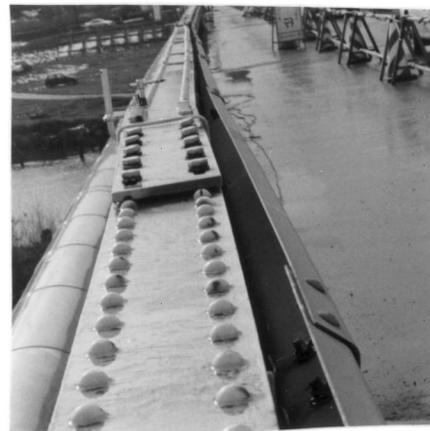
Photo.6 connection plate on the Ohhashi

Among the notable phenomena, the connection plates between simple beams on the Ohhashi bridge near the center of the city prevented the girders from falling down into the river. The plates continuously connected whole girders and restricted the movement of the piers. Although the bridge was so damaged that some piers settled down and several parts of structures were broken, it maintained service under traffic control, just after the main shock.
