SEISMIC DAMAGE TO CIVIL ENGINEERING STRUCTURES BY THE 1994 FAR-OFF SANRIKU EARTHQUAKE

Y.SHIOI and N.SAKAJIRI

Department of Civil Engineering, Faculty of Engineering
Hachinohe Institute of Technology (HIT)
88-1, Ohbiraki, Myou, Hachinohe, Aomori, Japan

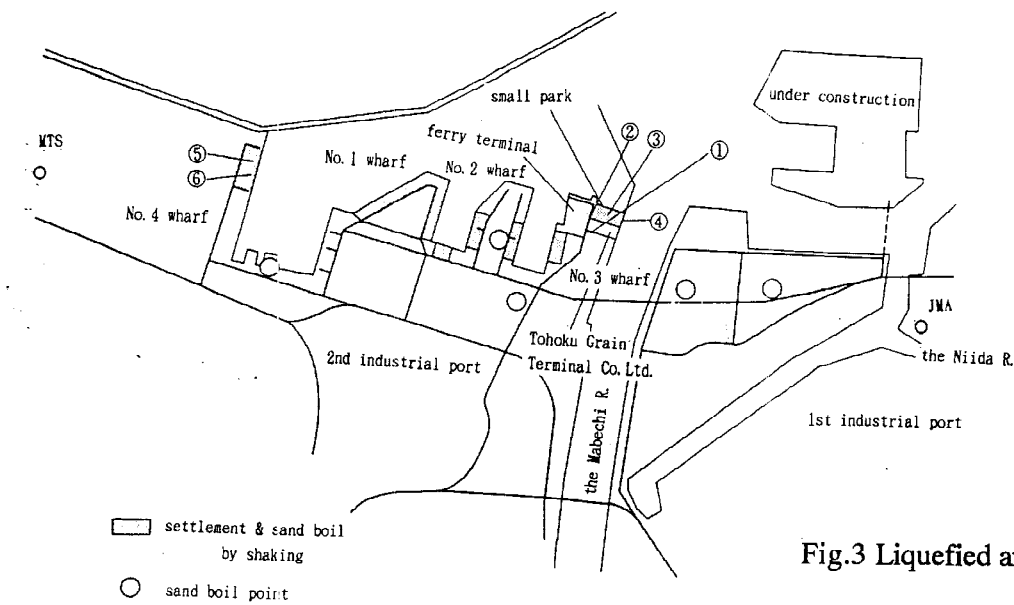
Fig.3 Liquefied area at Hachinohe Port

Although the phenomenon of liquefaction due to this earthquake was observed at some places, as shown in Fig.3, the one at Hachinohe Port was generated over a wide area and on a large scale, mainly at the 2nd industrial port which was newly reclaimed after the 1968 Off Tokachi Earthquake(hereinafter Tokachi Eq.). The bedrock at the 2nd port submerges at a steep angle from the old coastline to the north-west offshore, shown in Fig.2(Sakajiri and Sasatani,1994). The liquefaction caused small movement forward of quays, settlement of aprons, sand boil and so on, from No.1 to No.4 wharf.At the 1st port and the fishery port, the influence of liquefaction was relatively small and sand boil, fissures of pavement,etc.were observed in places.

Among the liquefaction phenomena at the 2nd port, several noteworthy facts were found at No.3 wharf. On the top of wharf, big silos and a plant of Tohoku Grain Terminal Co.Ltd.(TGT)(Photo.1) and a small park are situated along the Mabechi River(Fig.3). The ground of the silos and the plant was improved 10m below with sand compaction method in the 1st construction stage and with gravel drain method in the 2nd stage. The improved ground of the plant was quite sound except for a slight settlement (Photo.2), though a bit of boiled sand on the natural ground of the same area was observed. At the small park and its parking area neighboring to the plant a lot of boiled sand was found throughout the site (Photo.3), contrasting the other side of a fence. From a series of phenomena including other examples, it was confirmed that ground improvements with dewatering can be effective in preventing soil liquefaction or reducing its influence,

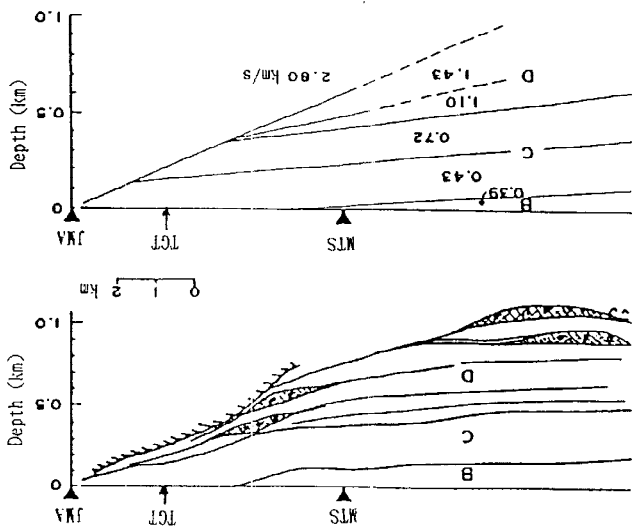
Fig.4 Geologic section & velocity structure of Hachinohe Port

Figure 4 shows the geologic column of both sites,where we can not find a bedrock under very thick sedimentary layers up to 80m. It is suggested that the phenomenon of liquefaction is strongly related to the existence of the thick or soft sedimentary layers which accumulate seismic energy and amplify the strain of upper layers (Shioi,1980). At observation point MTS in Fig.2, the predominant period of the ground is 2.5-3 second (Sakajiri and Sasatani,1994) and severe liquefaction is reported. Since the depth of the bedrock at TGT is presumed to be more than 200m, a fairly long period is considered. At 1st industrial port where sedimentary layers are relatively thin, a few small sand boils were found on some reclaimed grounds near the shore.

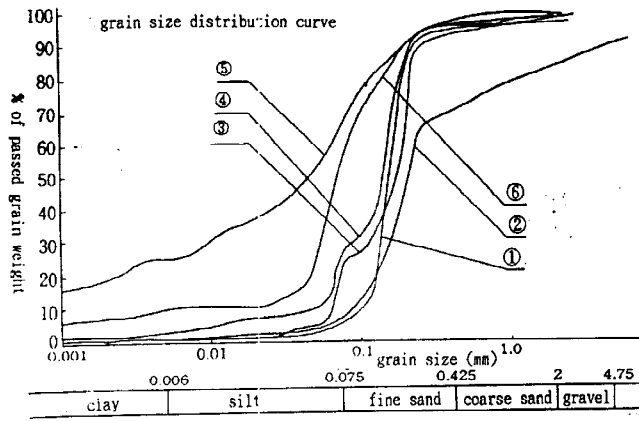
Fig.7 Grain size accumulation curve of boiled sands

In the liquefaction at Hachinohe Port, various kinds of soil were boiled, including small gravel, silt and well-graded soil,as shown in Fig.5. Although liquefied ground became a force to push the wharves, it caused no severe damage to the structures on flat ground. Most of the buildings on the liquefied area are still being used after some repairing. The conveyor viaduct (Fig.1) from the TGT plant to the unloading berth, with a top heavy structure, was sound during the two big earthquakes in spite of passing a severely liquefied park, and continued to supply feed to cattle in the cold winter. Though the energy to induce liquefaction was enormous, it appears that the acceleration of the force to act upon structures was not so strong.

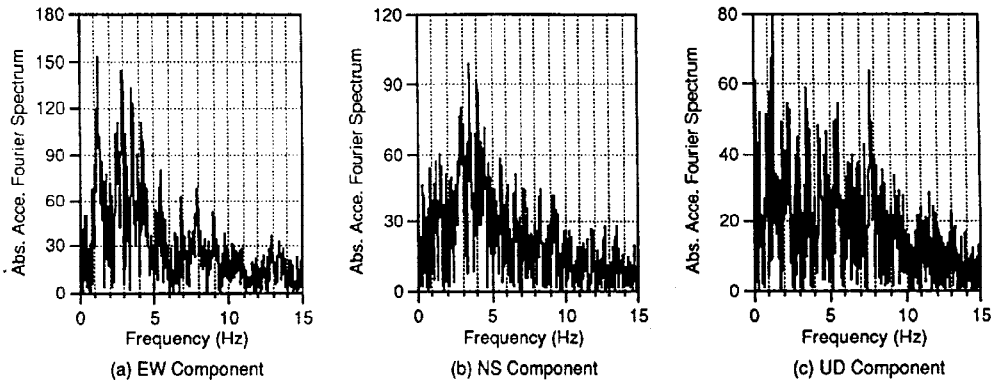
Fig.8 Fourier spectrum of the Sanriku Eq. at HIT

Damage due to the Sanriku Eq. was concentrated in Hachinohe City and distributed densely on the diluvium terrace, volcanic sediments on the peleozioc layer of limestone, clay stone, sandstone and chart. This earthquake was predominantly shorter in period than the Tokachi Earthquake with almost the same epicenter and the magnitude 7.9. Figure 6 (Takita et al,1995) shows the spectrum of acceleration on the peleozioc clay stone 20m below Hachinohe Institute of Technology. From Fig.6, the predominant period seems to be 0.3

second for the horizontal direction. But for the vertical direction, it is difficult to determine the predominant period since high acceleration was distributed up to 8 Hz. Therefore, we cannot neglect the influence of the vertical component of this earthquake motion in order to analyze the damage to structures. Photo.4 shows cracks in some intermediate columns of the city hall, with heavier loads than edge columns. Photo.5 shows a big shear crack in a column on the porch of a high school, sustaining the overhanged portion of the building. Figure 7 shows failure and rehabilitation of the bank of railway, where another type of failure, slope sliding, occurred due to the Tokachi Eq. and had been repaired.
