## **OVERVIEW OF THE AISC NORTHRIDGE MOMENT CONNECTION TEST PROGRAM**

T.A. SABOL<sup>1</sup>, M.D. ENGELHARDT<sup>2</sup>, R.S. ABOUTAHA<sup>3</sup>, and K.H. FRANK<sup>2</sup>

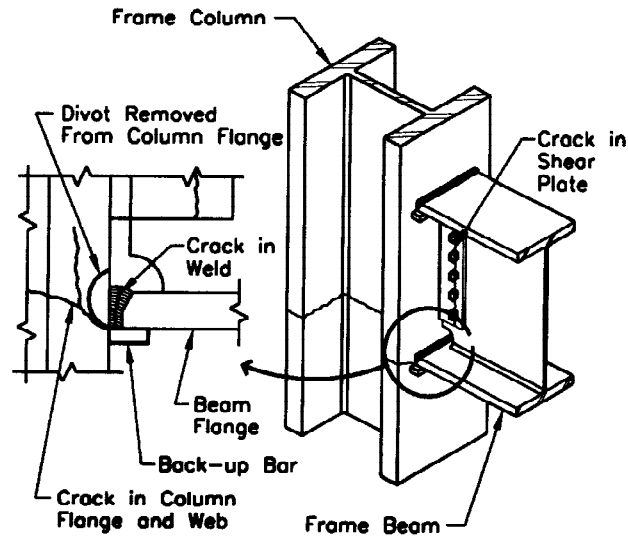
Figure 1 schematically illustrates six basic failure attributes including cracks at the frame girder bottom flange, divots of steel removed from the face of the column flange, cracks in the frame column; cracks in the shear tab or shearing of web bolts; failures at the frame girder top flange welds; and cracks in the beam bottom flange.

Fig. 1 . Moment Frame Connection Damage Attributes

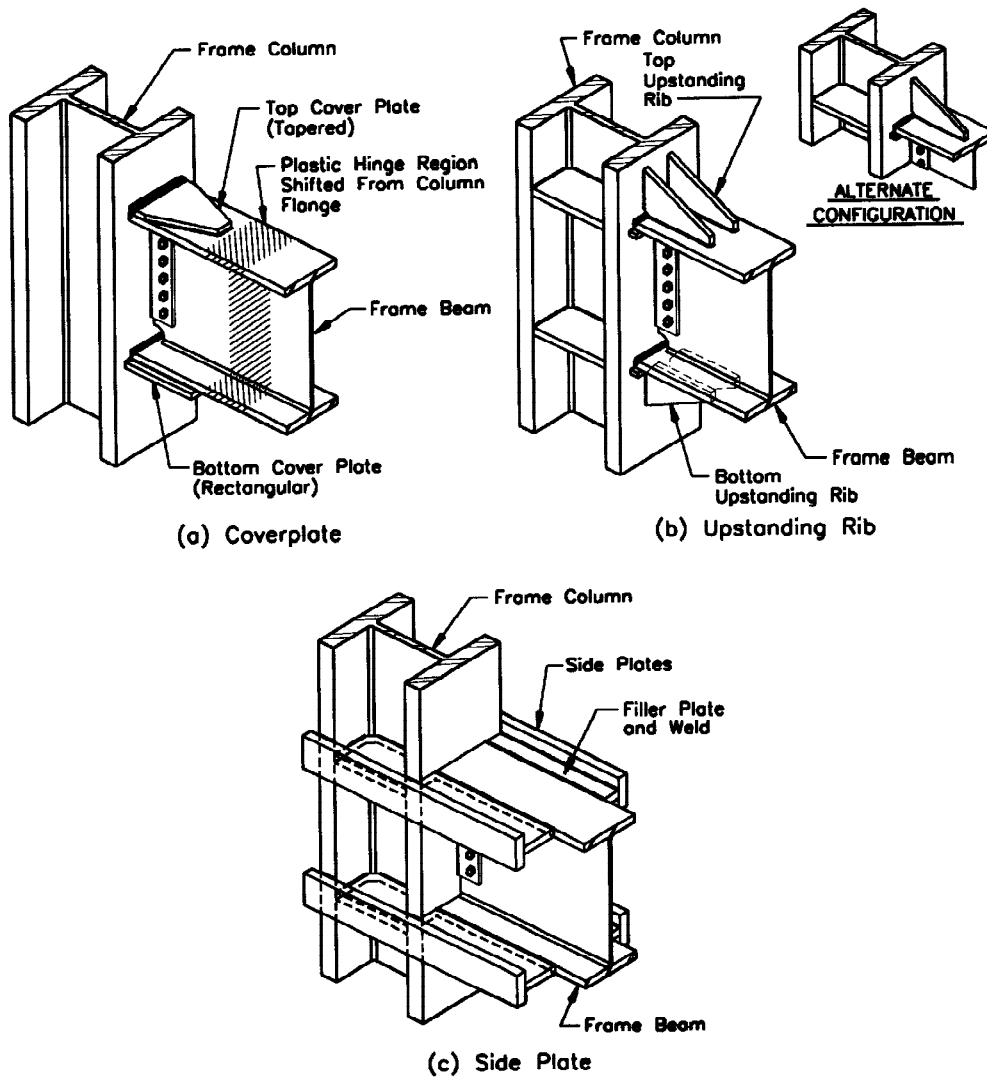
Figure 3a illustrates the basic configurations of cover plate connections. The assumption behind the cover plate is that it reduces the demand on the weld at the column flange and shifts the plastic hinge away from the column face. In the figure shown, the bottom cover plate is rectangular, and sized slightly wider than the beam flange to allow downhand fillet welding of the joint between the two plates. Two specimens using triangular plates at the bottom flange, similar to the top flange, have also been tested but did not demonstrate any performance advantages.

Six of eight connections tested were able to achieve plastic rotations of at least 0.025 radian and up to 0.05 radian, as shown in Figure 4 (solid line). These tests were performed using heavy column sections which forced nearly all of the plastic rotation into the beam plastic hinge; very little column panel zone deformation occurred. Strength loss at the extreme levels of plastic rotation did not reduce the flexural capacity to less than the plastic moment capacity of the section based on minimum specified yield strength. One specimen achieved plastic rotations of 0.015 radian when a brittle fracture of the CJP weld occurred. This unacceptable behavior may be a result of a weld that was not executed in conformance with the specified Welding Procedure Specification. The second unsuccessful test specimen achieved plastic rotations of 0.005 radian when a section of the column flange pulled out. Numerical results are presented in Table 2.

Figure 3b illustrates the basic configuration of connections with upstanding ribs. The two connections tested demonstrated the ability to achieve levels of plastic rotation in excess of 0.025 radian. Strength loss at the extreme levels of plastic rotation did not reduce the flexural capacity to less than the plastic moment capacity of the section based on minimum specified yield strength; however, strength loss occurred more quickly than with the cover plated specimen. The tests were terminated when a slow tear of the bottom flange occurred at the tips of the ribs.

Fig. 3. Modified Beam-Column Connections Tested

The failure of one cover plated specimen resulting a divot pulled from the face of the column suggested a detail to eliminate loading the column in the through-thickness direction. This was accomplished by eliminating the CJP welds at the girder flange and by shifting the plastic hinge from the column face. Figure 3c illustrates how the tension and compression forces are transferred from the girder flange through side plates into the column flange using fillet welds. Such a mechanism to provide direct connection between the column panel zone and the beam flanges must consider the unequal width of the beam and column flanges. A filler consisting of plate and weld metal was used to provide a load path between the girder flange and side plates. A tapered transition zone was used in an attempt to minimize the effect of the abrupt termination of the side plate.

These specimens achieved plastic rotations of only 0.015 radian and fractures developed within the weld connecting the beam flange to the side plates. Failure of the shear tab, and, finally, failure of the side plates themselves followed the initiation of these weld fractures. It is believed that the unsatisfactory behavior of these specimens was related to the detail used to increase the width of the beam flange to be equal to that of the column flange using a combination of a filler bar and welding. It has been suggested that a flat filler plate to transfer the forces, shown as an alternate to 3c, may perform better.

Reinforced connections using cover plates or upstanding ribs that shifted the plastic hinge away from the face of the column and the CJP weld performed better than connections that did not shift the plastic hinge. Sizing of the cover plate should keep the region of post-elastic behavior as close to the column face as possible to reduce the demand imposed on the weld and column panel zone. The cover plate should also have a minimum thickness to reduce the size of the CJP weld.

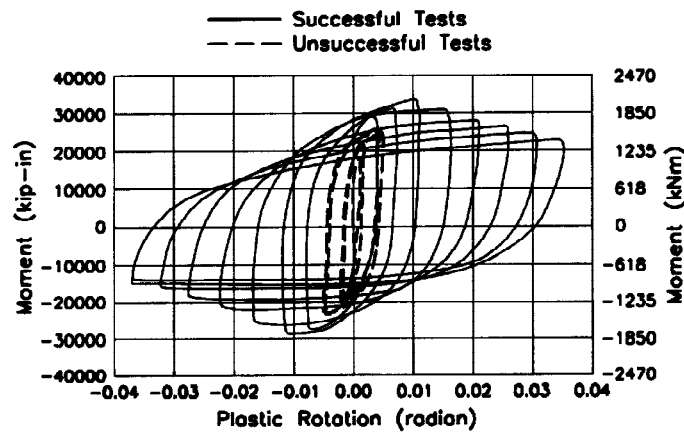
Fig. 4. Representative Moment-Rotation Curves for Unsuccessful and Successful Test Specimens

An effective yield stress in the beam must also be assumed. The moment reported in Figure 4 for the successful test specimen was calculated at the face of the column multiplying the applied load by the length of the cantilever (centerline of loading ram to face of column). This approach would not be appropriate to describe the plastic hinge moment for the modified connections, which is not located at the column face, because it will overestimate the actual moment at the plastic hinge, and, therefore, the stress at yield. However, the amplification of the moment from the plastic hinge to the face of the column should be reflected in the analytical model, but this amplified moment is not necessarily the moment obtained from calculations based on the total length of the cantilever times the applied load.
