DAMAGES OCCURRED TO CHURCHES DUE TO THE EARTHQUAKE OF FEBRUARY 8, 1995 IN PEREIRA, COLOMBIA

P. J. MONTILLA, A. I. UZCATEGUI and S. M. HERNANDEZ

Departamento de Estructuras, Facultad de Ingeniería, Universidad de Los Andes,
Av. Tulio Febres Cordero, Mérida, Venezuela.

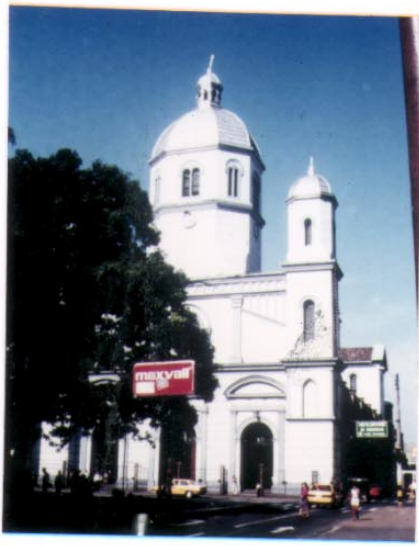
This church is constituted by a central nave and two lateral ones. It has two Towers located at the sides of the Frontispiece and in front of it. In the Presbytery zone there is a spherical cupola. The walls are of brick masonry of great thickness (Photo 1).

The minor damages observed are small cracks on the internal arches and walls and the inclination of the cross located on the top of the central cupola. All of the damages are slight and easily repairable.

Photo 1. Facade of La Pobreza Cathedral.

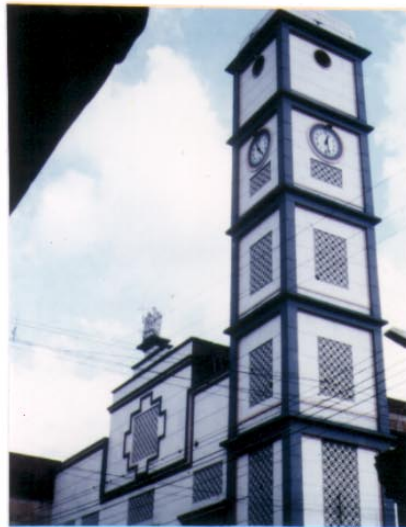
It is asymmetric on the plan, constituted by four naves, one central, two to the left and one to the right. To the right of the Frontispiece and out it is plane, there is a Tower made up of five bodies or levels (Photo 4). The structure of the church is made of reinforced concrete.

Photo 4. Facade of La Trinidad Church.

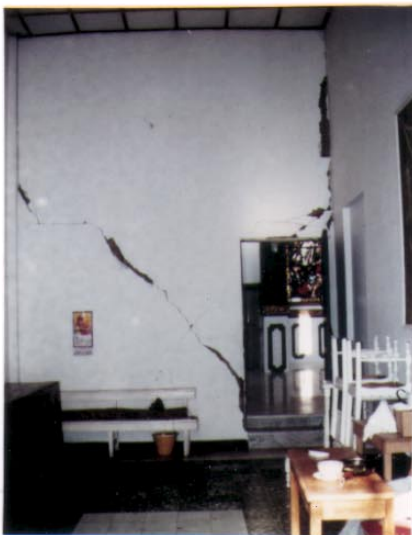
The damages were concentrated in the zone of the Presbytery, in the Tower and in some non-structural elements of the Central Nave. Great cracks were observed in the walls of the Presbytery and of the Sacristy, possibly due to the stress concentration originated by sudden change in stiffness in that zone (Photo 5). In the Tower small cracks were observed in the walls; at the top of the Central Nave some plaster fell off and the ornaments of one of the columns, that fell on to the wooden benches, breaking them (Photos 6 and 7). Also small cracks were observed in the top beams of the Central Nave. Some religious images that were on high stands connected to the columns also fell off (Photo 8). The false roof, made of sheets of heavy material, nearly collapsed in the zone close to the Presbytery. The falling of non-structural elements did not cause loss of lives because the church was empty at the moment of the earthquake.

Photo 5. Great cracks in the Presbytery of Balbanera Church.
