PILE DAMAGE DURING 1995 HYOUGOKEN–NANBU EARTHQUAKE IN JAPAN

Hatsukasu MIZUNO, Masanori IIBA and Tsutomu HIRADE

Building Research Institute, Ministry of Construction, Japan
Tatehara1, Tsukuba City, Ibaraki Prefecture, 305 Japan

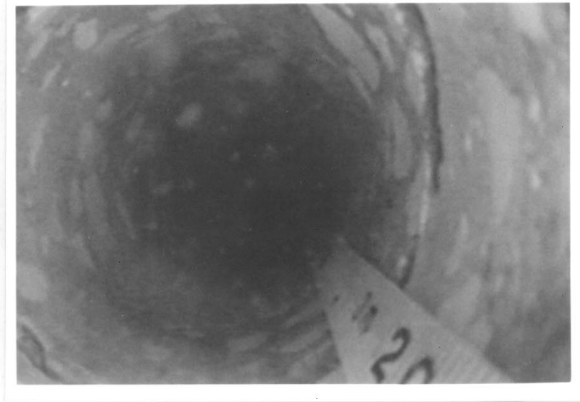
Figure 3 presented damage of the piles by televiewer observation in cored holes of the four piles after non-destructive tests as screening tests. The holes were cored down to a depth of 12 –16 meters. The locations of the four piles are shown in Fig. 2. Figures 4 and 5 present a video picture and damage to a strap beam near the south-east plant corner, respectively. The piles are considered to be ruptured due to lateral soil flow with liquefaction. From comparison of soil profile, soils from G.L. – 5 meters to –10 meters considered to liquefy and move.

Fig.4 Video picture in cored hole of cast in-situ pile

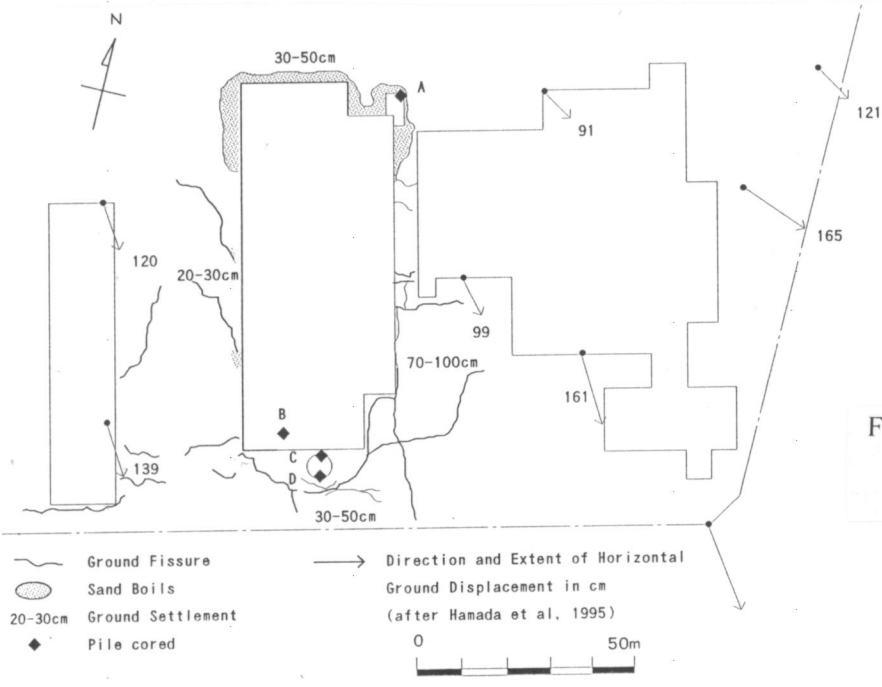
Cast-in-situ concrete piles and strap beams in a refuse incinerating plant near completion were damaged in Ashiyahama, Ashiya City during the earthquake. The site in Asiyahama Seaside Town, Ashiya City had been reclaimed by Awaji Island soils and dredged soils, and is surrounded by breakwater walls and the sea on the east and south sides. The plant is supported by 30 meters long cast in-situ concrete piles with 1 – 1.2 meters diameter and with enlarged diameter at the bottom. Many sand boils on the north of the plant, and many ground fissures around the plant occurred, as shown in Fig. 2. Ground settlements of the site were 20 – 100 cm, and the settlement amounts were largest on the east and south sides of the plant. A column bottom at south-east corner moved 10.2 cm to the south sea and 1.8 cm to the orthogonal direction from original positions by precise distance measurements in the plant. Horizontal displacements to the south at column bottoms on the south side of the plant were 2.4 – 19.8 cm to the south sea. The movement amounts were largest at the center of the south side, namely near to an assembled chimney. The chimney bottom moved 52.6 cm to the south sea and 21.3 cm to the orthogonal direction, and the chimney 1/240 radian to the south sea and 1/1500 radian to the west. Horizontal ground displacements in Fig.2 are derived from comparison of aerial pictures before the earthquake and after the earthquake (Hamada, M., Isoyama, R. and Wakamatsu, K., 1995). Due to comparison of measurements at very close two points on the south-east breakwater before the earthquake and after the earthquake, the south-east breakwater is evaluated to move 110 cm to the south, 60 cm to the east, and to settle 120 cm. On the other hand, by aerial pictures comparison, the south-east breakwater is evaluated to move 239 cm to the direction of an arrow at the south-east breakwater in Fig. 2. This numerical value is excluded and presented only by the length of the arrow in Fig. 2.

Fig.2 Ground fissures, sand boils and horizontal displacements, CASE A

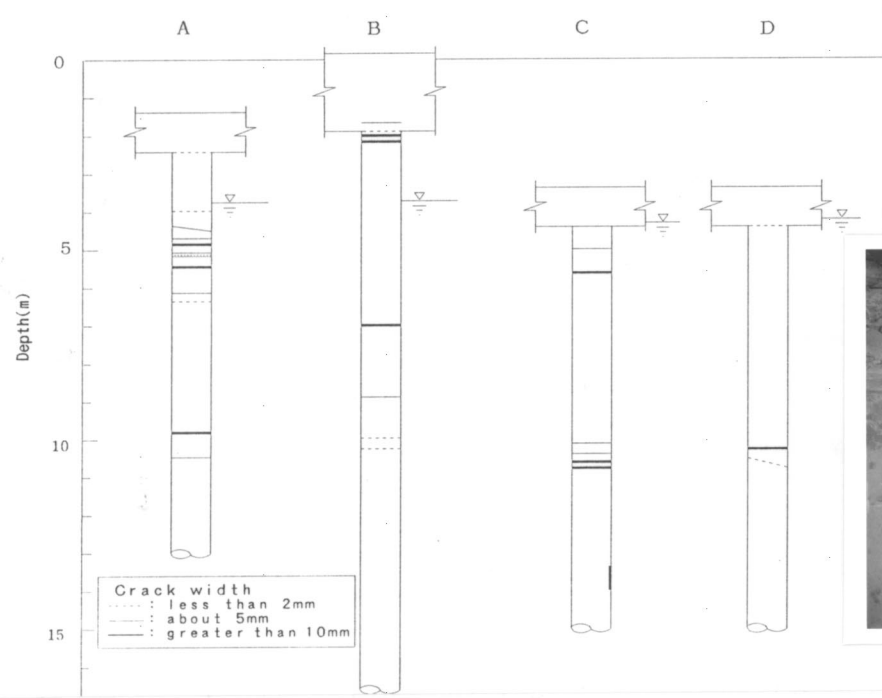
Fig.3 Damage of cast in-situ concrete piles, CASE A

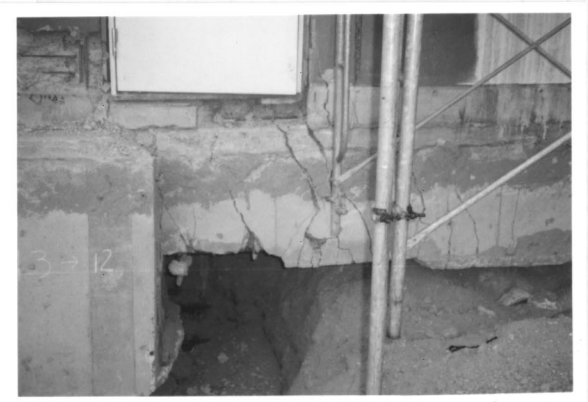
Fig.5 Cracks of strap beam

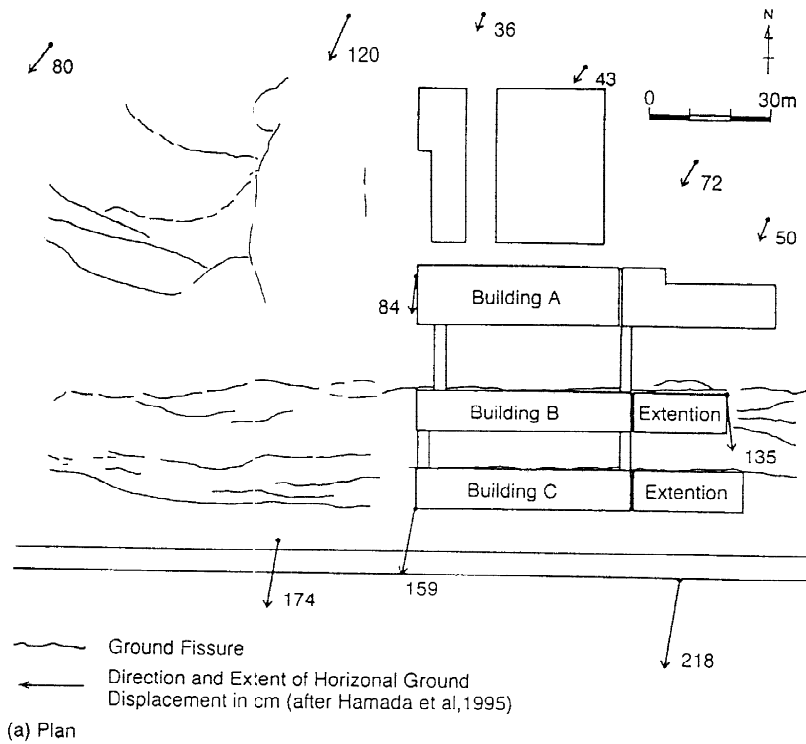
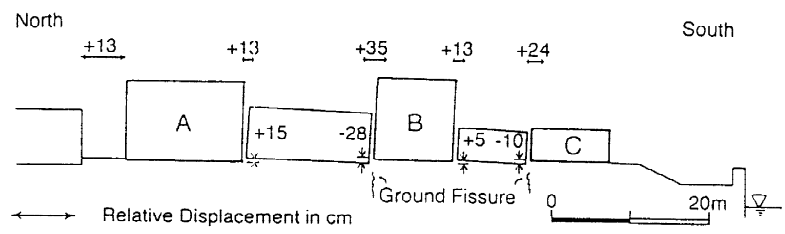
Figure 6 (a) presents ground fissures and horizontal soil displacements in a site of a junior high school at Ashiyahama. Horizontal ground displacements in Fig. 6 (a) are determined from an aerial photograph survey (Hamada, M., Isoyama, R. and Wakamatsu, K., 1995). South side of the site faces the sea. Buildings A, B and C are supported by precast concrete piles (PHC piles (type B and C), diameter ; 45cm, total length ; 32 meters). The buildings and passageways tilted to the south after the earthquake. The largest and the widest ground fissure ran through along the north side of the building B. Figure 7 shows relative displacements (change of distance) among the buildings and relative vertical displacements in the buildings. The largest horizontal relative displacement, 50 cm occurred between the building A and the building B. In summary, Figure 6 (b) depicts relative horizontal and vertical displacements among the buildings and the passageways in sectional view.

Fig.6 Plan view and sectional view (ground fissures and displacements), CASE B

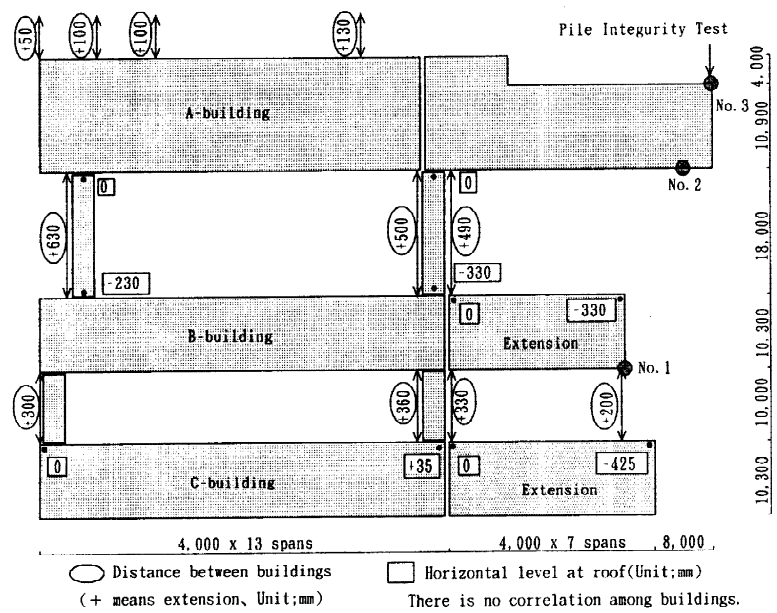
Excavation of pile heads and non-destructive tests were performed at No.s 1, 2 and 3 points in Fig. 7. Pile heads had no damage, although boiled sands were observed along piles and around strap beams. Figure 8 depicts soil profiles at the building A and B. Figure 9 presents the result of non-destructive test at No. 1 point, the building A with finite difference simulation result based on wave propagation analysis. In consequence, the pile is considered to be cracked at a depth of G.L. –8 meters, and to be broken at a depth of G.L. –16 meters.

Fig.7 Change of distance among buildings and vertical displacements in buildings

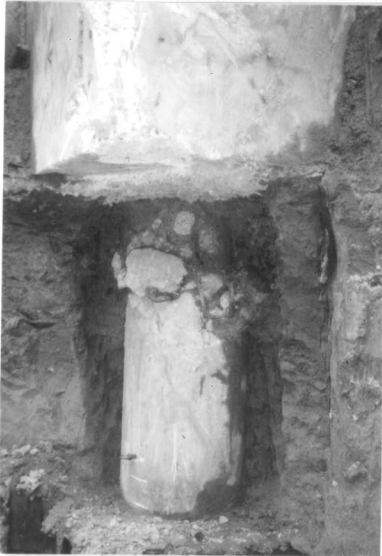
Figures 14, 15, 16 and 17 are damage of piles. The main cause of pile damage, at least in the building B, is considered due to inertial forces of the buildings, although soil lateral displacements are observed in the damaged pile pictures of the building A and C.

Fig.14 Damage of precast prestressed concrete piles, CASE C (Compressive failure, building A)

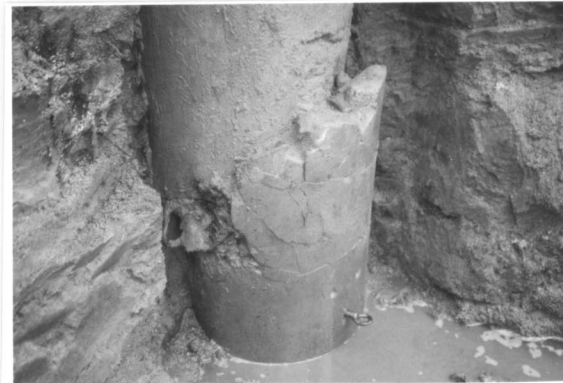
Fig.15 Damage of precast prestressed concrete piles, CASE C (shear failure, building B)

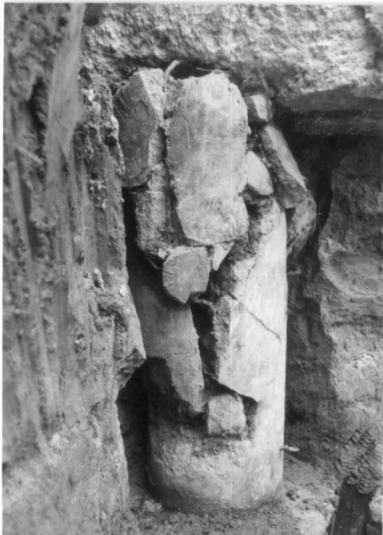
Fig.16 Damage of precast prestressed concrete piles, CASE C (shear failure + compressive failure, building C)

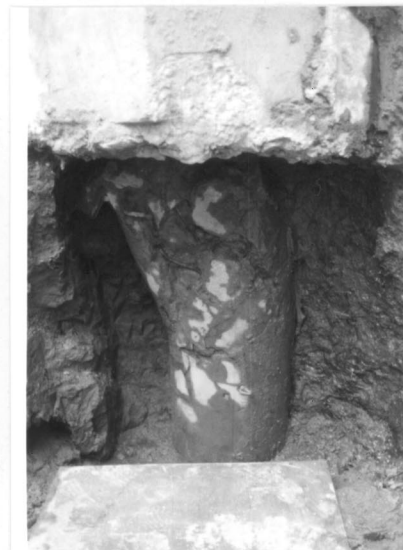
Fig.17 Damage of precast prestressed concrete piles, CASE C (Soil moved and pile head remained)
