EVALUATION OF PARKING GARAGE RESPONSE DURING THE 1994 NORTHRIDGE EARTHQUAKE

SHARON L. WOOD¹, JOHN F. STANTON², and NEIL M. HAWKINS³

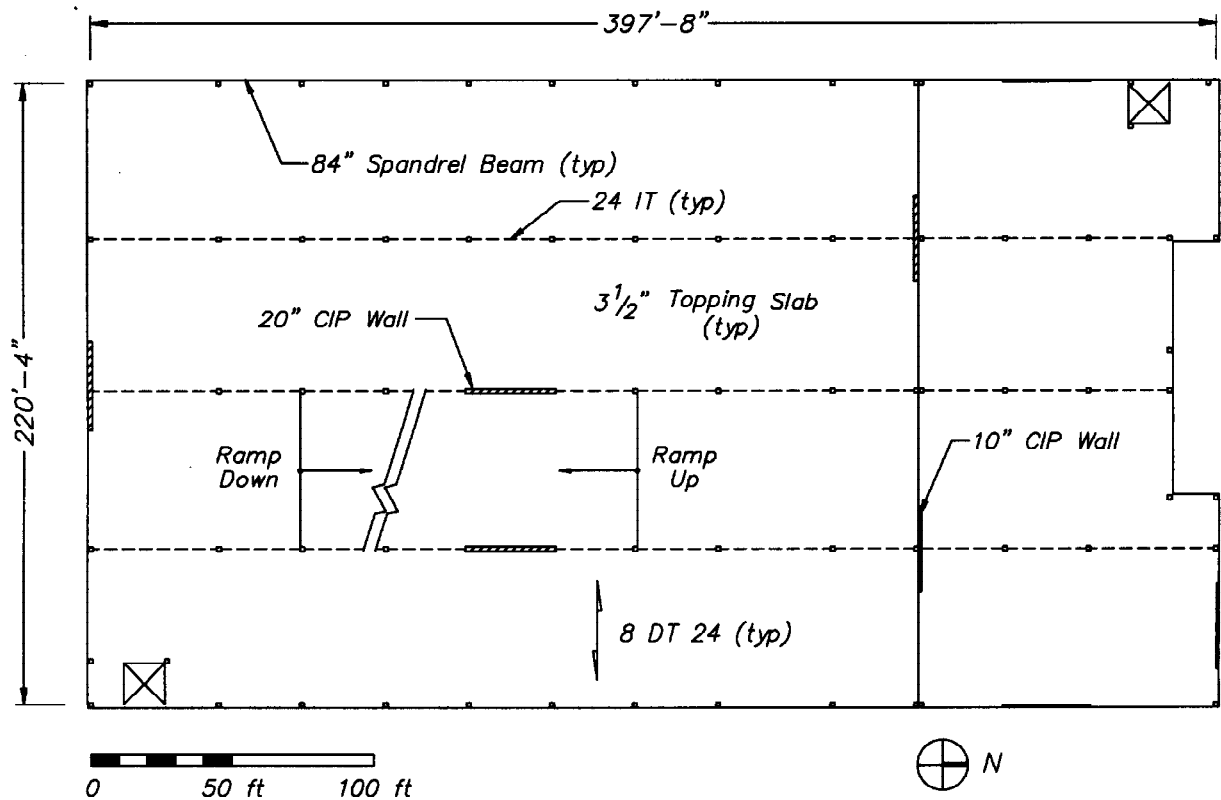
Fig. 1 Second-Floor Plan of Parking Garage A

Parking garage A was approximately 400 ft. by 220 ft. in plan (Fig. 1). It consisted of two adjacent and independent structures, physically separated by an expansion joint. Parking was provided on three levels: one on grade and two supported levels. The ramps that connected the parking levels were located near the center of the south section of the building. Both sections of the garage contained two structural walls in each direction. The walls were 20-in. thick in the south section, and 10-in. thick in the north portion of the building. All walls were approximately 30 ft. long, corresponding to an aspect ratio of 0.75. Cast-in-place beams extended beyond the walls at the elevations of the floors and served as drag struts. The drag struts were positioned on one side of the wall at some locations and on both sides of the wall at others.

Parking garage A sustained extensive damage during the earthquake. Large sections of the garage collapsed. Only those portions of the structure immediately adjacent to the structural walls remained standing.

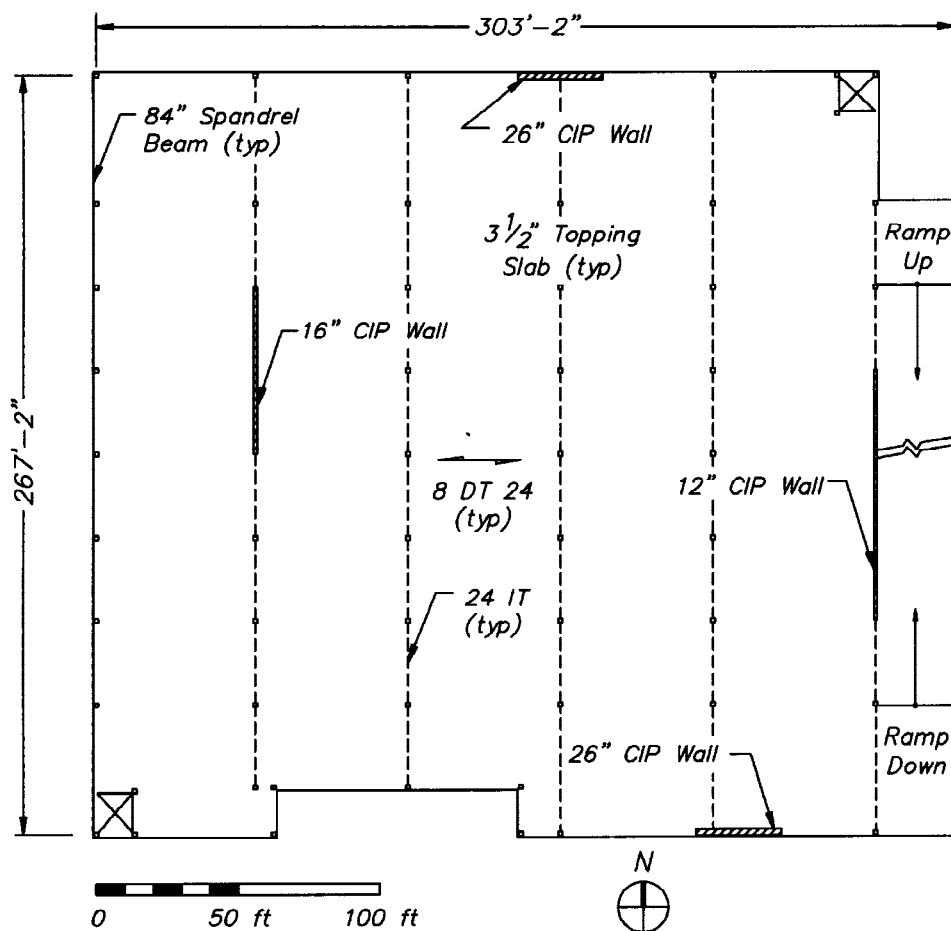
Fig. 2 Second-Floor Plan of Parking Garage B

Garage B was a single structure that was approximately 300 ft. by 270 ft. in plan (Fig. 2), and also contained three levels of parking. The structural system used in garage B was essentially the same as that in garage A. Four cast-in-place walls formed the lateral-load resisting system and precast members formed the gravity-load resisting system. Wall thicknesses ranged from 12 to 26 in., wall lengths ranged from 30 to 88 ft.,

and the wall aspect ratios ranged from 0.25 to 0.75. The ramp was located along the east side of the structure. Eight bays in the east half of the parking garage collapsed during the earthquake.

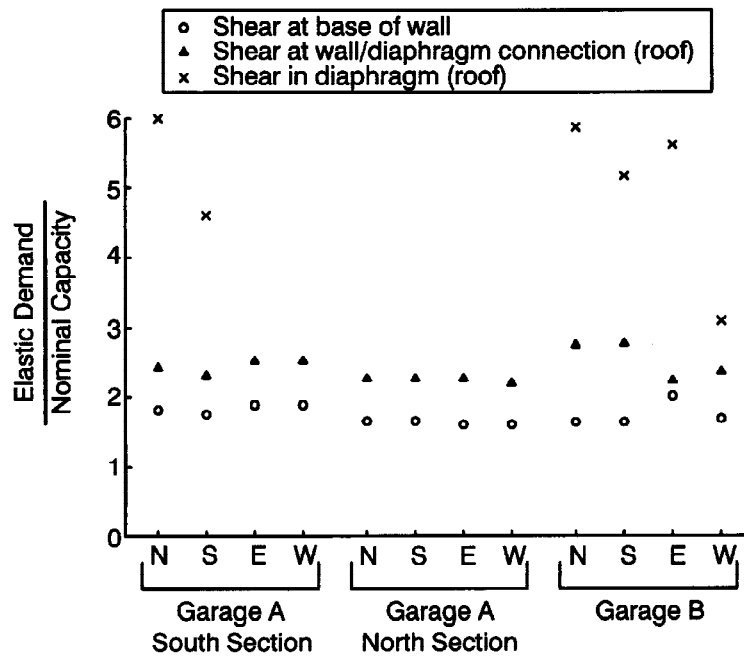
Fig. 3 Elastic Demand to Capacity Ratios for Potential Load Paths in the Parking Garages

The demands placed on the structural elements were calculated using the equivalent lateral force procedure defined in the Uniform Building Code (1994) assuming elastic response ($R_w = 1$). Elastic forces were selected to provide a basis for comparison, and were not intended to represent the actual lateral forces resisted by the buildings during the Northridge earthquake. Ratios of the elastic shear demand to the nominal capacity of the structural elements for the two garages are plotted in Fig. 3. The two sections of garage A are considered separately.

As expected, the elastic shear demand exceeded the nominal shear capacity of the structural members and connections at all locations. At the base of the walls, the elastic shear demand was approximately twice the nominal capacity. The elastic demand placed on the connection between the walls and the diaphragm was two to three times the nominal capacity. The diaphragm appeared to be the critical element in the south section of garage A and in garage B, where the demand to capacity ratios reached five to six. Demand to capacity ratios for the diaphragm were not calculated for the north section of garage A or for the east and west walls in the south section of garage A because all possible load paths intersected cast-in-place members.

The data shown in Fig. 3 indicate that the shear capacity of the diaphragms was the weakest of the three failure modes considered. Seismic forces were not transferred into the structural walls because the diaphragms did not have sufficient strength to carry the inertial loads.

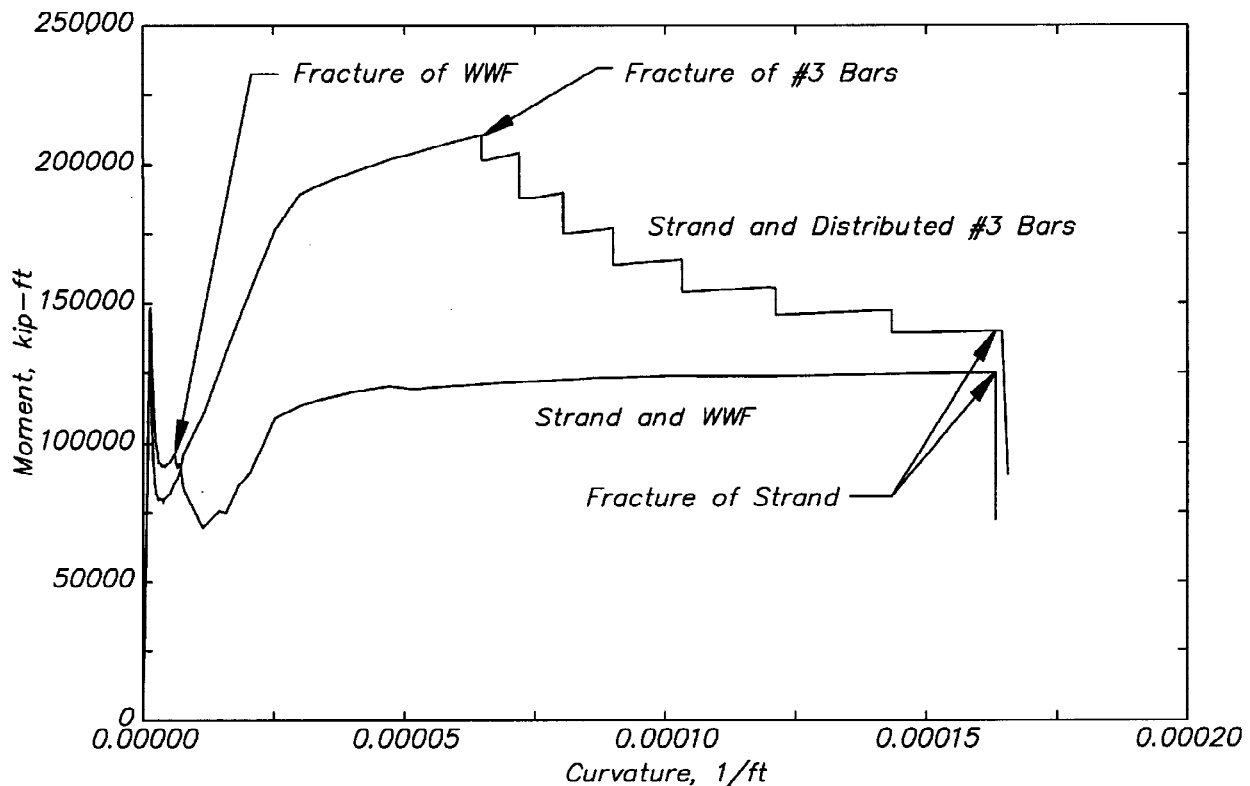
Fig. 4. Calculated Moment-Curvature Relationship for Diaphragm in Garage A

The calculated moment–curvature relationship for the diaphragm in the south section of garage A is shown in Fig. 4. The lower curve approximates the as–built conditions. Material properties representative of the unstressed strand were used for the diaphragm chords and properties representative of welded wire fabric were used for the distributed web reinforcement. The largest calculated moment resisted by this cross section corresponds to the cracking moment.

After cracking, the flexural capacity decreases with increasing curvature. The strength of the diaphragm at larger curvatures does not exceed the cracking moment because the welded wire reinforcement in the web begins to fracture. As the crack opens, the calculated strains in the wire are concentrated over a development length of 6 in., which corresponds to the mesh spacing. The fracture strain of the wire was assumed to be 0.02. The post–cracking strength of the cross section is reached when the chord reinforcement yields and the web reinforcement in tension has fractured. The calculated curvature capacity corresponds to fracture of the strand that forms the tension chord.

A second analysis was performed using the material properties of deformed #3 reinforcing bars as the web reinforcement (upper curve in Fig. 4). The web reinforcement ratio is the same in the two analyses; however, the fracture strain in the bars was assumed to be 0.08 and the development length was increased to 14 in. The calculated flexural capacity of this diaphragm exceeds the cracking moment. The influence of fracturing of

the web steel may be seen in the discrete drops in flexural strength with increasing curvature. The limiting curvature for this diaphragm also corresponds to fracture of the strand that forms the diaphragm chord.

The forgoing arguments suggest that the as-built diaphragms exhibited brittle in-plane flexural behavior. After cracking, the deflections would become large before the strand develops its full strength, and some precast elements could have lost their support, thereby precipitating collapse.
