LATERAL LOAD RESPONSE OF STRENGTHENED REINFORCED CONCRETE BEAM-TO-COLUMN JOINTS

Alexander G TSONOS¹

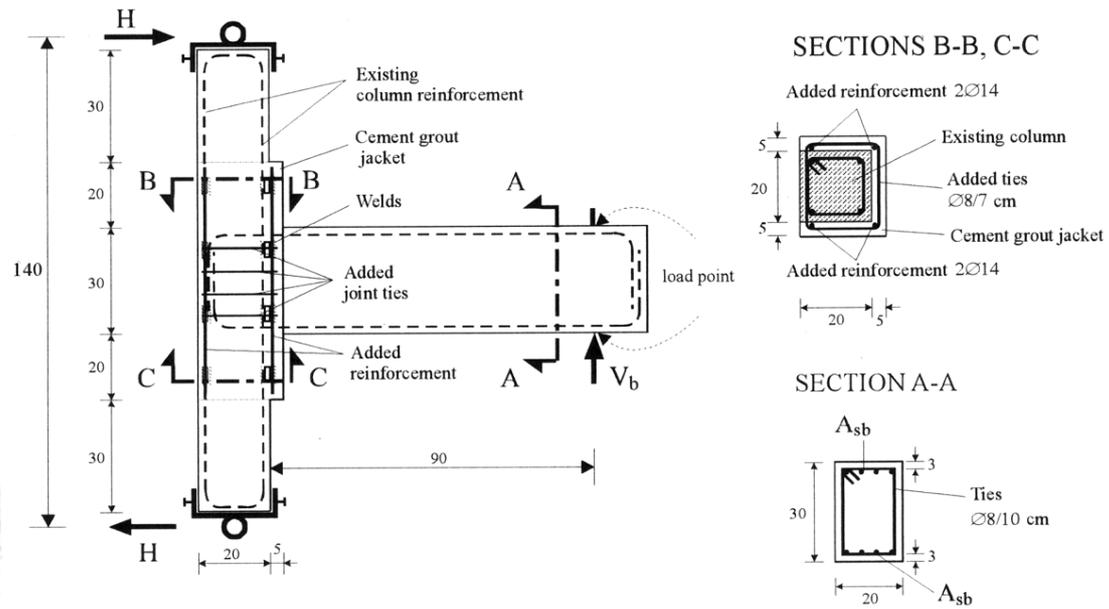
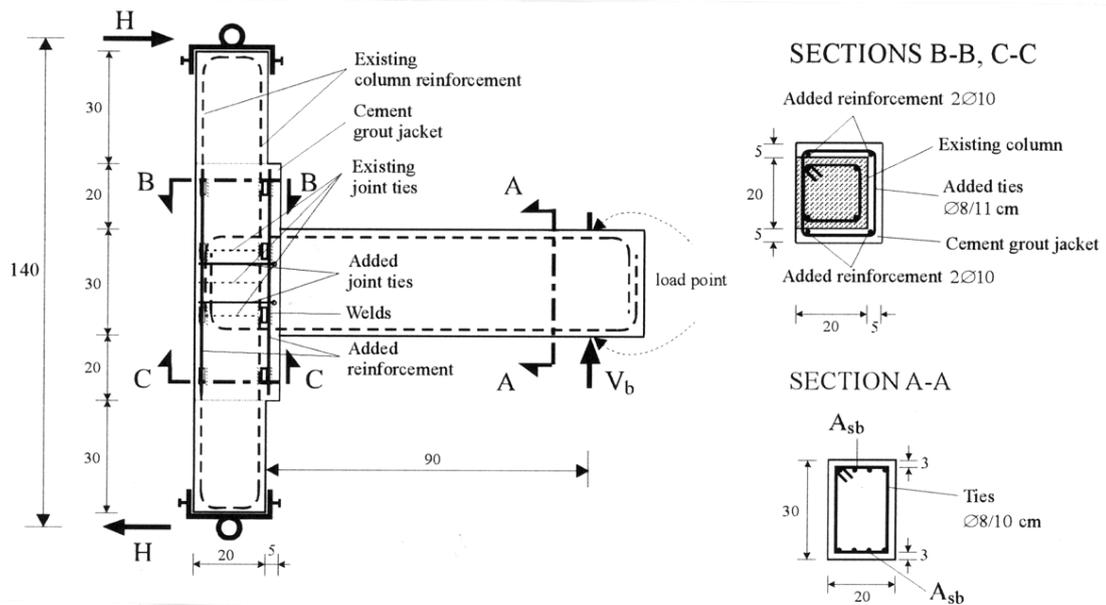
Fig. 2 (a) Jacketing of Beam-Column Connection of Subassemblage RO₁ (dimensions in cm, 1cm=0.39in), (b) Jacketing of Beam-Column Connection of Subassemblage RO₂, RP₁, RP₂, RP₃, RM₁ and RM₂ (dimensions in cm, 1cm=0.39in)

The values of the flexural strength ratio were higher than 1.40 and those of the joint shear stress were lower than $12\sqrt{f'_c}$ psi for all the specimens $RO_1, RO_2, RP_1, RP_2, RP_3, RM_1$ and RM_2 , (Figures 2(a), 2(b)). The additional joint transverse reinforcement of specimen RO_1 was $\varnothing 8$ at 5cm. This reinforcement satisfied the requirements of the Committee. The joint transverse reinforcement of specimens $RO_2, RP_1, RP_2, RP_3, RM_1$ and RM_2 with the two additional ties was $\varnothing 8$ at 3.50cm. It is obvious that the joint reinforcement of $RO_2, RP_1, RP_2, RP_3, RM_1$ and RM_2 also satisfied the requirements of the Committee.

Specimen RO₁ $M_R = 2.50$
 $\gamma = 6.15$

Specimen RO₂ $M_R = 2.50$
 $\gamma = 3.80$
 Specimen RP₁ $M_R = 1.90$
 $\gamma = 6.60$

Specimen RP₂ $M_R = 2.40$
 $\gamma = 3.80$
 Specimen RP₃ $M_R = 2.00$
 $\gamma = 5.40$

Specimen RM₁ $M_R = 2.50$
 $\gamma = 4.10$
 Specimen RM₂ $M_R = 1.70$
 $\gamma = 6.70$

Strengthening involved encasing the original beam-column joint and the critical regions of the columns of the specimens with a three-sided cement grout jacket reinforced with additional ties in the joint region and the columns (Fig. 2). To support the transverse steel, additional longitudinal reinforcement was placed at each corner of the jacket, which was then welded to the existing column reinforcement. To improve the bond between the old and new concrete and for the welding of the new reinforcement to the existing reinforcing bars, the concrete cover of the original specimens ($O_1, O_2, P_1, P_2, P_3, M_1$ and M_2 after the tests) was chipped away and the surface was roughened by light sandblasting.

As shown in Fig. 2, all specimens $RO_1, RO_2, RP_1, RP_2, RP_3, RM_1$ and RM_2 had the same three-sided cement grout jacket, plus $\varnothing 14$ longitudinal bars for specimen RO_1 , and plus $\varnothing 10$ longitudinal bars for specimens RP_1, RP_2, RP_3, RM_1 and RM_2 , at each corner of the column connected by $\varnothing 8$ supplementary ties at 7cm. All longitudinal bars in the jackets extended into the beam-column region of the subassemblages. The beam to column joint is undoubtedly the most difficult to strengthen because of the great number of elements assembled in this region (Gulkan 1977, Corazao et al. 1988).

Four horizontal ties were placed in the joint of specimen RO_1 in order to provide enough confinement and shear capacity to the joint. Two additional horizontal ties were placed in the joint region of specimens $RO_2, RP_1, RP_2, RP_3, RM_1$ and RM_2 in order to increase their shear strength (Fig. 2).

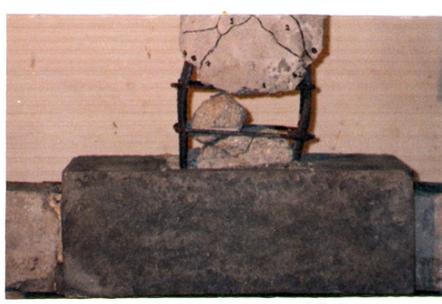
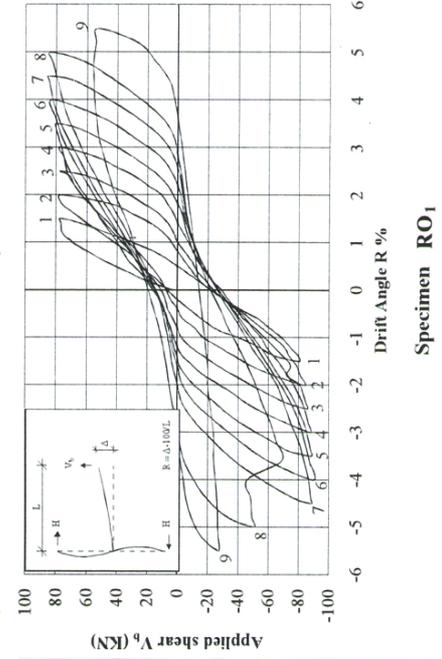
Specimen RO₁

Specimens RO_1 , RO_2 , RP_1 , RP_2 , RP_3 , RM_1 and RM_2 : the failure mode of specimens RO_1 , RO_2 , RP_1 , RP_2 , RP_3 , RM_1 and RM_2 , as expected, involved the formation of a plastic hinge in the beam near the column juncture and damage concentration in this region only. It is worth noting that the flexural hinges occurred just outside the retrofit area, see Fig. 4. The formation of plastic hinges caused severe cracking of the concrete near the fixed end of the beam.

In particular, during the final cycles of loading, when large displacements were imposed, the damaged concrete cover could not provide adequate support for the beam longitudinal reinforcement. As a result, buckling of the beam reinforcement in specimens RO_1 , RO_2 , RP_1 , RP_2 , RP_3 , RM_1 and RM_2 occurred after the seventh, eighth, ninth, eighth, seventh, eighth and seventh cycles of loading, respectively.

Strengthened specimens RO₁, RO₂, RP₁, RP₂ and RM₁ exhibited stable hysteresis up to the eighth cycle of drift angle R, of 5.0 percent, after which a significant loss of strength began due to the noticeable buckling of the beam reinforcement (see Fig. 4 for the representative strengthened specimens RO₁ and RP₁). The strengthened specimens RP₃ and RM₂ demonstrated stable hysteresis up to the seventh cycle of drift angle R of 4.5 percent.

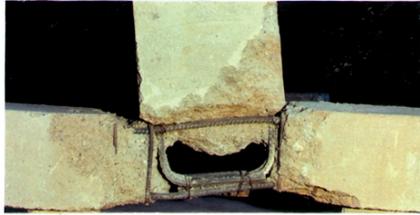
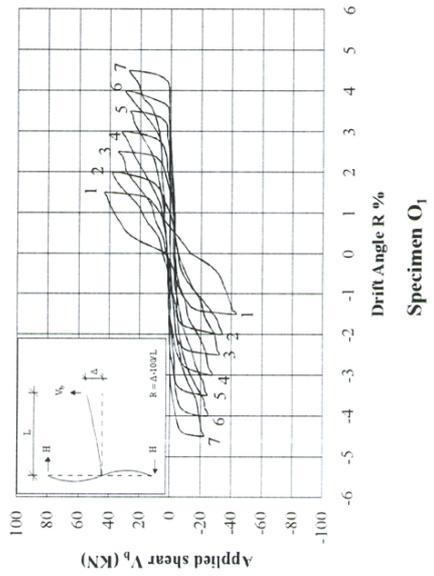
Specimen O₁

Specimens O_1 , O_2 , P_1 , P_2 , P_3 , M_1 and M_2 : the connections of all these subassemblages, as expected, exhibited explosive shear failure during the early stages of seismic loading. Damage occurred both in the joint area and in the columns' critical regions. Of course, more rapid deterioration was observed in specimen O_1 (without joint shear reinforcement); the extreme joint shear deformations are obvious in this specimen, see Fig. 4. It is worth mentioning that the column longitudinal reinforcement of specimens O_1 and P_1 , consisting of $\varnothing 14$ bars, was bent into permanent waves in the joint region (Fig. 4), while the column longitudinal reinforcement of specimens O_2 , P_2 , P_3 , M_1 and M_2 consisting of $\varnothing 10$ bars, was buckled into permanent waves in this region. The beams in all specimens O_1 , O_2 , P_1 , P_2 , P_3 , M_1 and M_2 remained intact at the conclusion of the tests.

In summary, the strengthened subassemblages RO_1 , RO_2 , RP_1 , RP_2 , RP_3 , RM_1 and RM_2 exhibited cracking patterns dominated by flexure. In contrast, the original subassemblages O_1 , O_2 , P_1 , P_2 , P_3 , M_1 and M_2 , exhibited cracking patterns dominated by shear (Fig. 4).

The original beam-column specimens O_1 , O_2 , P_1 , P_2 , P_3 , M_1 and M_2 showed stable hysteretic behaviour up to drift angle R ratios of 1.0 percent, 3.0 percent, 2.5 percent, 3.0 percent, 3.0 percent, 3.5 percent and 2.0 percent. They showed a considerable loss of strength, stiffness and unstable degrading hysteresis beyond drift angle R ratios of 2.0 percent, 3.0 percent, 3.0 percent, 3.5 percent, 3.5 percent, 3.5 percent and 2.0 percent, respectively (see Fig. 4 for the representative specimens O_1 and P_1).
