PERFORMANCE OF SCHOOL BUILDINGS IN BINGÖL DURING THE 1 MAY 2003 EARTHQUAKE

**Turel GUR¹, Julio A. RAMIREZ¹, Mete A. SOZEN¹, A. Cihan PAY¹, Arvid M. JOHNSON¹
Antonio BOBET¹, Adolfo MATAMOROS², Ayhan IRFANOGLU³, Lili AKIN¹**

SUMMARY

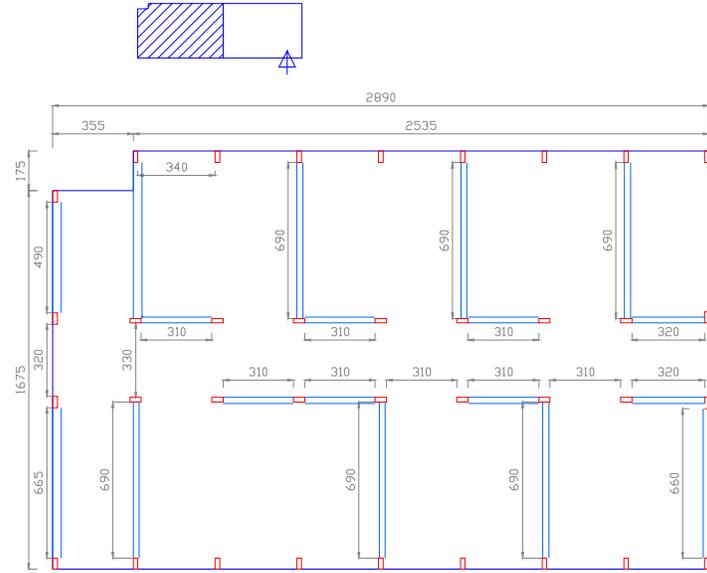
The only school building with a different column layout was C-13-02. The school complex was a combination of two separate buildings. The separation afforded by the expansion joint between the two buildings was not sufficient to avoid pounding between the two structures. The floor plan of the northern building is shown in Fig. 6. All the columns shown in the figure have dimensions of 0.2m x 0.5m.

Figure 6. The floor plan for C-12-02. The structural system is a moment-resisting frame. The columns are 0.2m x 0.5m. The school building comprises two independent structures separated by an insufficient expansion joint. Only the shaded part in the upper figure was surveyed. The arrow indicates the entrance to the building. The dimensions are in cm.

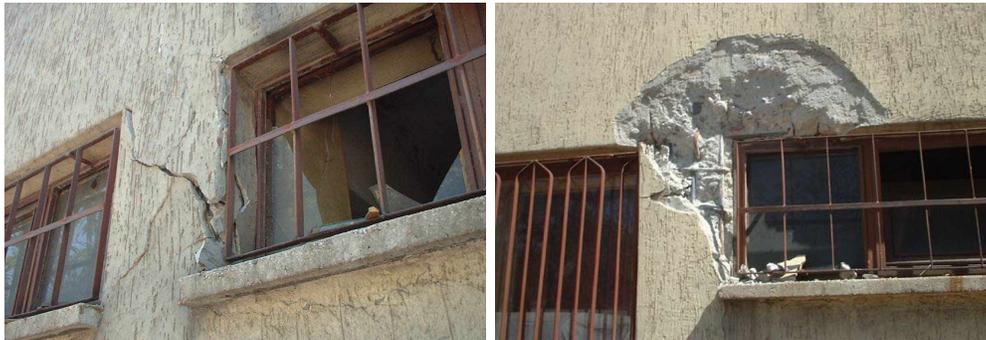
One of the most common structural problems observed in these buildings was the presence of captive columns, which made the structures vulnerable with respect to column shear failures. In almost all the schools, openings for small windows in the furnace room and restrooms were placed adjacent to columns. The exterior rectangular columns were oriented with the strong axis resisting moments in the short direction of the building layout in Fig. 4. Therefore, windows on the exterior walls in the long direction of the building exposed columns to shear forces acting perpendicular to their weak axis for bending (Fig. 7). It was observed also that crushing of the masonry walls in the upper corners created captive columns (Fig. 8).

Figure 7. Shear failure of captive columns created by the small windows of the furnace room in building C-14-03.

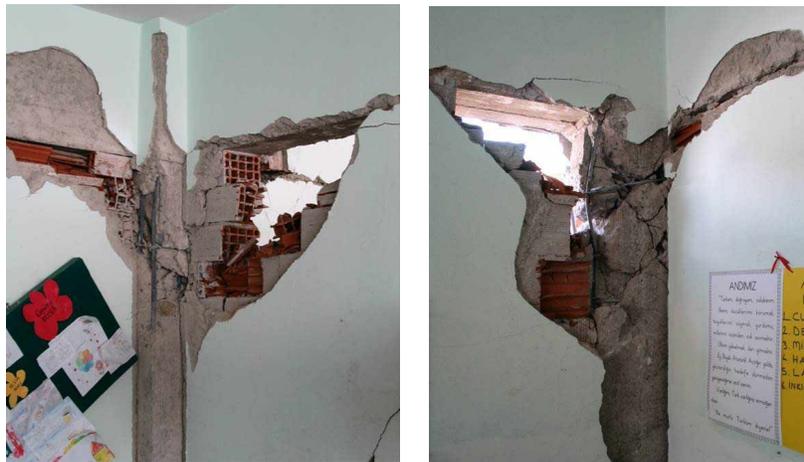
Figure 8. Shear failure of captive columns as a result of crushing of upper corner of masonry walls in building C-14-01.

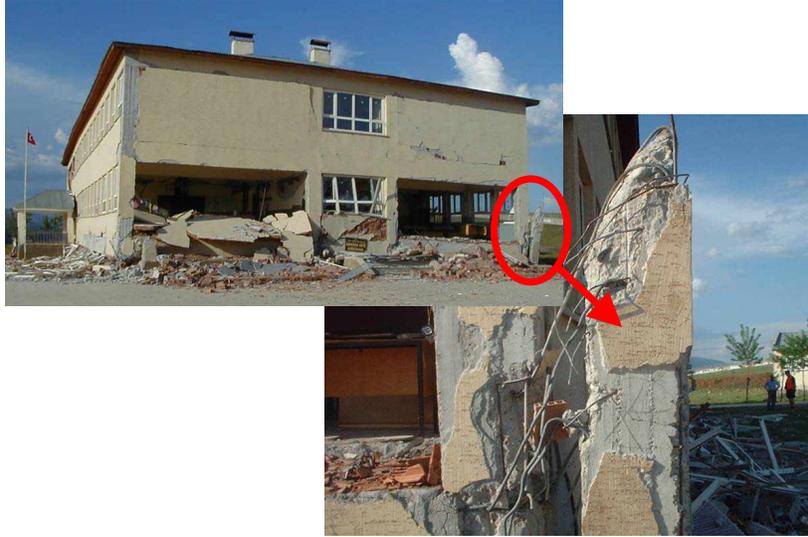
In the school buildings that were visited the detailing of structural members was inadequate with respect to requirements of modern seismic codes. Lack of confinement in plastic hinge regions of the columns was observed to be one of the most significant causes of damage. Even though the spacing of the stirrups was reduced in the end regions of some columns, the amount of transverse reinforcement provided was not sufficient to prevent shear failures, particularly in the case of captive columns (Fig. 9). Another detailing deficiency commonly observed was the inadequate anchorage of the free ends of the stirrup reinforcement.

Figure 9. The shear failure of the corner column in building C-13-09 (collapsed). The spacing of the transverse reinforcement is 10 cm at the top 30-cm portion of the columns. The ends of the stirrups were not anchored properly.

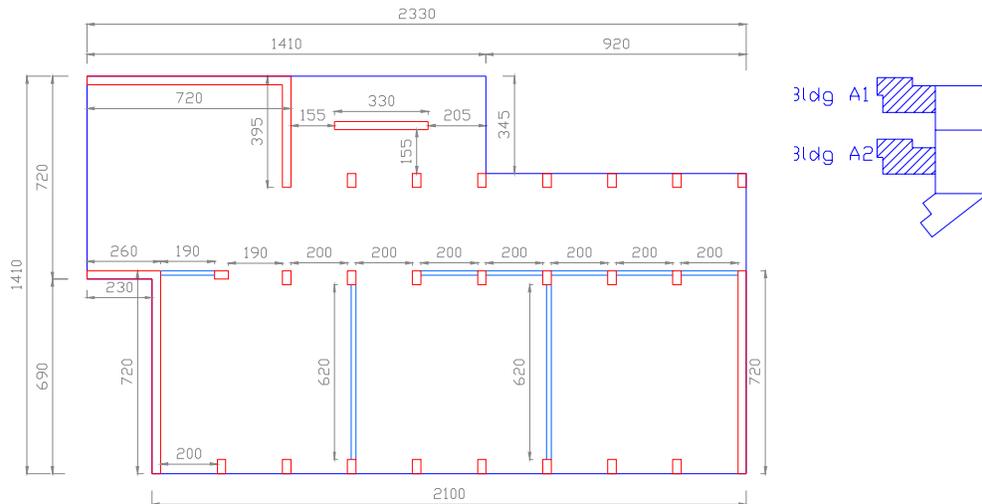
There were no indications of structural damage in the buildings, and the masonry walls were only lightly damaged.

Figure 10. Structural floor plan for building C-13-04A. All the columns have dimensions of 0.3m x 0.5m. The thickness of the reinforced concrete and masonry walls were 0.3m and 0.16m, respectively. Dimensions are in cm.

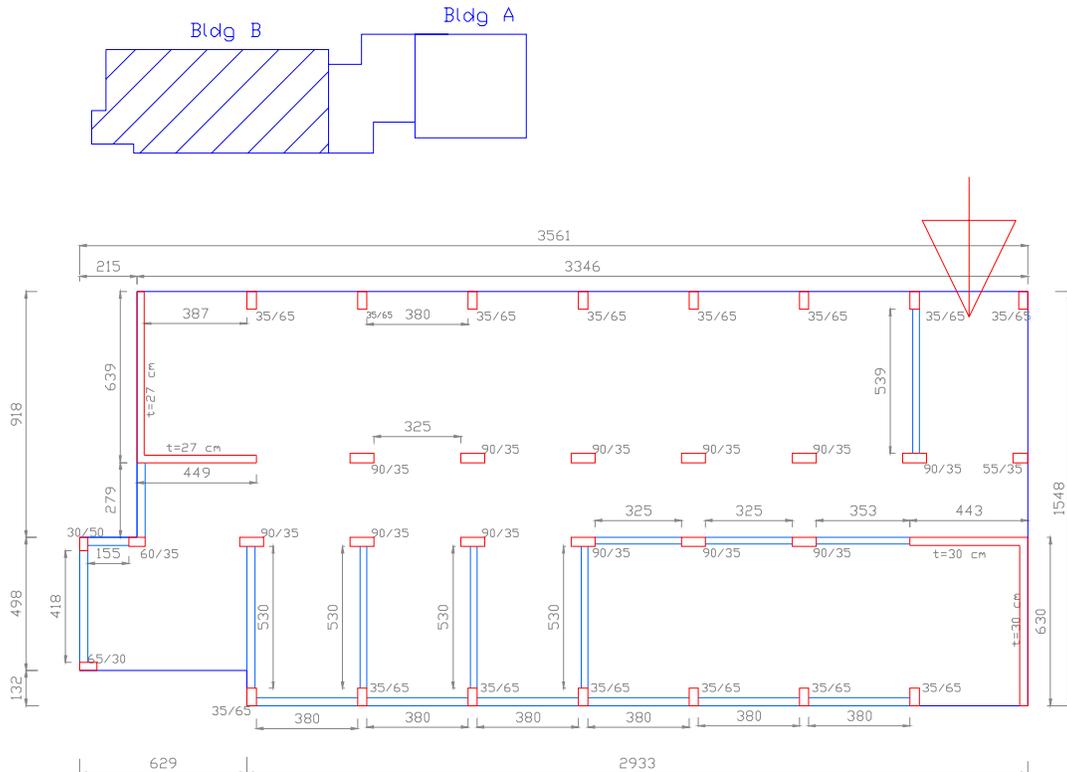
In building C-14-08, damage to the structural system consisted of hairline cracks in the shear walls. There was no damage observed in the columns and a few beams had severe flexural cracks. The structural system of this building was rated as moderately damaged. The masonry walls were separated from the structural frame because of crushing of the bricks at the edge of the walls. There was no partial or full collapse of the masonry walls.

Figure 11. Structural floor plan for building C-14-08. The thickness of interior and exterior masonry walls were 0.25m and 0.3 m, respectively. The arrow shows the entrance to the building. Dimensions are in cm.

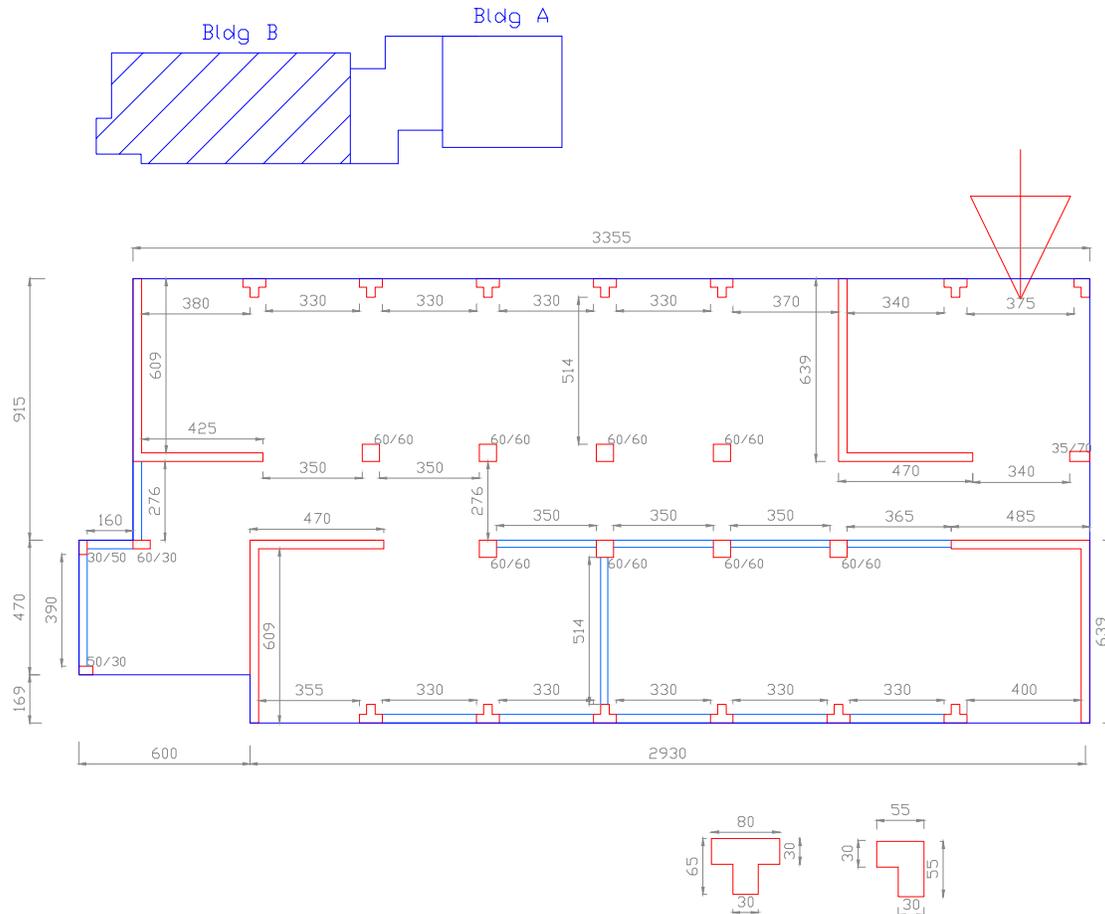
Buildings C-13-03 and C-15-03 with higher shear wall ratios than the other two (ratio of wall to floor area) had only moderate damage to their structural systems and the masonry walls.

Figure 12. Structural floor plan for building C13-03. The thickness of the shear walls was 0.3m. The masonry wall thickness was 0.25m for the interior walls and 0.3m for the exterior walls. The arrow shows the entrance to the building. Dimensions are in cm.

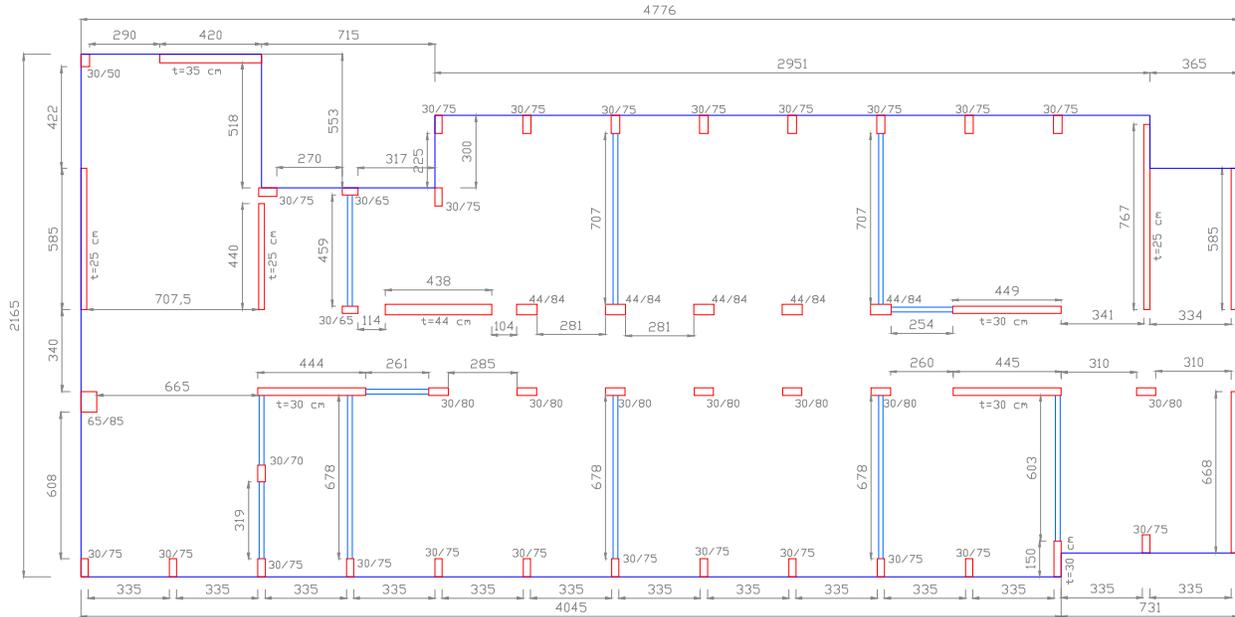
Damage to the structural system and the masonry walls were both rated as moderate. There were no inclined cracks observed in the columns or shear walls. There was some local damage to members in the form of spalling of concrete cover likely as a result of construction deficiencies.

Figure 13. Structural floor plan for building C-17-03. Masonry wall thickness was 0.19m. Dimensions are in cm.

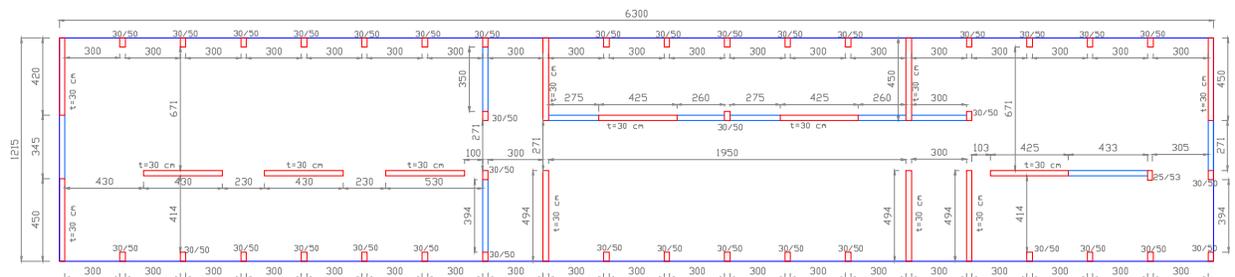
Of the four dormitory buildings that were surveyed, the structural systems of two of them, D-17-01 and D-17-02, were rated as severely damaged because of the inclined cracks on the captive columns. There were also inclined hairline cracks on the shear walls. Some of the beams had flexural and shear cracks, and damage was commonly observed in beams that framed into other beams as opposed to columns.

Figure 14. Structural floor plan for dormitory buildings. The masonry wall thickness was 0.3m. Dimensions are in cm.

Because buildings D16-02 and D-17-04 had inclined hairline cracks on shear walls and shear and flexure cracks on beams the damage to them was rated as moderate.

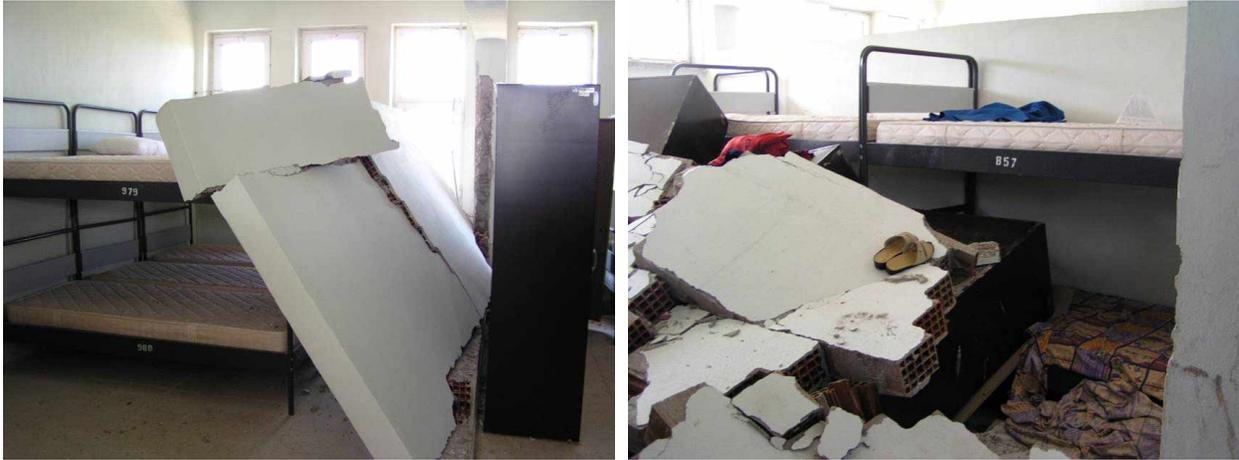
The most striking damage in these buildings was the collapse of the free standing masonry walls separating the sleeping units in the upper levels. These walls were not included in the damage rating because they were unattached to the structural system. However, they presented a serious hazard to the students living in these

dormitories because in some cases the walls collapsed on the beds (Fig. 15). Fortunately the collapse of the walls did not result in any fatalities because almost all the beds so affected were unoccupied at the time.

Figure 15. Collapse of the free standing masonry walls onto the beds in the dormitory buildings.

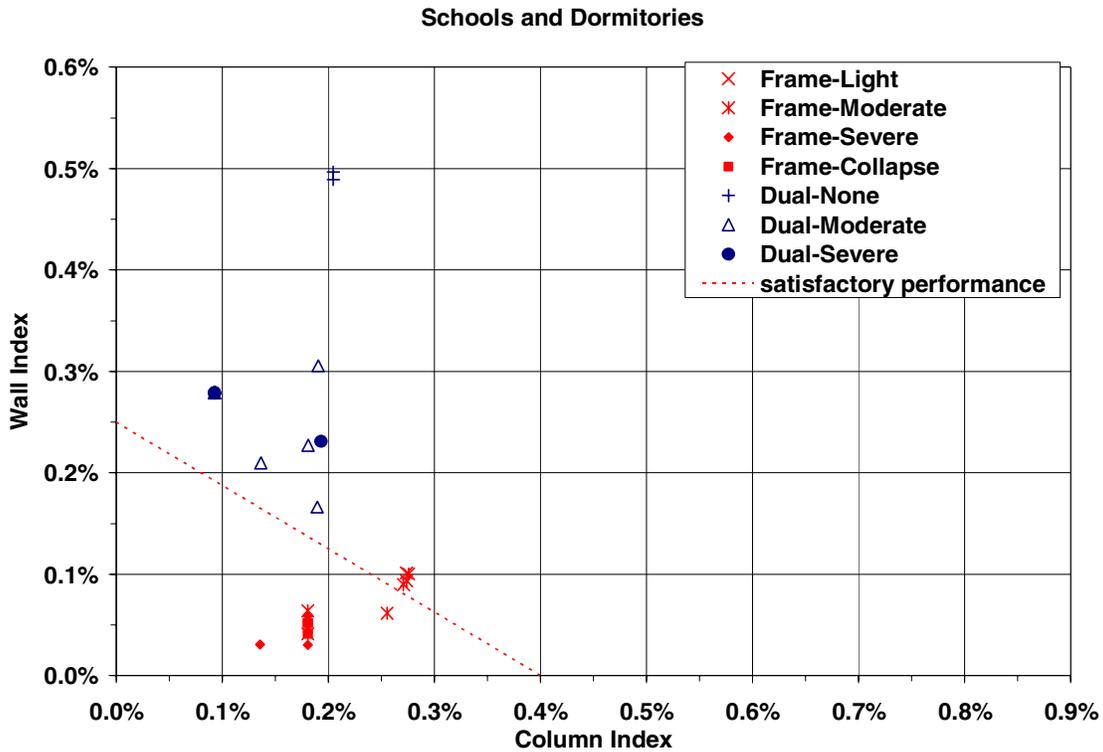
The wall index is calculated for both main horizontal axes of the buildings, and the smaller of the two is taken as the wall index for the given building. The wall and column indexes calculated for the school and dormitory buildings in Bingöl are given in Table 2. The correlation between the damage category of the buildings and the wall and column indexes are presented in Fig. 16. As the figure shows, the damage level tended to decrease as the wall and column indexes increased.

Based on the damage assessment of these buildings, a boundary for the minimum column and wall indices for satisfactory performance is shown in Fig. 16.

Figure 16. Correlation between the structural performance and the wall and column indexes defined by Hassan and Sozen (1997).

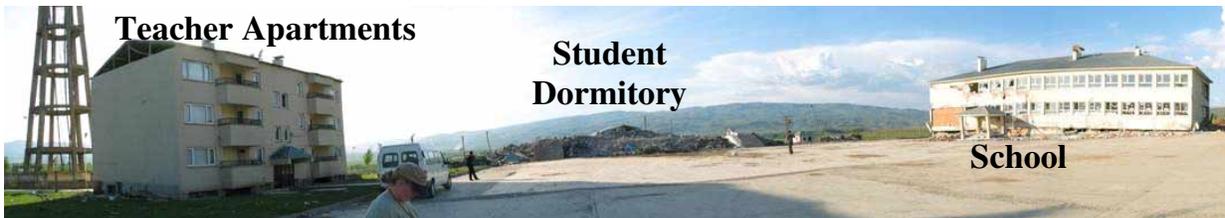
A good example of the different types of response experienced by different structural systems is illustrated in Fig. 17. Before the earthquake, there were three buildings at the site of Celtiksuyu Boarding School, located approximately 10 km to the south east of Bingöl. The buildings were the teachers' apartments (C-13-11), the student dormitory and the school building (C-13-10). The figure shows the state of the three structures after the earthquake. Both the school building (right of the picture) and the student dormitory (center of the picture), with moment-resisting frames, collapsed with a death toll of 84 (mostly children). The apartment building for the teachers, with a dual structural wall – moment frame resisting system, survived without damage.

Figure 17. Comparison of the performance of the moment-resisting frame (MRF) and dual system buildings at the same school site. The two MRF buildings, the school and the dormitory, collapsed whereas the dual system building on the left survived without damage.

The observations in the school buildings showed that structural walls improve the behavior of reinforced concrete systems drastically. Especially in the structural design of school buildings using reinforced concrete frames such as those found in Bingöl, structural walls are recommended.
