EARTHQUAKE DAMAGE OF WINDOW GLASS AND DOOR OF A HOTEL DAMAGED IN THE 1999 CHI-CHI TAIWAN EARTHQUAKE

SUMMARY

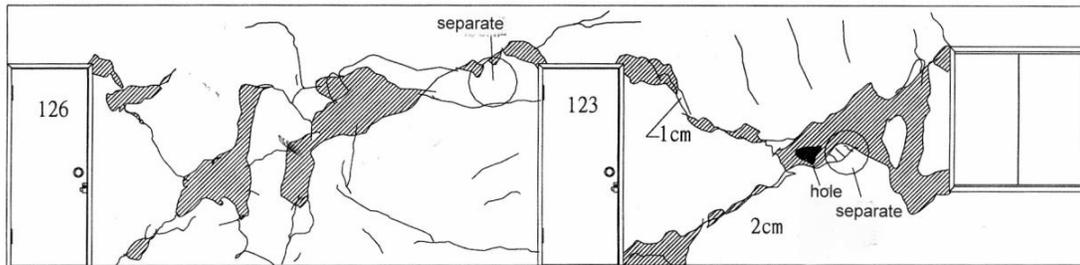
Fig1~fig4 show the damage of the brick partition wall in the first story of building A . In figure1 , the brick wall had a shear crack on the 45° , and the crack had pass through the wall. Because the slide bricks extruded door frame and caused the deflection of the door , the panel and the lock damaged. For example , the door of No.123 and No.126 rooms could not been opened after earthquake.

fig.1 brick walls were seriously damaged, the doors couldn't be opened(damage degree V)

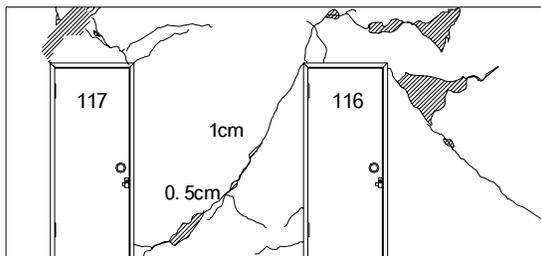
fig.2 shearing cracks appeared on the brick walls, the doors were compressed and couldn't be opened (damage degree IV)

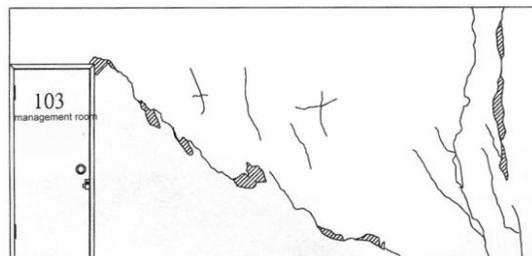
fig.3 oblique cracks occurred on the brick wall , the plaster flaking off (damage degree III)

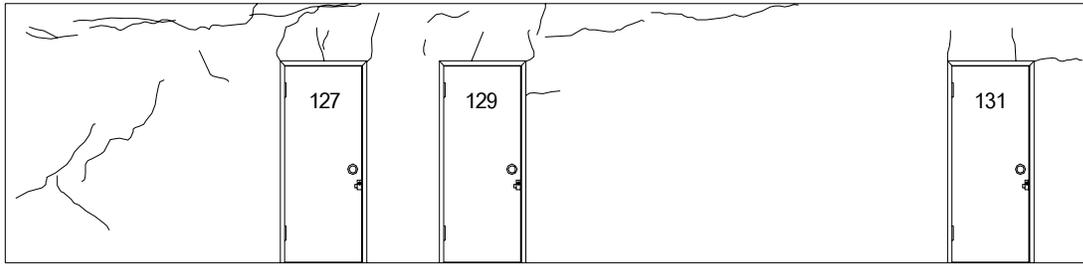
fig.4 the width of crack was under 2mm, damage was slighter(damage degreeII) , the No.131 was on the level of damage degree I

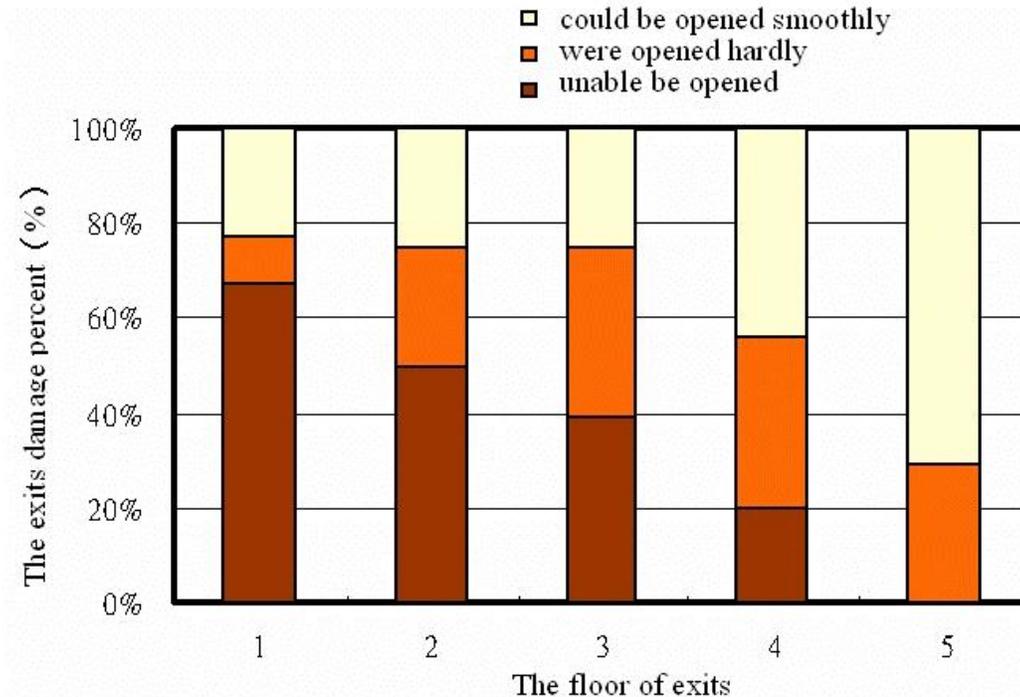
We divided the damage into three types: “O” meant the door opened smoothly , and “D” meant to open the door have a little difficult but still can be opened , and “X” meant the door was unable to be open(Table.1). The number of door , including rooms and exit , total is 222. According to the records showing in Fig.1, there were 92 doors (41 %) unable to open , and 62 doors (28 %) opened hardly , and only 68 doors (31 %) can be open smoothly. Fig.5 showed that if the exits were in the lower story , the doors which opened hardly or couldn’t opened would get higher percentage.

fig.5 The relationship between exits damage and floor

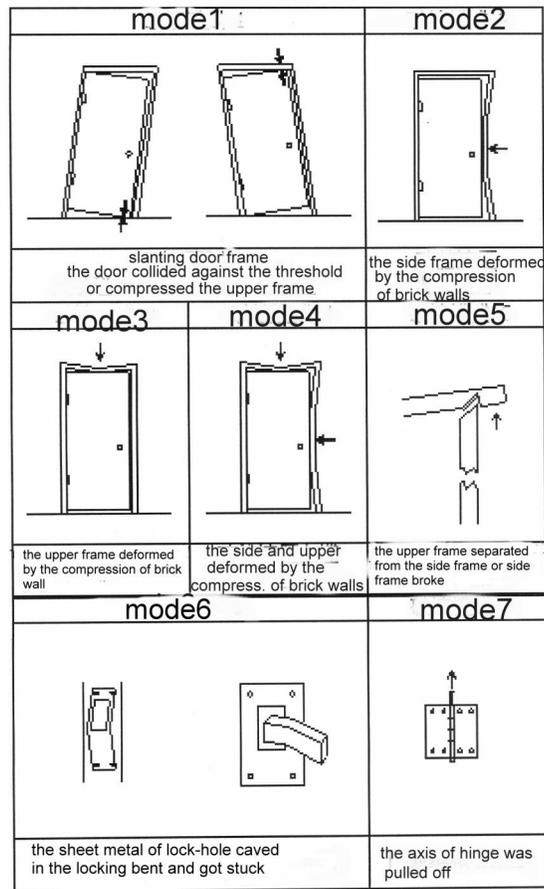
From the investigation of brick walls and exits , seven destruction modes(fig.9)has been divided. Mode_1(the door collided against the doorsill or extruded upper frame)was the mostly frequent of exits destruction modes from Table 5, there were 112 exits which occupied 73% of totally 154 cases; the following was Mode _2(the side frame deformed by the compression of brick walls)which were 61 exits which occupied 40%. Consequently, the generally sequence of destruction of wood doors were firstly door collided against the upper frame or doorsill, secondly the destroyed brick walls squeezed the frame to deform and close strictly with panel, in the end the locking was stuck , even the axis of hinge was pulled off.

Fig.9. The destruction modes of exits

- (5) If there are lintel of the exit doors , that can prevent the cracked brick walls from directly pressing the top of the door frame to extrude the panel and hinder from fleeing.

- (6) The interval between panel and top of the frame or doorsill and between the lock strike and strike hole must have more than 10mm spare space.

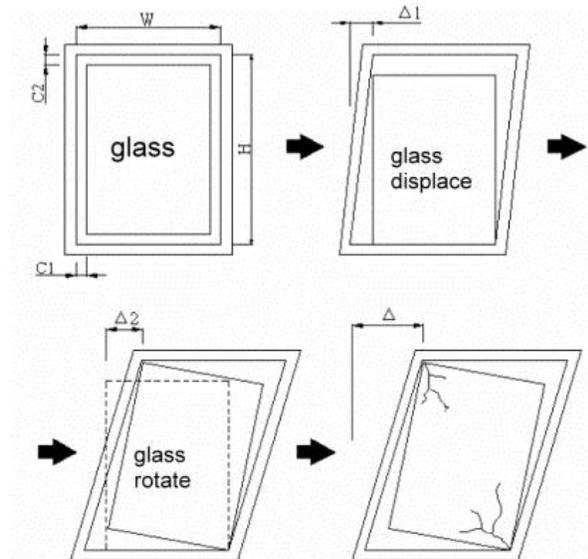
Fig.10. The destruction modes of fixed window glass
