INNOVATIVE RESTORATION OF THE APAGNI ROMANESQUE CHURCH, DAMAGED BY THE 1997 MARCHE-UMBRIA EARTHQUAKE

M. INDIRLI¹, A. VISKOVIC², M. MUCCIARELLA³, C. FELEZ⁴

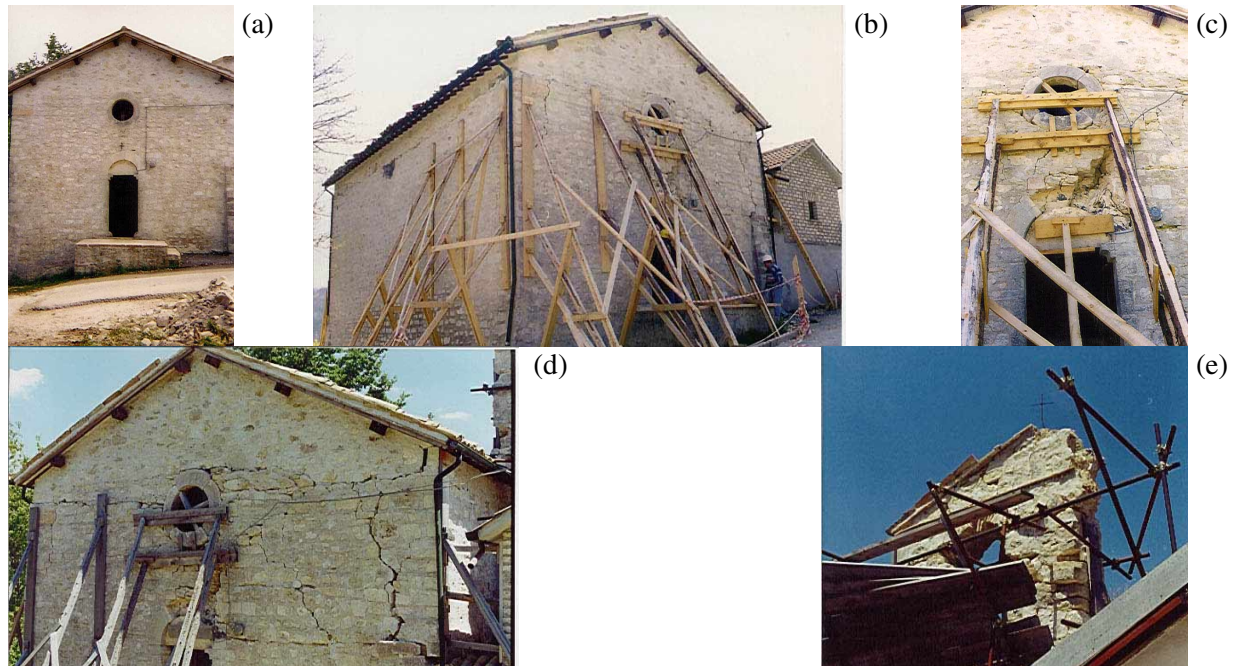
The new seismic event (classified as moderate) damaged the Apagni church again (Figs. 4-5) and the church was declared unsafe and closed. The cracks present on the structure pointed out the effects of the interventions realized in the 80's. Under seismic excitation, the architectonic organism (in addition to several typical injuries due to its intrinsic structural vulnerability, as the falling down of the bell-sail, rotation of the front, additional parts separation, widespread presence of cracks near the openings), gave an unexpected answer, showing abnormal damage. The large cracks allowed to verify the walls width in which the injections were effective and the injection points. The reading of fissures and lesions was interesting from a didactic point of view. The typical seismic excitation shear-force response of the entire single-room building should have been the opening and overturning towards the exterior. However, the insertion of the concrete string-courses and the cement injections (done in the previous restoration) conferred different stiffness to the masonry wall structure along its verticality; consequently, the entire building was roughly divided by the horizontal shear-force into three parts, which moved reciprocally amongst themselves with different behavior: the lower part largely resisted, conserving almost entirely intact its "a sacco" masonry; the upper part (concrete string-courses, triangular trusses and roof), separated itself completely from the underlying masonry and rotating autonomously; therefore, the central part experienced relevant torsion stresses, due to the differential movements between the inferior and superior portions. The "a sacco" masonry suffered a general loss of cohesiveness and extensive detachments; a typical damage in blocks, due to the walls non-uniform resistance (subsequent to the above-mentioned injections), was evident; the masonry walls fractured exactly along the reticular lines along which the injections were executed (i.e. corresponding to the still in-situ pvc-nozzle positions).

The façade suffered a visible detachment from the longitudinal walls (slight planar rotation/translation and plastic hinge formation at the height of the of the lightly buttressed section). Through-passing cracks

(vertical and oblique, singular and multiple) were present, especially in the central strip including the voids; many punctual collapses occurred, including those of the portal and the arch keystones; the four keystones of the central circular window underwent downward shift and planar rotation; the two corners, immediately below the concrete string-course, suffered twisting movements along two axes and evident rotation (causing several detachments), due to the interaction between the orthogonal masonry panels and the hammering of the stiffened roof (added during the latter restoration).

Fig. 4. The Apagni church: (a) before the 1997 earthquake; (b) (c) (d) (e) 1997 seismic damage

completely free. Therefore, the suffered damage was different in the two sides. The below-wall moved and divided itself into three parts and showed perfectly horizontal cracks. Due to the loss of the upper connection (concrete string-course detachment), it remained connected to the remaining three sides, flexing freely and showing positive out-of-plumbs in the corners and negative in the middle; the failure-summary regarded inclined through cracks in the depressed central portion, oblique cracking due to the façade and end-wall rotation. The out-of-plumb highest values occurred in the corner connected to the façade (about 10 cm in the orthogonal direction and 4 cm in the parallel one). The above-wall presented minor cracks; the loss of the roof-wall connection was shown by an horizontal cut and a misalignment of about 3 cm. Oblique cracks presence attested the rotation of the two orthogonal wall panels. Detachments were suffered by the annexed chapel (about 1-2 cm) and the non-connected funereal chapel (about 4-5 cm); the latter experienced also strong cracking, due to the weak-bonding between the wall concrete blocks. Both the structures suffered roof damage, due to the sail bell-tower collapse (some of its stone elements fell down during the earthquake).

The very notable damage to the sail bell-tower was caused by its specific vulnerability. The free portion oscillated largely (due to its own acceleration and bell-swinging), and the last small column and the right-hand arch collapsed, falling on the roofs of the two small chapels, as described above. The two remaining-in-place columns were completely cut along an horizontal plane, separating themselves into three parts; each of these parts underwent torsion rotation, causing the expulsion of some stone elements and misalignments in the longitudinal (5 cm) and orthogonal (3 cm) directions. The remaining-in-place arch key-bricks slipped downwards (about 6-7 cm). The presence of reinforcements (threaded bars insertion into the columns) avoided the overall collapse of the structure.

The (improperly named) apse, more precisely a body joined to the sacristy, suffered global detachment and translation of the upper part, along a perfectly horizontal plane (misalignment of about 3 cm). Due to its reconstruction in concrete blocks, the shear-fracture mechanism induced horizontal cracking (in correspondence with the joints) and below-corner expulsion (translating along two axes of about 5 cm). The more ancient basement, better tied to the existing masonry of the main room, remained undamaged. The translation movement involved also the external masonry side of the end wall (misalignment of about 3 cm of the part included between the annexed building roof and the string-course level).

The triumphal arch underwent a geometric deformation, with a shear fracture of the two shoulders (height of about 60 cm above the floor level), collapse of the spring point, punctual failure of the midpoints and keystone lowering.

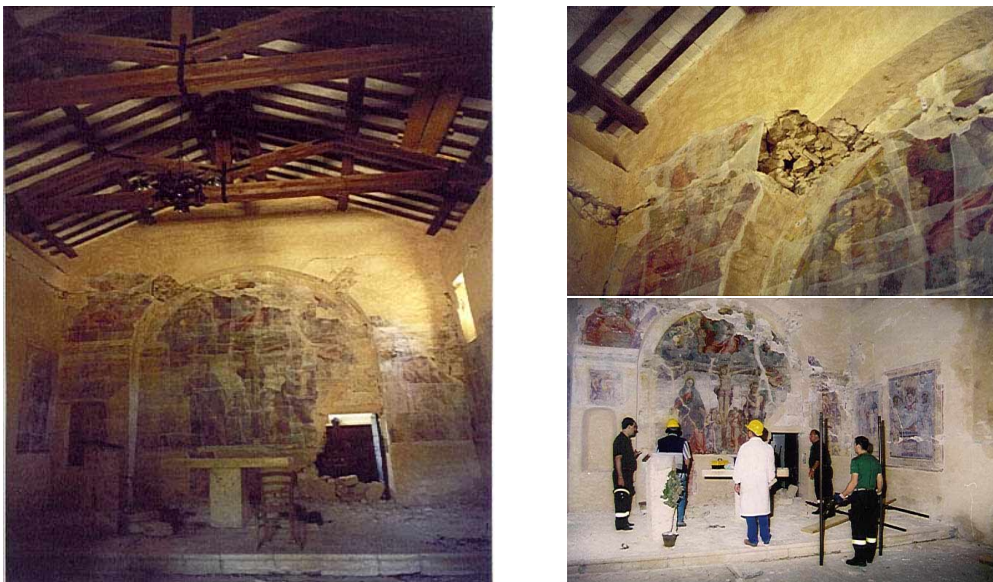
Fig. 5. Internal damages to the church and frescoes

The cracking summary of the internal walls was in line with that of the exterior, because the most of the cracks were passing through. Also in the façade and below wall interior, the subdivision into three horizontal parts was clearly legible. In addition, the oblique cracks (due to the façade rotation/translation, sacristy translation and free wall inflexion) were still found in the two longitudinal walls.

The connection between the roof string-course and the upper portion of the masonry walls had to be realized by a steel bars anchorage. The sacristy was reconstructed with self-supporting antiseismic blocks, in order to guarantee a better dynamic response. The new construction was isolated from the main hall by an antiseismic joint, realized in-situ with a compressive material. The roof had to be rebuilt in a load-bearing wood structure (strengthened by a reinforcing slab) and connected to the new masonry walls by reinforced concrete string-courses. Finally, all the mortar joints were deeply raked and refilled with a mortar studied specifically for that purpose, together with the Fine Arts Office, in order to assure a chromatic continuity with the environment. This intervention contributes to the enhancement of the mechanical characteristics of the masonry. Thanks to funds availability, it was possible to include in the restoration also finishing works (internal stucco-work and external walls cleaning) previously not planned, in order to give the church back to its community in a well-usable condition. The external walls cleaning was performed by low-pressure jets of water and successive application of a protective chemical product; residuals were removed by a final wash. The frescoes were in a worrisome state of detachment; thus, they

were subjected to “first aid” works, by using tissue-paper and glue. They were consolidated by injections underneath the painted and/or supporting surface; the tissue-paper was then removed and the residue cleaned. Two highly damaged frescoes, found in a out-of-plumb area, were removed and re-glued after being fixed to a backing panel. Fig. 3c shows the church after the intervention.

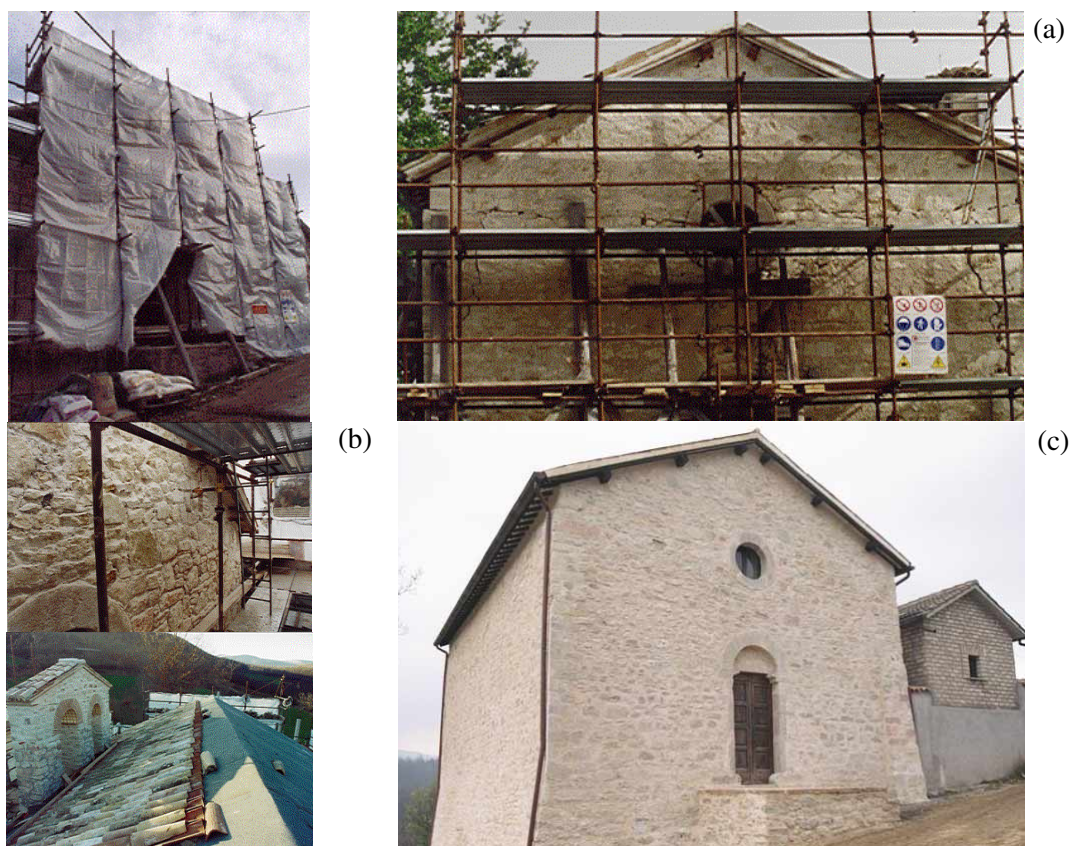
Fig. 6. (a) Prompt safety intervention, (b) rehabilitation works and (c) church after the conventional intervention

Above all, the project foresaw the scaffoldings construction around the church (Fig. 6a), in order to avoid further collapse of the crumbling masonry and assure the workers safety during the restoration. A metallic reticular structure (tubes and joints) was realized, offering the advantage of a swift execution.

The conventional rehabilitation (financial resources provided by public funds) was conceived in order to give back the wall structure its original stiffness and placing resistant systems capable of improving the building dynamic response to seismic shear-force actions (Fig. 6b). The designers decided to intervene according to the existing set of rules and respecting as best as possible the original church structure and components, in order to obtain a functional synergy with the existing elements and guarantee the reversibility. The intervention handled the critical situations assessed and outlined the following patterns: repairing damages and strengthen the weak points of the masonry structure; joining one each other roof, concrete string-course and walls; eliminating the mutual actions due to the additional parts.

The damaged masonry had to be repaired through “*cuci-scuci*” (“stitching and unstitching”) method, in order to reorganize the structural continuity, realizing effective connections between new and old wall parts, utilizing stone elements rescued from the ruins and compatible mortar. In addition, a ring of metal tie-bars on each of the four walls was introduced, at the critical height between the portal and the round window, where the greatest damage occurred; the anchorage to the walls was realized in concealed stiffened steel plates and the four corners were reinforced with steel-stitching. The stone elements of the main portal and round window above had to be replaced in their former exact position. The collapsed triumphal keys of the arch and sail bell-tower had to be reused (if possible) or replaced with compatible materials. Reinforced perforations in the sail bell-tower base columns had to be carried out, in order to anchor them to the bell-tower, in addition to the tie-bar insertion in the arches spring point.

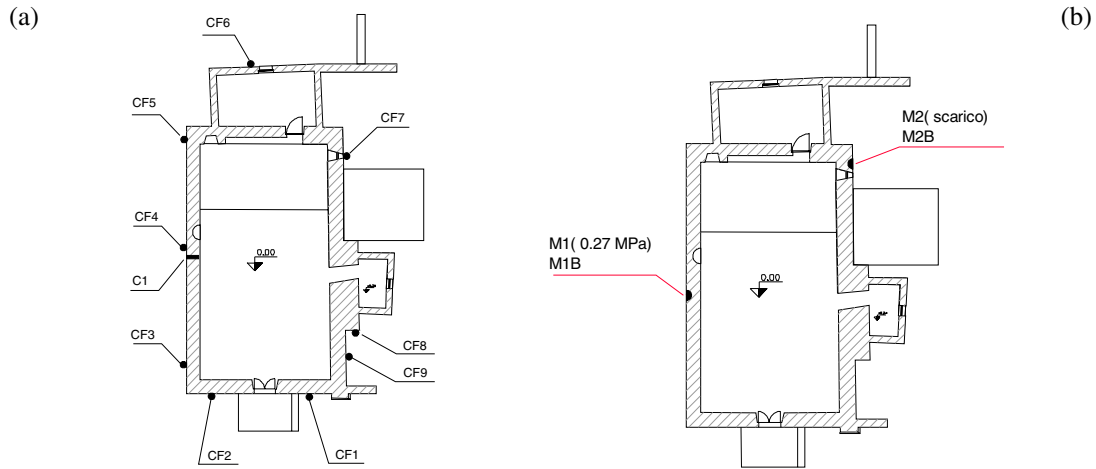
Fig. 8. Location of the horizontal and sub-vertical drillings (a) and flat jacks tests (b)

The work has been carried out on masonry walls and foundations by ENEL.HYDRO, performing the following tests (Fig. 8-10): continuous drillings on the rising walls (label Cx), detailed stratigraphy, TV color probe survey; continuous drillings on the foundation walls (label CFx), detailed stratigraphy, TV color probe survey; tests with single flat jack, in order to determine the stress conditions (label Mx); tests with double flat jacks, in order to determine the deformation properties (label MxB).

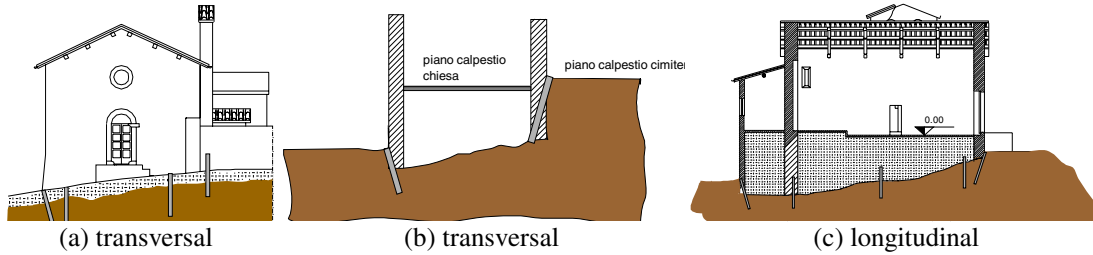
The masonry structure of the raising walls is made by blocks of medium-large dimensions in the two external faces and a rubble fill core ("muratura a sacco") composed by smaller and less regular stones with discontinuities and cavities; the mortar is well distributed in the vertical faces, less accurate in the internal

foundation layers. The foundations are shallow (20-30 cm) and immediately under the ground surface, except at the West (250 cm) and South-East sides, where the laying line seems to be deeper, due to the presence of filling soil moved throughout the time in order to realize respectively the cemetery level and a small country road. Along all the church perimeter, the soil, investigated until -3 m, is constituted by clay. The stress conditions, compatible with the structural dimensions, are 0.27 MPa on the East church wall, while the West side is unloaded; those results are certainly influenced by the different elevation levels. The masonry walls have medium-high deformation properties, little better in the East side with respect to the West side (30-40% variation).

Fig. 10. Sections and profiles of the foundations

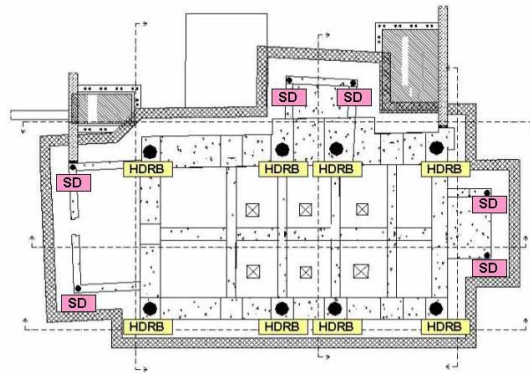
Fig. 13. Foundation string-course and disposition of HDRBs and SDs

The BI system adopted in the preliminary calculations (Fig. 13) is constituted by 8 identical High Damping Rubber Bearings (HDRB) and by 3 couples of Sliding Devices (SD) under sacristy, chapel and entrance portal. If about 1/5 of the structural mass is supported by SDs, the vertical load acting on each HDRB is 755.4 kN. Refining the design, different dimensions and stiffness will be selected for the HDRBs, depending on the position under the church, in order to minimize the distance between the structural center of mass and the BI center of stiffness (reduction of the torsional effects). Knowing the structure total mass M and assigning a first attempt value to the BIS isolation period ($T_{is}=1.5$ s), the total

equivalent horizontal stiffness of the isolation system ($K_e=1349.7$ kN/m) is obtained from the expression $T_{is}=2\pi (M/K_{esi})^{1/2}$. Thus, the horizontal stiffness of the single isolator is $K_{esi}=10797.4$ kN/m. Taking from the design spectra a displacement of 0.20 m, diameter and height (i.e. area) of the bearing can be get from the expression $K_e=G_{din} A/t_e$, where: G_{din} shear dynamic equivalent modulus, A surface of the single elastomeric layer after deducting eventual holes, t_e total rubber layers thickness. The equivalent viscous damping is given by the expression $\xi_e=W_d/(2 \pi F d)$, where: W_d energy dissipated in a single complete loading cycle and F maximum force reached by the isolation bearing in a single loading cycle. After fixing diameter and height of the bearings (respectively 0.4 m and 0.2 m), it is possible to determine the shape factors $S_1=A'/L$ and $S_2=D/t_e$ (where: A' common surface to the single elastomeric layer and to the single plate after deducting eventual holes, L free lateral surface of the single elastomeric layer increased by the lateral surface of the eventual holes, D dimension in plan of the single steel plate in parallel with the horizontal acting action and t_e total thickness of the elastomeric layers). The vertical pressure load acting on a single device is about of 6.0 MPa.

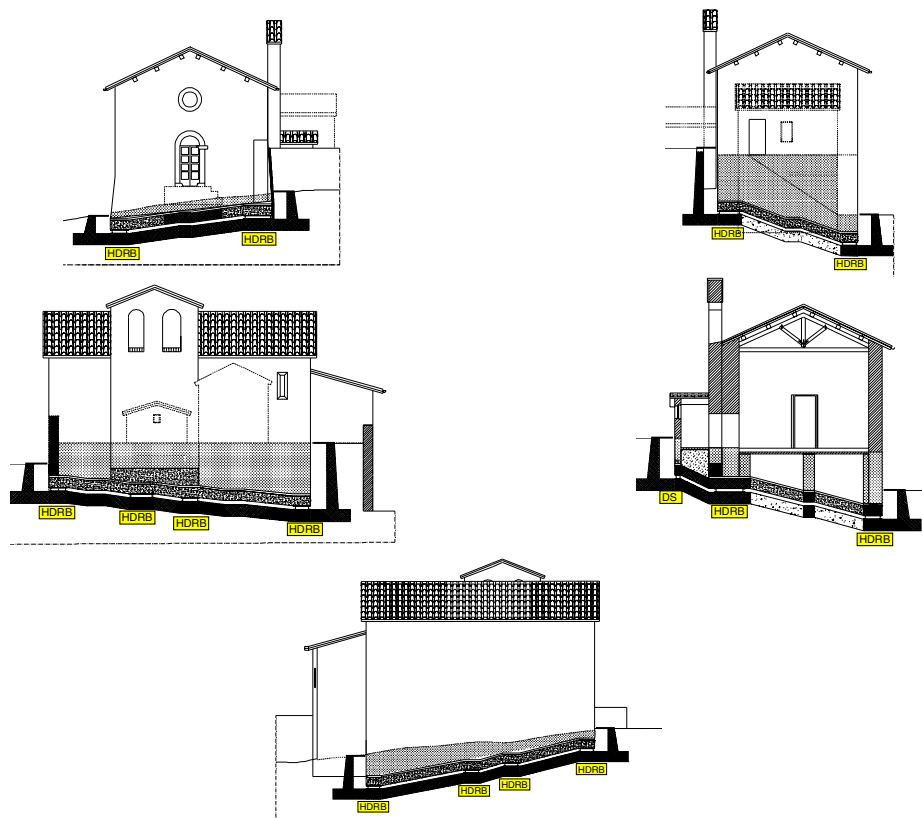
Fig. 14. Preliminary design of the subfoundation system

Complying with the conservation criteria, it has been decided to avoid vertical wall cuttings and insert the BI system providing a new r. c. foundation under the original masonry, taking into account the charnel-house presence under the pavement. The r. c. structure shall support the added bodies (sail bell-tower, sacristy and entrance stairs) and shall be rigid enough to take into account longitudinal and transversal slope, transferring SI actions to the ground. Sliding joints are obviously foreseen, in order to make completely free the building in the horizontal direction (respecting the design horizontal displacement) and avoid hammering effects. Fig. 14 shows the double foundation string-course, following the existing slope. The devices distribution in plan, as mentioned before, shall minimize torsional effects in case of earthquake. In a first phase, the construction of the superior string-course (connected to the church foundations) shall be provided; the inferior string-course (connected to the ground) shall be done in a second time. Between the string-courses, HDRB e DS devices have to be inserted with appropriate jacks. The inferior string-course execution steps are the following: reinforcement of the existing foundation walls, excavations through small sectors (about 50-80 cm of length) with adequate propping cribs, insertion of temporarily supporting joists, excavation for the realization of the string-course cast (sectors of about 150-200 cm of length) and laying of the r. c. reinforcing bars (Fig. 15). The masonry walls shall be connected to the subfoundation string-course by an appropriate anchorage (regular grid of inclined steel ties incorporated in the reinforced concrete). The temporarily supporting joist tips, left in the string-course, have to be cut at the end of the work. Due to the shallower foundation level of sail bell-tower with respect to the church nave, an additional integrating r. c. portion is foreseen. In order to permit inspection and maintenance of the BI system, a proper gap shall be realized, covered by a walking metallic grid anchored to the church walls (Fig. 16).

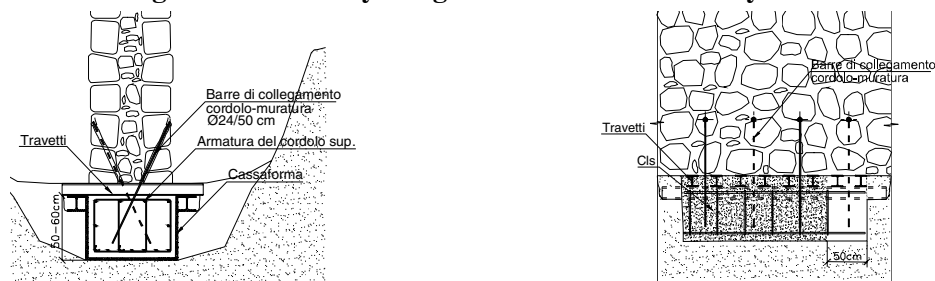
Fig. 15. Excavation for the string-course casting and laying of the r. c. reinforcing bars

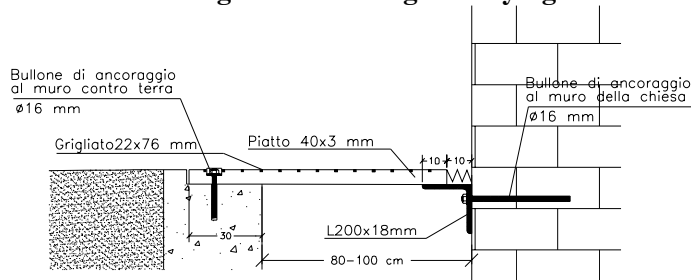
Fig. 16. Particular of the walking metallic grid for SI system inspection and maintenance
