## DAMAGE SURVEY OF THE WOODEN HOUSES DURING THE 1997 KAGOSHIMAKEN-HOKUSEIBU EARTHQUAKE

Takeshi YAMAMOTO<sup>1</sup>

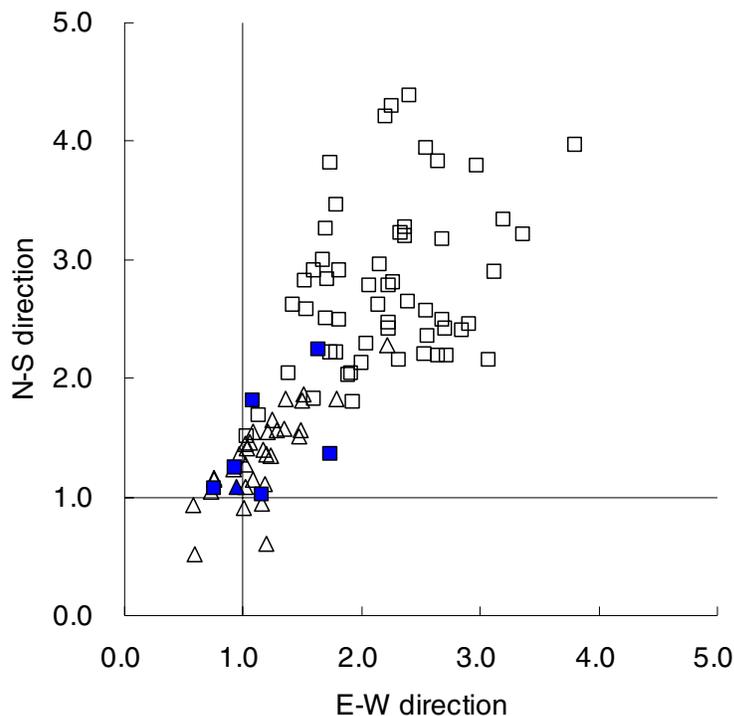
**Fig. 2 Wall Quantity Ratio**

The distribution of wall quantity ratio is shown in Figure 2. Here the term 'wall quantity ratio' is used to show the ratio of wall quantity to necessary wall quantity under the Building Standard Law in Japan.

It is simply because earthquake resisting elements inside the wall such as brace were not evaluated about partial collapsed houses that the wall quantity ratio of partial collapsed houses seem to be rather small compared to non-damaged or slightly damaged houses. It seem to be quite all right to consider wall quantity ratio of partial collapsed houses is not smaller than those of non-damaged or slightly damaged houses.

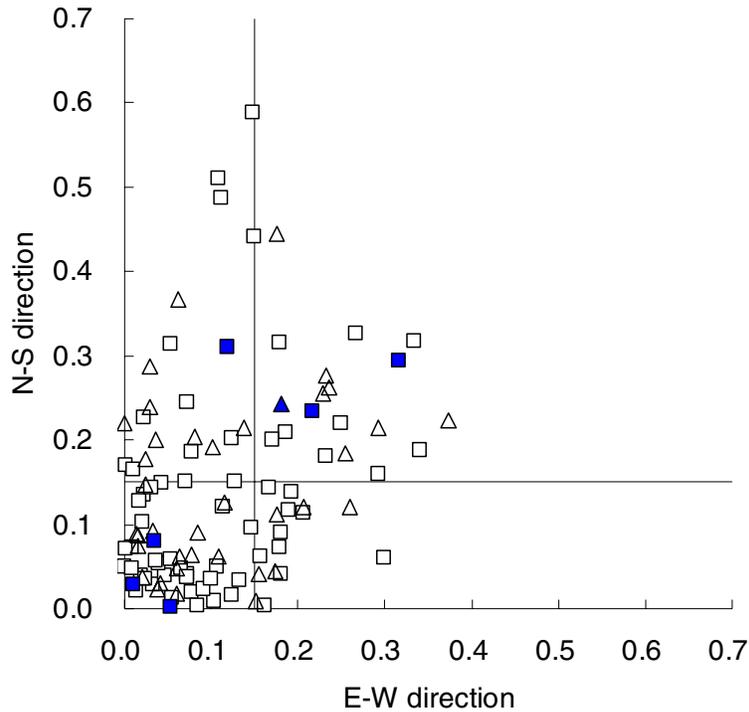
**Fig. 3 Modulus of Eccentricity**

Though modulus of eccentricity of four of seven partial collapsed houses is greater than 0.15 which is the lower limit value to enforce buildings to increase their wall quantity prescribed by The Building Standard Law, that of some non-damaged or slightly damaged houses exceed 0.15.

These results suggest the lack of wall quantity and the exceeding of modulus of eccentricity are not main factor of partial collapse damage.

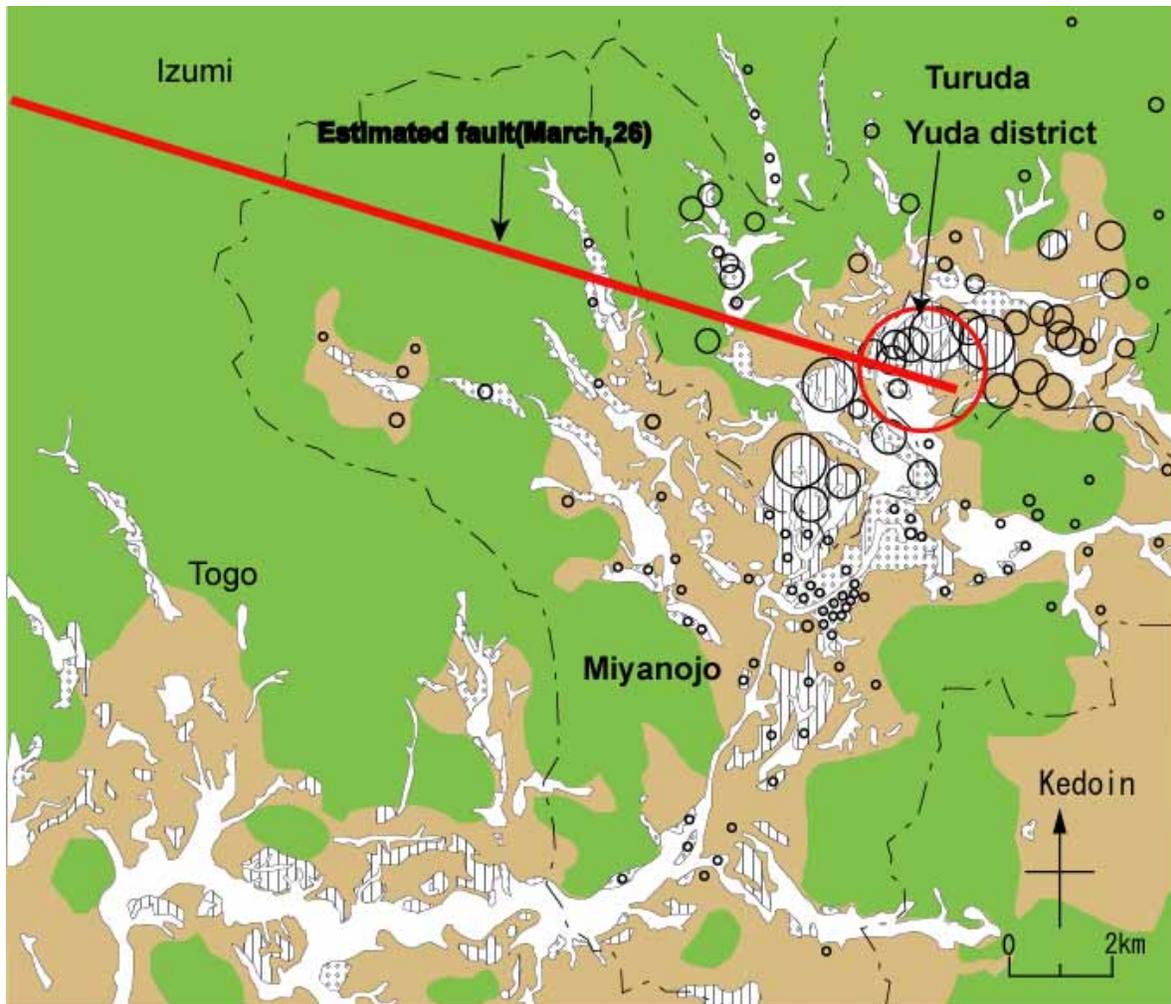
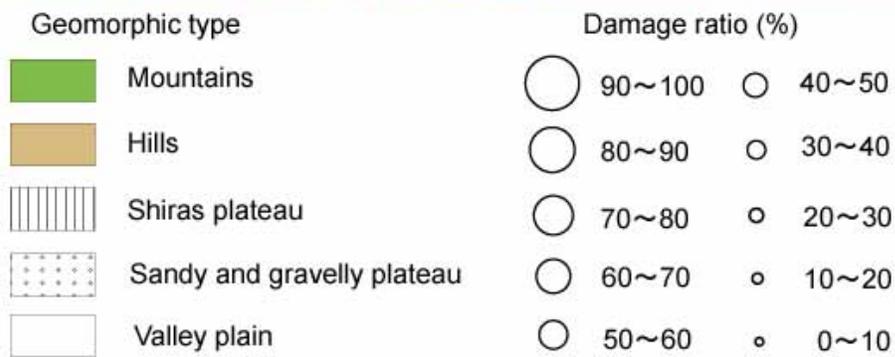
Fig. 4 Distribution of Wooden House Damage on March 26

Some areas where the damage ratios of wooden house are comparative high can be seen along the estimated faults, and the others where the damage ratios of wooden house are greater than or equal to 50% can be seen near the east side edge of estimated faults.

However, damage ratios of wooden houses are not similar everywhere in the areas. It indicates that the distribution and damage degree of wooden houses are concerned with the factors such as the relationship among the location of estimated fault, the location of a subsection of a village and the effect of topography on surface ground.

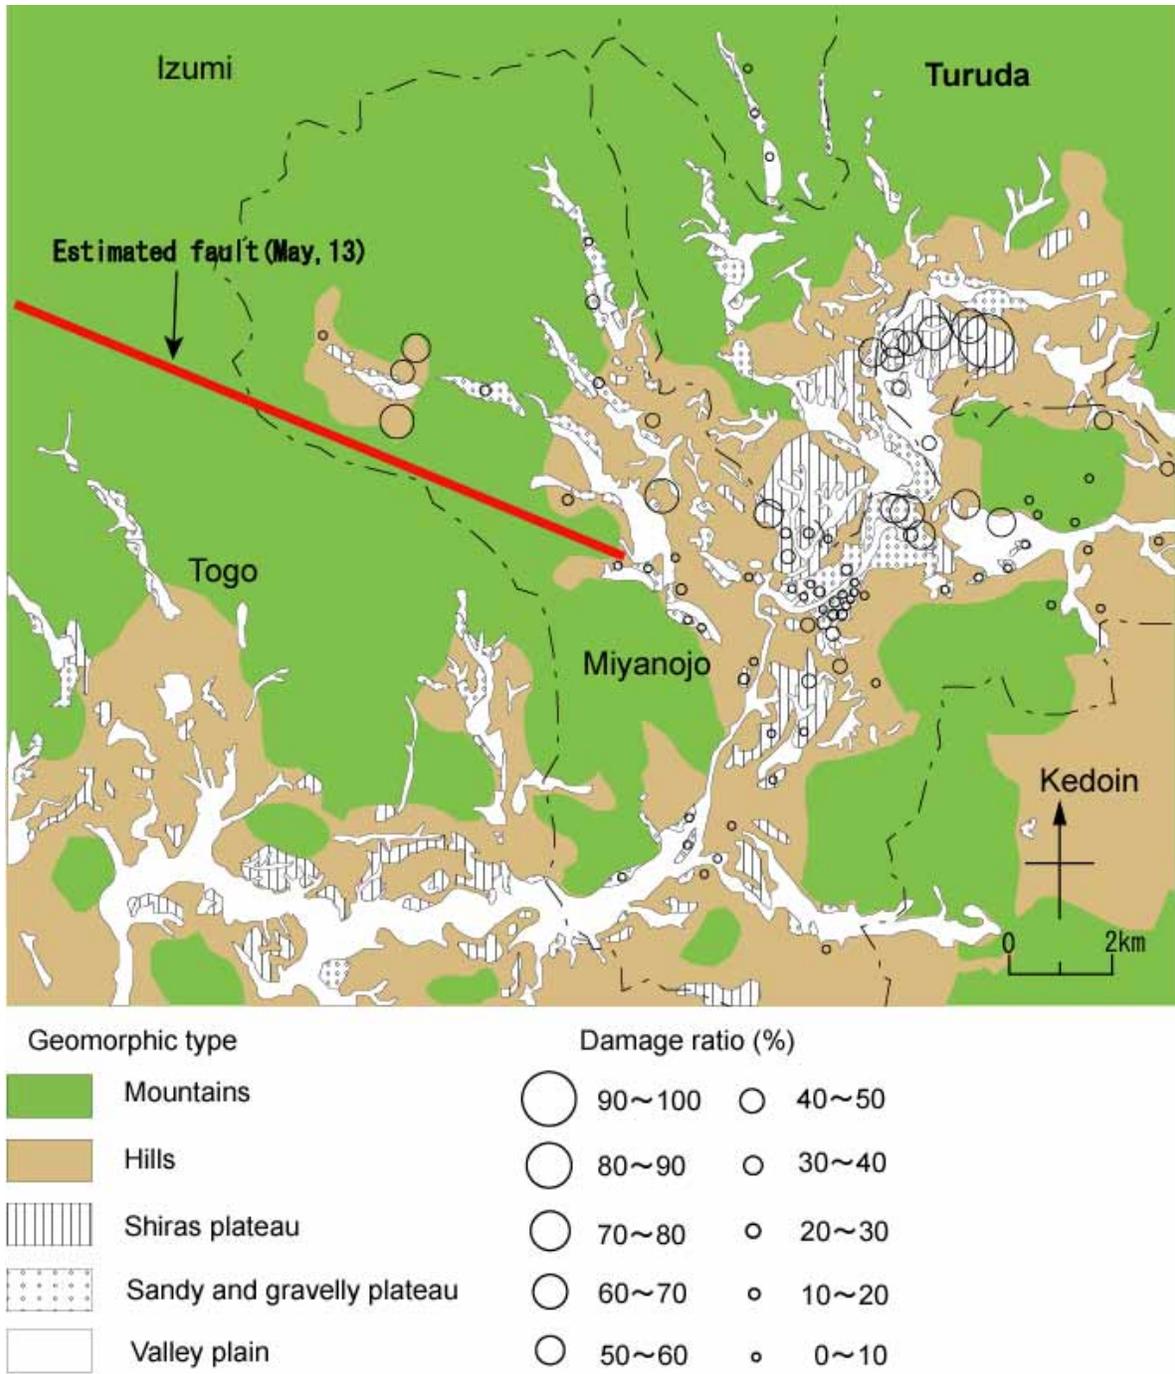
**Fig. 5 Distribution of Wooden House Damage on May 13**

Though the total number of damage houses in Turuda town is due to two earthquakes, most of them were caused by an earthquake on March 26(See Table 1). So the damage ratio of Turuda town on March 26 is excluded from the Figure 5.

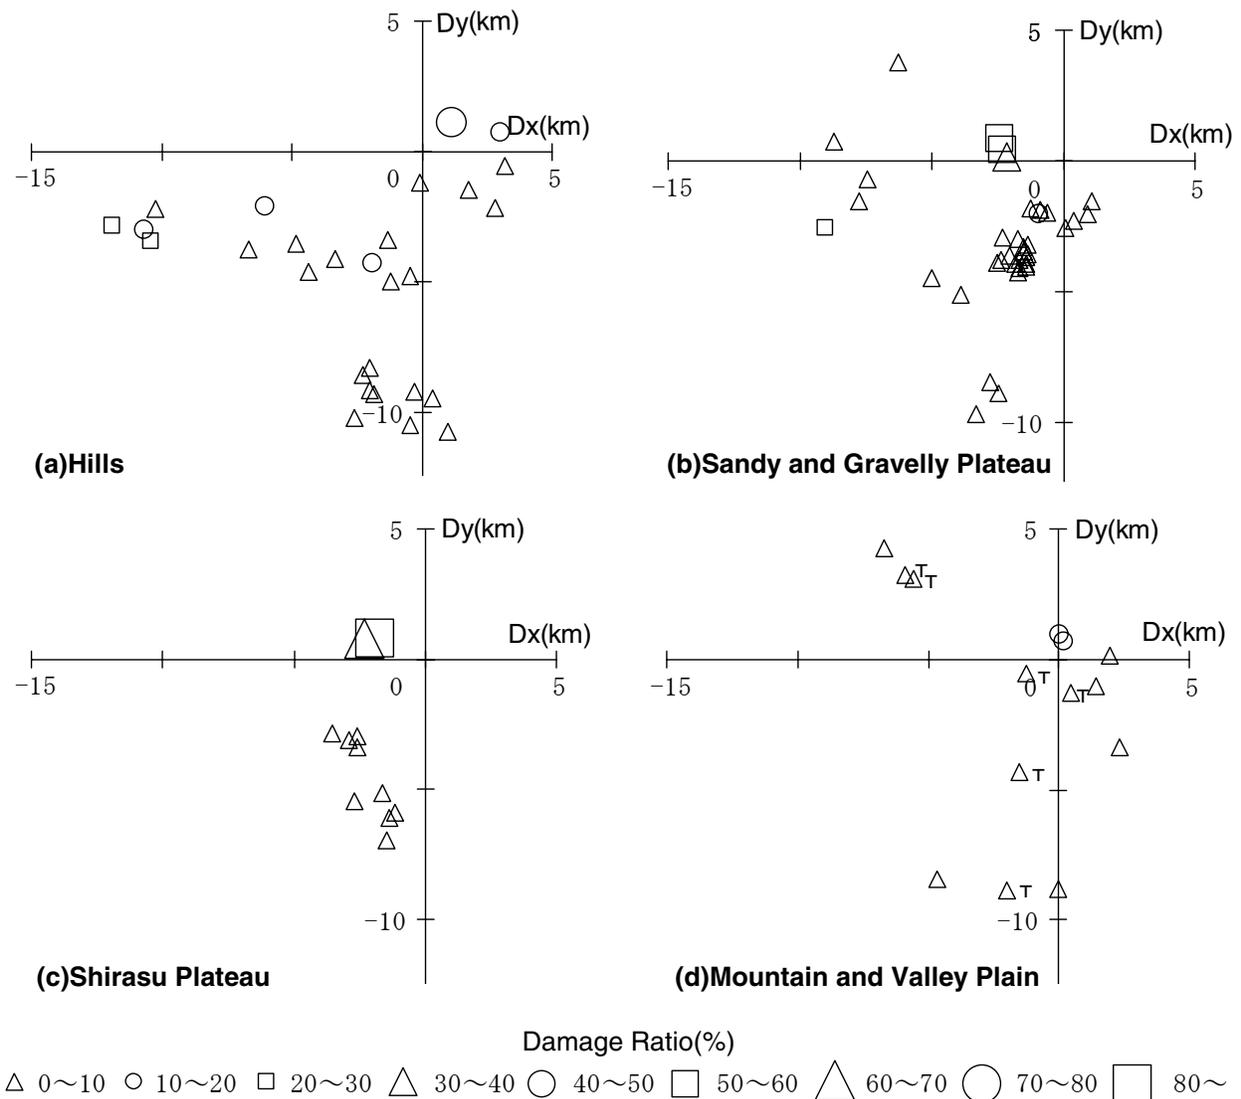
**Fig. 6 Damaged Ratio Classified by Geomorphic Types on March 26**  
 origin of coordinate: east side edge of estimated fault, Dx-axis: WNW-ESE direction,  
 Dy-axis: NNE-SSW direction, open triangle with T: Mountain

Subsections of a village on every geomorphic type where the damage ratio is greater than or equal to 30 % are located along Dx-axis on March 26 and are located within 6km from the estimated fault along Dx-axis on May 13. This indicates that the distribution of damaged wooden houses is influenced by the distance from an earthquake fault.

Subsections of a village where the damage ratio is greater than or equal to 50 % are located parallel to Dx-axis or Dy-axis near the east side edge of estimated faults. Though this indicates existence of asperities in a shallow part of the east side edge of each fault, however, no existence of asperities are recognized in the result of source modeling of these two earthquakes using Empirical Green's function method [6].

However, in Yuda district(See Figure 4), where  $D_x$  and  $D_y$  satisfy  $-3 < D_x < -2$  and  $0 < D_y < 1$  in Figure 6 and satisfy  $3 < D_x < 4$  and  $5 < D_y < 6$  in Figure 7, the difference among damage ratios classified by geomorphic type can be seen remarkably. The damage ratios are greater than or equal to 60% on *Shirasu* plateau, from 30 to 60 % on sandy and gravelly plateau and smaller than 10% on valley plain.
