## **EFFECTS OF LOCAL GEOLOGY ON DAMAGE SEVERITY DURING BHUJ, INDIA EARTHQUAKE**

**J. P. NARAYAN<sup>1</sup> and M. L. SHARMA <sup>1</sup>**

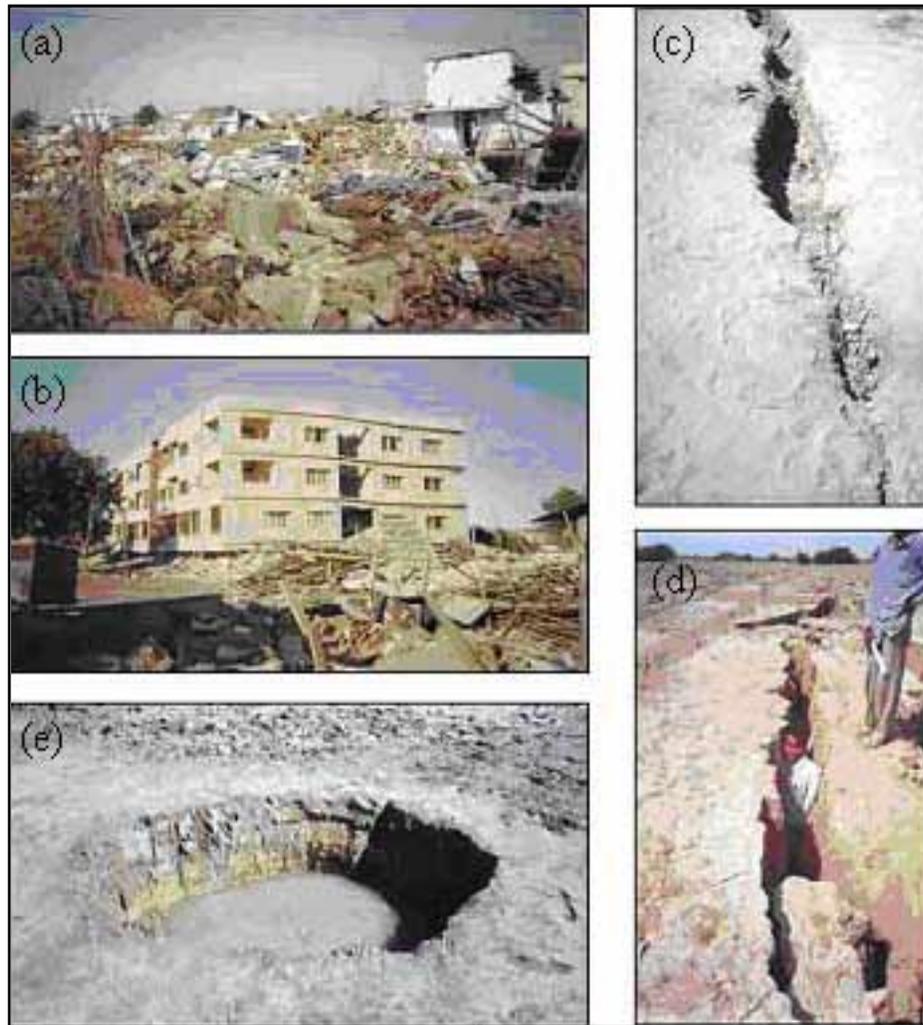
*Fig. 2a. Destroyed Ratnal village,  
 b. Collapsed of ground floor of a RC building in Bachau,  
 c. Ground fissure oriented in the east-west direction in Dhrang village (20 km N-W of Bhuj),  
 d. Ground fissure oriented in the N-S direction in Chobari village (12-15 Km North of Bachau,  
 e. Violent geyser developed an elliptical ground hole in Khengarpar near Ludai village.*

The spatial distribution of the intensity and isoseismal map for the Bhuj earthquake of January 26, 2001, based on the damage survey, is given in Figure 1. Analysis of isoseismal map reveals that some of the localities have higher intensity as compared with the surrounding. Ground fissures associated with geysers and liquefaction (i.e. Kandla Port) were observed mainly in the swampy and Rann areas and in the heavily alluviated low land region in the meizoseismal area. Ground fissures were surficial in nature and were secondary effects i.e. not directly associated with the earthquake rupture. Deep and wide ground fissures were observed at many places like ground fissures oriented in the east-west direction about 2-3 km east of the Dhrang village (Fig. 2) and in north-south direction in the Chobari and Manfara villages (Fig.2d). Two violent geysers causing elliptical holes (3.4x4.3m) were observed between Khengarpar and Shrawan Kawara near Ludai, and the height of intermittent water flow was of the order of 6 to 7 m (Fig 2e).

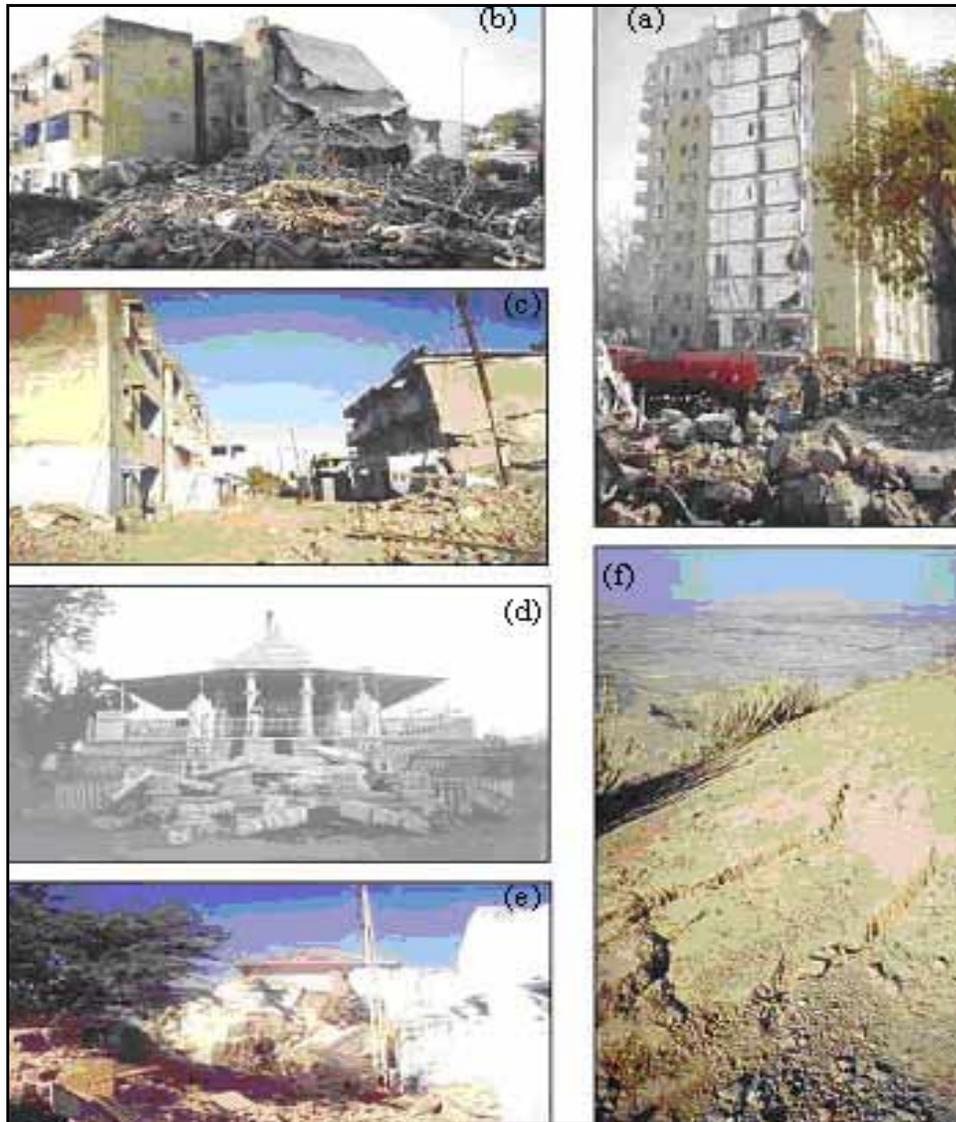
Fig. 3a. Total collapse of Block D of the Shikhar apartment building in Ahmedabad. The debris is being removed,  
 b. Collapsed B-type three storey building of Gujarat Housing Board in the Morbi city,  
 c. Severely damaged Gujarat Housing Board colony of Morbi city,  
 d. Damaged gate of newly constructed Jain temple in the Bhawar village,  
 e. Collapsed temple of Ludra village and  
 f. Parallel ground cracks oriented in the east- west direction on Ramdev Pir hill, 3 km away from the Hawai village.

Housing Board colony and its surrounding region in the Morbi city. Most of the three story brick buildings of this colony suffered severe damage (partial collapse) and a few collapsed completely (Fig. 3b,c). The effect of unconsolidated soils was also observed in the Ludra and Bhawar villages (Fig. 3d,e). Severity of damage in these villages was of the order of intensity VIII, whereas it was VI in the nearby town of Dyodhar (5 and 10 km from Ludra and Bhawar, respectively). The heavy damage in Ludra and Bhawar may be attributed to very loose soil (more than a meter) overlying a harder soil layer, where the foundation of the single story adobe houses are very shallow, mostly within the loose soil layer.

The effect of ridge topography on the amplification of ground motion was observed on approximately 100 m high Ramdev Pir hill near Hawaii and Ludai villages. The ridge effect was inferred on the basis of the contrast in the severity of damage on the hill (intensity IX<sup>+</sup>) and in the nearby Hawaii village (intensity VIII<sup>+</sup>). Hawaii village is not located on the hill. Many deep and wide parallel cracks on the top of the hill and along the slope predominantly in north-south direction were observed (Fig. 3f).

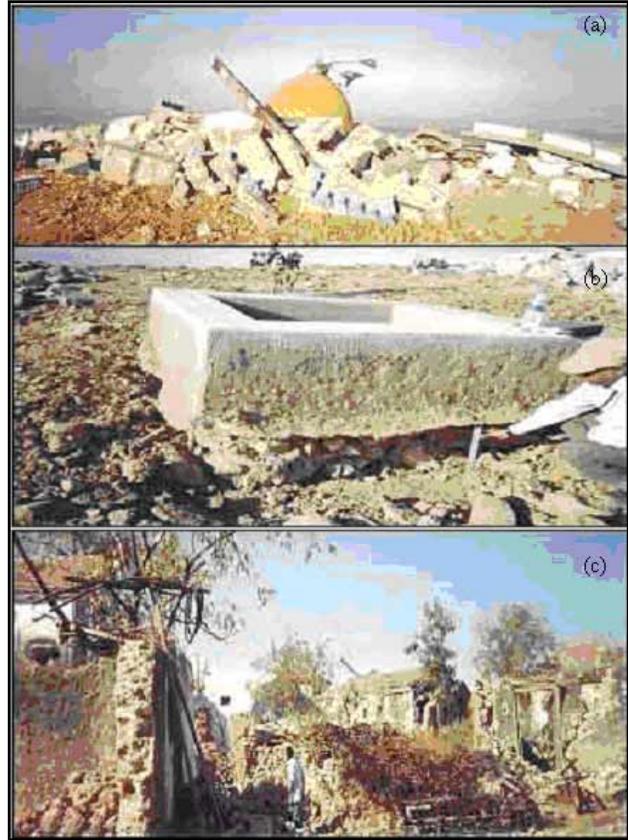
Fig. 4a. Collapsed temple situated on the top of Ram Dev Pir hill,  
 b. Uprooting of water tank situated on the Ram Dev Pir hill and  
 c. Damaged Kutri village situated on an elevated ground

The collapsed temple on the hill (Fig. 4a), shifting and uprooting of a water tank (Fig. 4b), and displacement and breaking of large boulders on the hill indicate amplification of the ground motion there. The walls of the temple located at the top of hill were thrown outward, and the dome of the temple fell down vertically at the same place. Strong damage to the hill mass itself in the form of long and deep ground cracks and uprooting of water tank and shifting and breaking of large rock boulders and collapse of the temple on the hill may be attributed to the ground motion amplification by the hill (Pedersen [6]; Narayan [7]). Further, amplification of the ground motion depends on the slope and the elevation of the ridge (Sánchez-Sesma [8]; Geli [4]). Ridge type effects were also observed at the Kutri village (Fig. 4c) and at Sajan Garh fort constructed on a hill near the Udaipur city.

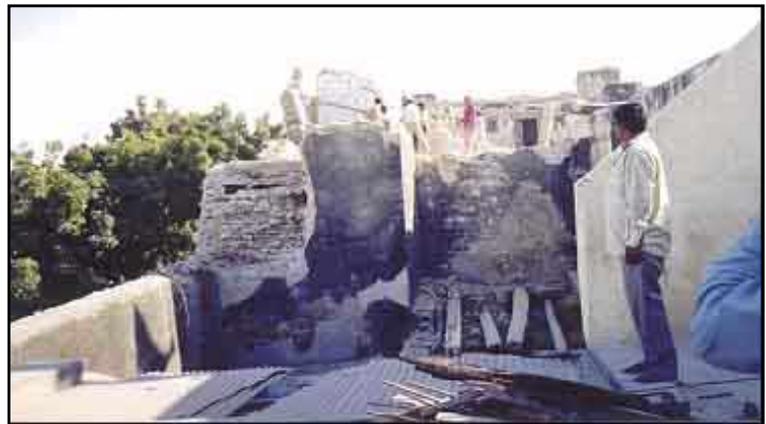
The residences of the four queens of Lord Krishna situated on the first and second floor of the Beyt Dwarka temple (500 years old) were partially collapsed. However, the ground floor constructed on a wooden frame suffered no damage, and the 5,000-year-old idol of Krishna was safe. Figure 7 shows the damage to Beyt Dwarka temple. The very old and traditional Jetty of Beyt Dwarka suffered damage in the form of falling of the parapet, cracks and subsidence (5-8cm) at one place. On the other hand, Okha suffered almost no damage and only fine/minor cracks were observed in some of the weak houses.

*Fig. 7 Severely damage Beyt Dwarka temple.*

The reasons behind the longer duration of shaking, and severe damage to buildings on Beyt Dwarka island may be due to ground motion amplification, surface wave generation and their trapping by the weathered surfacial layer of the island.
