SEISMIC VULNERABILITY OF INFORMAL CONSTRUCCION DWELLINGS IN LIMA, PERU: PRELIMINARY DIAGNOSIS

ABSTRACT

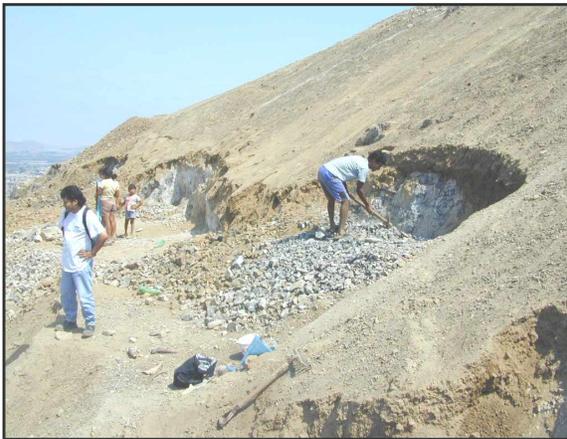
Many dwellings are located in sloped terrains. In these cases builders need to cut and fill the ground to obtain a flat, horizontal surface (Figure 1). In many occasions this has resulted in failure of the foundation of the dwelling located right above the house being built.

a) Cutting the slope

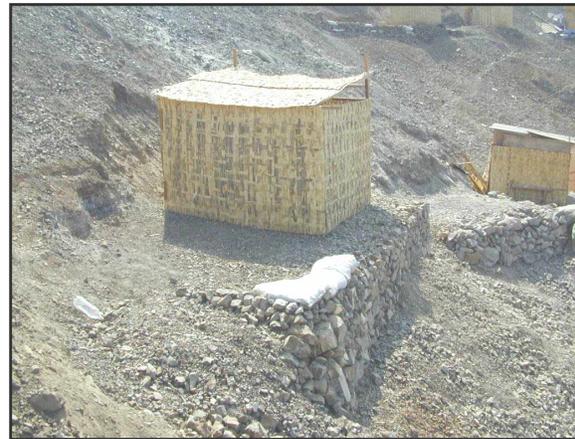
b) Temporary straw dwelling on a fill

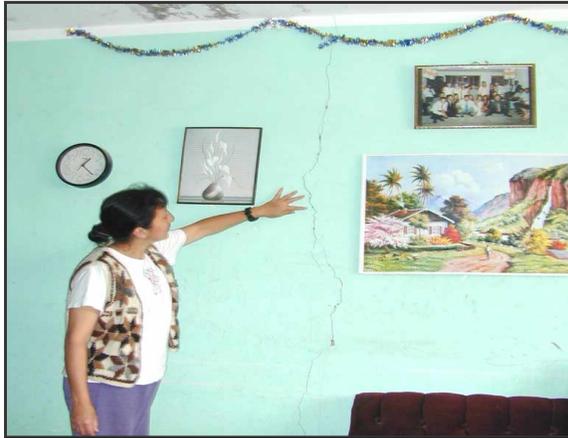
The majority of the houses in Villa El Salvador are located in loose sandy soils. Most of the dwellings have inadequate foundations and present extensive wall cracking due to ground settlement. The few dwellings with reinforced foundations do not present this problem. In Carabayllo, many dwellings are located over soft fills, and they also show many cracked walls (Figure 2). Also, since there are no water or drainage systems, water and sewage are dropped to the ground, and they filter down the slope, damaging the walls of the houses existing below (Figure 3). Many houses built in ravines are exposed to inundations during rainy seasons, and to falling rocks and debris caused by earthquakes.

Figure 2. Cracked wall

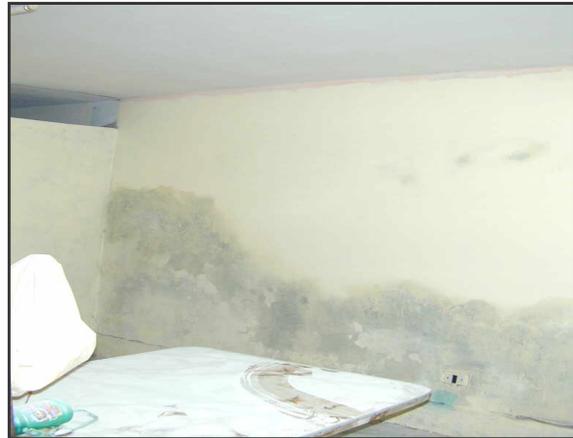
Figure 3. Humidity in wall

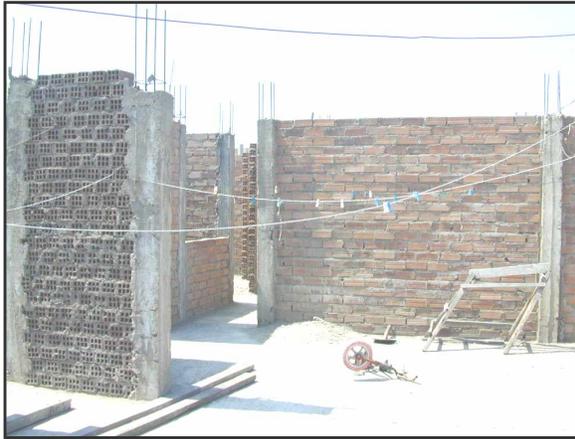
There is a widespread misconception that the “structure” is composed only by the reinforced concrete beams and columns. Accordingly, these elements are generally overreinforced, even though reinforcement is very expensive, and the beams and columns mainly work as confinement to the masonry walls. In many cases load bearing walls are built with hollow clay bricks (they are cheaper than solid bricks) since they are not considered to be “structural” by the builders (Figure 4).

Figure 4. Masonry walls

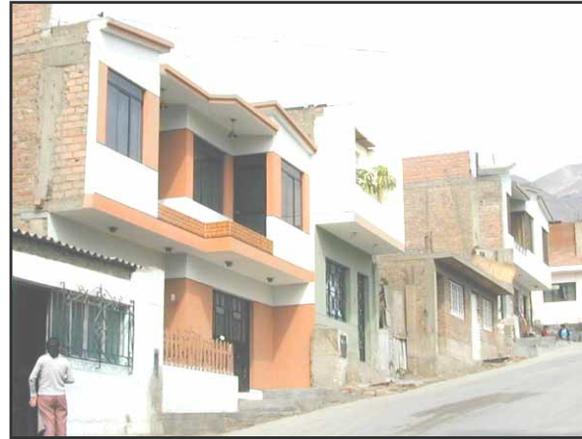
In order to take the most advantage of the available land, houses are generally built side by side, with no separation between them. In hilly areas, therefore, floor slabs of adjacent dwellings are at different levels. During a strong earthquake floor slabs could cause severe damage by punching the walls of adjacent houses (Figure 5).

Figure 5. Floor slabs at different levels

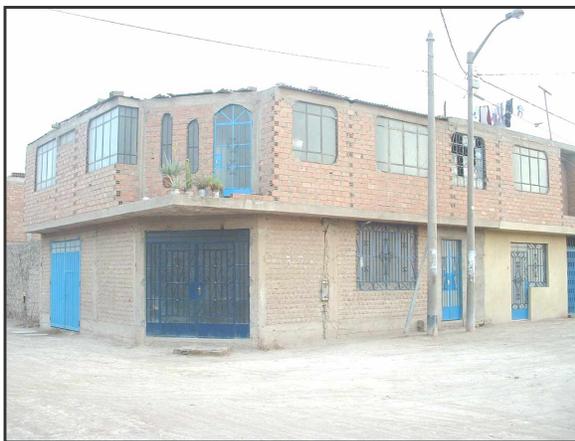
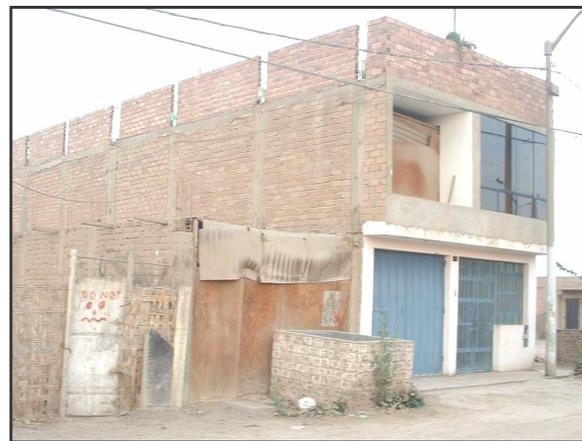
Many walls located on the upper floors of the house are usually built without any confining elements. This is especially prevalent in façade walls and roof parapets (Figure 6).

Figure 6. Unconfined masonry walls

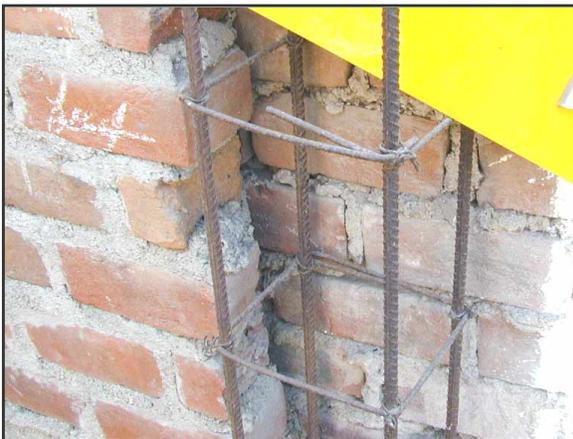
There is an understanding of the importance of reinforcement in the strength of the structure. Therefore, most elements are overreinforced, even though steel reinforcement is very expensive. Stirrups, however, are believed to be useful only to maintain the main reinforcement in place, and in most cases they have open hooks, or are made with small diameter rebar. In areas with access to welding factories, it is common to find welded steel bars, instead of overlapping rebar connections. Since safety is always a concern, many owners weld metal doors and windows to the reinforcement of columns or beams. A common problem observed is corrosion of the steel reinforcement. This happens because of poor quality of concrete with small covers or filtration of rain water.

a) Open stirrups

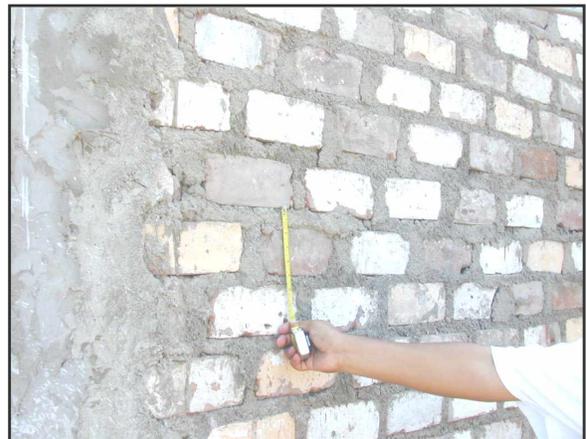
The bricks used to build the masonry walls are usually hand made by local artisans, because these bricks are significantly cheaper less than industrial bricks. Clearly the quality of non-industrial bricks leaves much to be desired: they are irregular in shape and much weaker than the industrial bricks. Furthermore, the quality of the masonry is generally quite poor, since mortar joints are very thick and vertical joints are in many cases left empty. The photos in Figure 7, below, show many of the construction problems prevalent in most houses surveyed.

b) Thick mortar joints

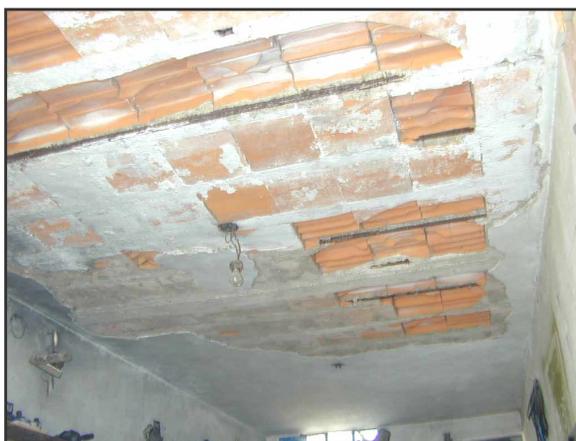
c) Exposed and corroded reinforcement

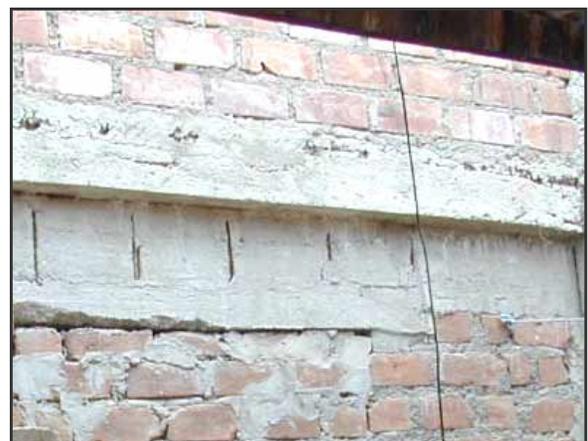
House owners and builders believe that the reinforced concrete beams and columns are the most important structural elements. Accordingly, they pay a lot of attention to their construction. The results, however, are usually very poor. Concrete is prepared with high water/cement ratio, large aggregate size, and inadequate mixing and vibration. Aggregates are usually bought from informal quarries, where there is absolutely no quality control in the cleanliness or the size of the material. Furthermore, curing is not considered to be important: beams and columns are almost never cured, and slabs are sometimes cured by pouring some water on the surface the day after they are built. As a result of these poor construction practices concrete is weak, porous, and full of honeycombs.

d) Honeycombs, exposed reinforcement, etc.

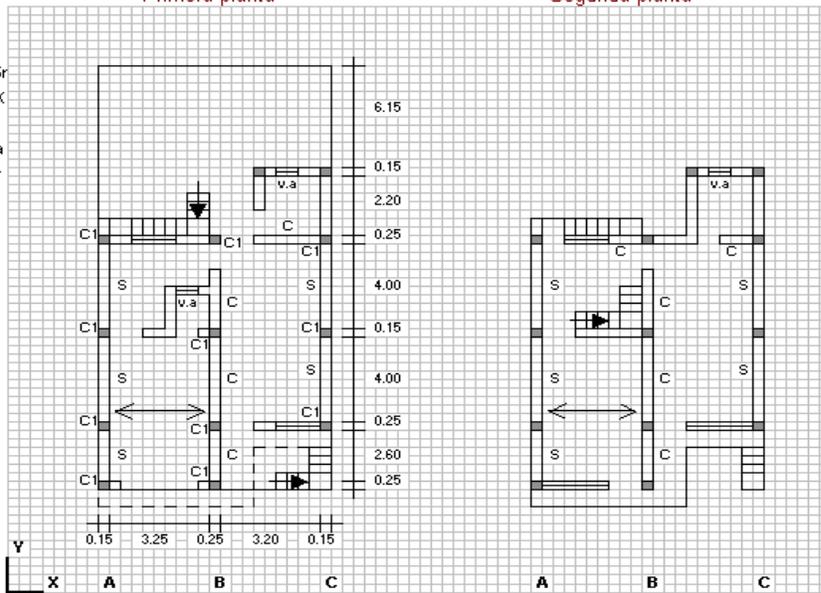
Planta:

Estado de la vivienda: Se relleno para nivelar el terreno en la parte posterior del lote. La vivienda tiene dos pisos con techo de losa aligerada, algunos muros del primer y segundo piso tienen grietas verticales, algunas se proyectan al techo. Existen muros de aparejo de soga y cabeza, con ladrillos de arcilla. La mano de obra es de regular calidad. En la azotea, en la parte delantera, entre los ejes B y C existe un parapeto sin confinamiento.

Sismo frecuente: La densidad de muros es deficiente en el sentido "X", los parapetos de la azotea que dan hac la calle no tienen confinamiento, la mano de obra es de regular calidad y los materiales son de baja calidad (ladrillos artesanales), la estructura se encuentra en una regular ubicación; zona con pendiente media y suelo de arenas sueltas. Algunos muros del segundo piso presentan grietas que pueden degradar su resistencia sísmica. La vivienda presenta un mal nivel de desempeño en el análisis por sismo frecuente.

Sismo raro: La vivienda presenta una densidad de muros deficiente y un riesgo sísmico alto.
