**AN ANALYSIS OF FIRE SPRINKLER SYSTEM FAILURES DURING THE
NORTHRIDGE EARTHQUAKE AND COMPARISON WITH THE SEISMIC DESIGN
STANDARD FOR THESE SYSTEMS**

Philip D. LeGrone, P.E., CSP, CFPS¹

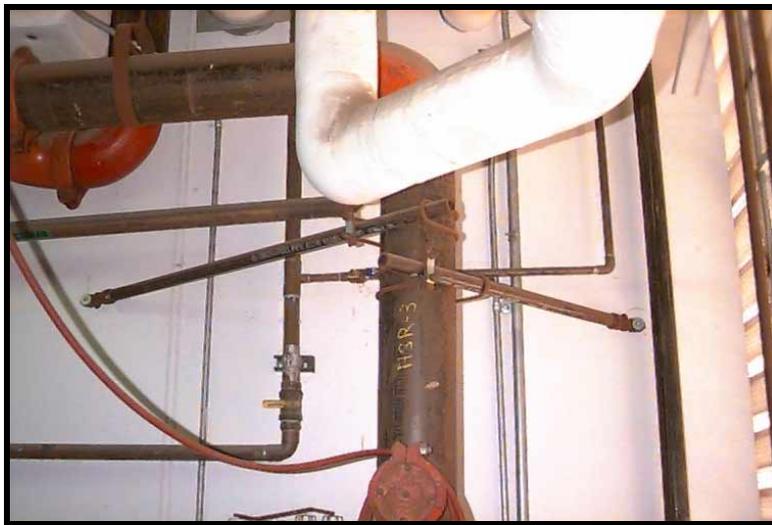
Longitudinal bracing refers to the bracing of piping from moving in a direction parallel to the pipe itself. This type of bracing has been required in NFPA 13 for sprinkler mains since the 1951 edition of the standard, which required a longitudinal brace for each feed and cross main. Unfortunately, this requirement could be met in many cases by installing a four way brace at the top of the system riser as shown in Figure 4 [7].

Figure 4
Four-way brace at a sprinkler system riser

In the 1987 edition of NFPA 13 the requirement was supplemented to require longitudinal braces spaced at a maximum of 80 feet for mains thereby removing the single brace on the system possibility in all but the very smallest systems. The average facility age in the database is 1972 so it is evident that the 1987 version of the standard is not represented in the data. In fact less than 8% of the buildings in the database were constructed after 1987. It is clear that the technical committee took action on an issue that the data developed in this report from the Northridge event further emphasizes is a serious issue in seismic events.

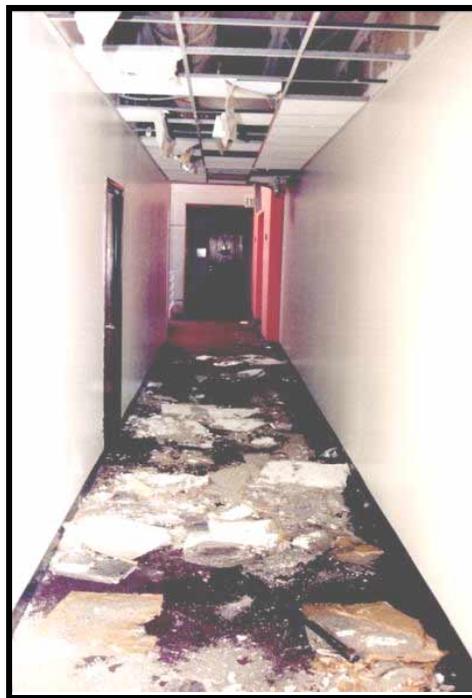
The common mode of failure in this case involves the breaking of threads at the top of sprinkler drops to sprinklers penetrating a substantial ceiling (fire rated or decorative metal ceilings being prime examples). There were also many cases where sprinkler heads were pulled up through the ceiling and then slammed back down. In these cases the sprinkler heads often impacted ceiling materials when they came back down resulting in sprinkler head damage and failures at fittings [7]. As previously indicated, this issue is especially troublesome for fire rated and decorative metal ceiling systems since they offer more resistance to the movement of the sprinkler piping, but has also been noted in standard T-bar drop down ceiling systems to a lesser extent as shown below in Figure 5.

Figure 5
Drop-down ceiling contact resulting in fire sprinkler system damage
Northridge earthquake 1994

At present there is no requirement in NFPA 13 that ceiling and sprinkler systems be braced as a unit, which would minimize the extent of differential movement. However, following the Northridge event there was considerable debate with regard to this issue as to how the standard needed to address differential movement [1]. The bracing the systems as a unit concept was one of the proposals placed on the table for consideration. The biggest proponents were commercial insurers that paid substantial EQSL losses. Loss estimates for this coverage for the Northridge event are in the hundreds of millions. Opponents of the bracing as a unit approach are concerned with both the cost and complexity of designing this type of system.
