HISTORY OF AN EARTHQUAKE

P. CLEMENTE¹, M. INDIRLI², B. SPADONI², G.B. ARATO², A. MARTELLI²

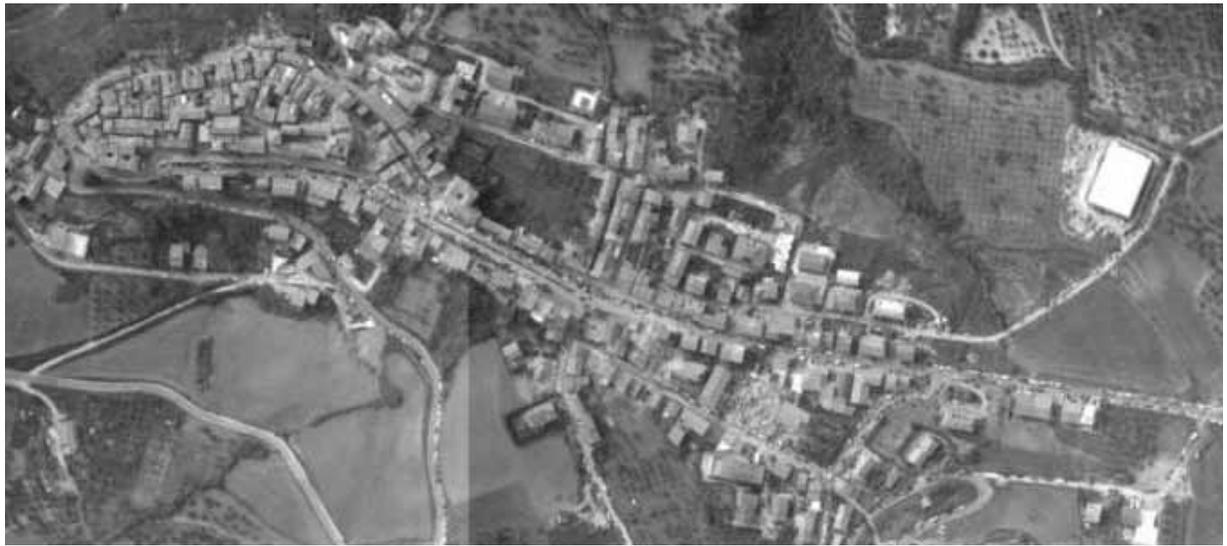
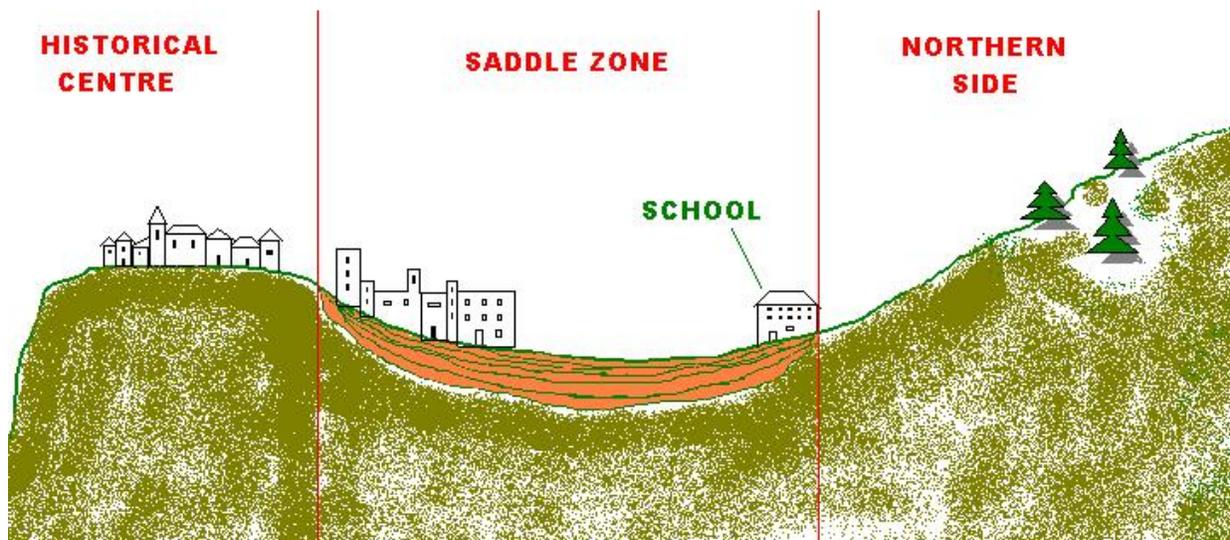
Fig. 6. Microzoning: plan view and N-S section

Just after the earthquake, the Italian Civil Protection Department appointed a technical commission to perform the seismic microzoning in San Giuliano [7]. The results can be summarised as follows (Fig. 6):

- a) the historical centre is classified as A1.2, i.e., soil A and amplification factor $S=1.2$; the saddle area is classified as B1.6 (soil B, $S=1.6$); the Northern side is B1.4 (soil B, $S=1.4$); small areas with lower hazard, at North and West of the historical centre, have been classified as A1.0 (soil A,

- $S=1.0$);
- b) the urban area was also divided into zones, characterised by three different degrees of slope instability hazard: LR – low risk, with instable soil thickness $t < 1\text{ m}$; MR – medium risk, $1 < t < 3\text{ m}$; HR – high risk, $t > 3\text{ m}$);
 - c) some stream phenomena have been pointed out, in the East side of the town, not related to the seismic event.

As you can see, the seismic microzoning reflects what already said about the presence of different areas (historical centre, saddle zone and North side) characterised by different topography and built in different ages. It is worth observing that the maximum spectral amplitude expected at San Giuliano in zone B1.6 is lower than the amplitude suggested by the Italian Code for zone 2. This occurrence is mainly due to the fact that the amplitude at the bedrock is very close to the minimum value for zone 2.

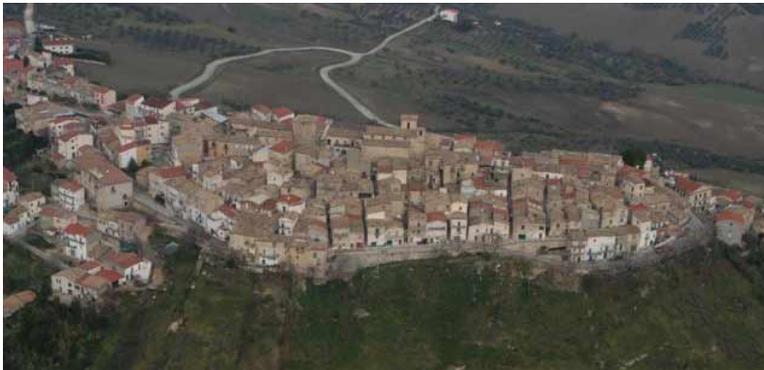
Fig. 7. The historical centre composed by complex systems of buildings

The medieval historical centre of San Giuliano (Fig. 7) is characterised by masonry constructions, made with stones irregularly placed with very poor mortar. Almost all the constructions in the historical centre were made of masonry, most of them (75%) with stones irregularly placed with very poor mortar. Only in a few cases good masonry have been observed. Almost always the typical “muratura a sacco” was used,

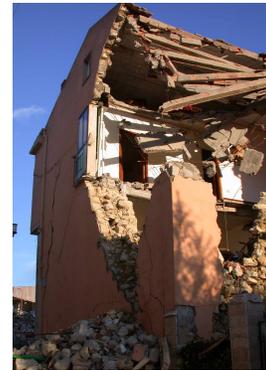
Fig. 8. The typical “a sacco” masonry with heavy fill

with very low effective thickness and very heavy fill (Fig. 8); the two sheets were often not linked between them. The most usual collapse mechanisms were the inflexion of them and the typical cross cracks (Figs. 9 and 10). Often recent restoration works, made without improving the strength of masonry, hid the actual conditions of the walls, which looked to be in very good conditions (Fig. 11). Most of the horizontal structures were steel or timber floors (75%), while only 10% are vaults and 10% concrete floors. Sometimes the pull out of the beams from the walls was observed. The vaults supported the seismic action very well where suitable supports were at the springings. In other cases the vaults collapsed, especially where not suitable interventions had modified geometry and loads (Fig. 12).

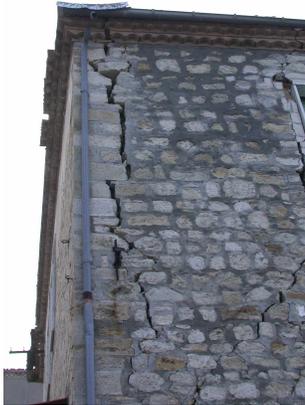
Fig. 9. Not effective connection

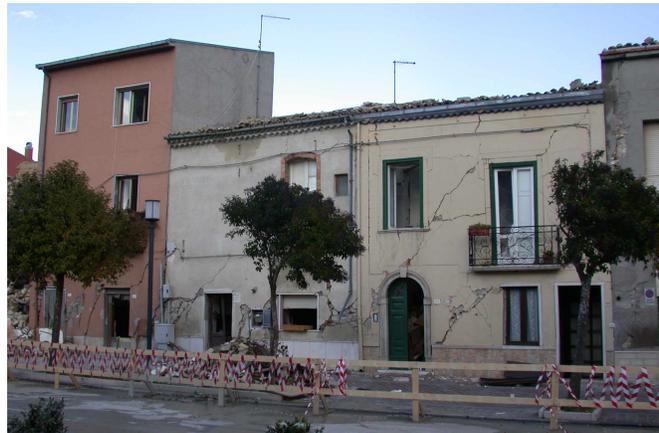
Fig. 10. Typical cross cracks

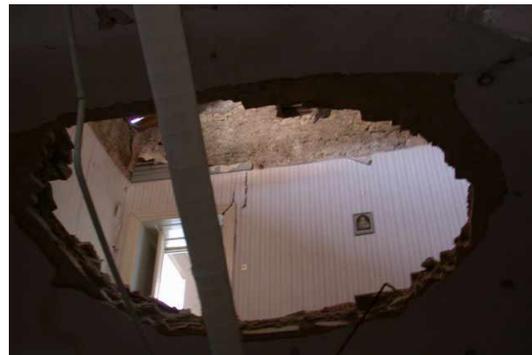
Fig. 12. A restored vault collapsed

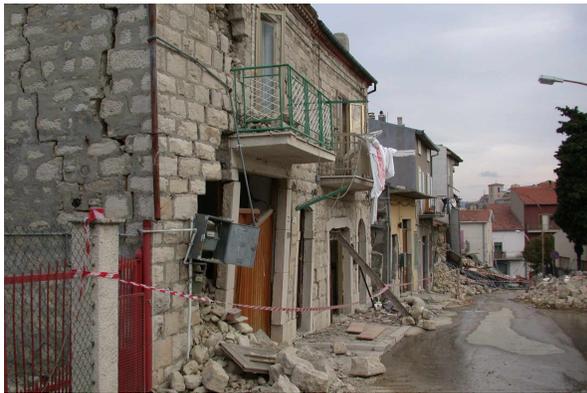
Fig. 15. Poor masonry, bad connections, lots of openings: all the defects are in this building

The most impressive feature was that lots of buildings were made of perforated bricks, certainly not suitable to absorb vertical nor seismic actions (Figs. 15 and 16). The most usual collapse mechanism of walls was due to shear actions. In fact, the typical cross cracks in the walls could be observed, due to the

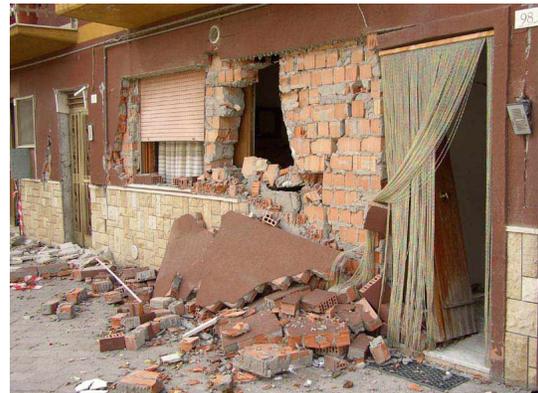
Fig. 16. Too many openings in the walls made of perforated bricks

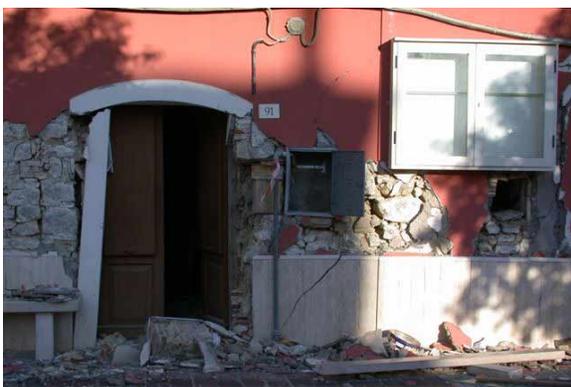
Fig. 17. The niches for the facilities were a characteristic in San Giuliano

very low strength of the walls, which is to be related both to their very thin thickness and the presence of too many openings in the external and internal walls. Another characteristic was the presence of niches for the facilities, which played an important role in reducing the wall strength (Fig. 17). Recent restoration interventions often made worse the vulnerability, because they introduced heavy concrete elements not well connected to the masonry (Fig. 18). As pointed out by the seismic microzoning, soil in this area is sometimes unstable. In fact, damages due to soil yielding were detected. Also concrete buildings showed serious damages in this zone (Figs. 19 and 20).

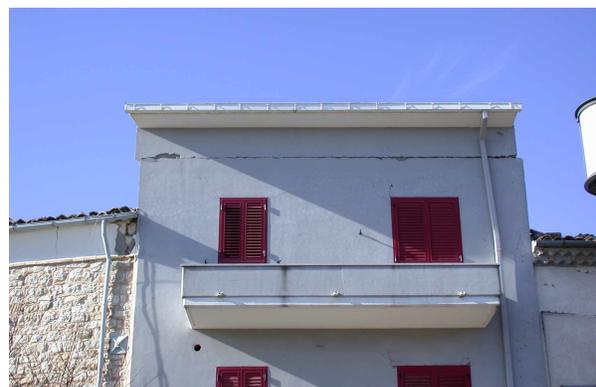
Fig. 18. The concrete roof shifted with reference to the building

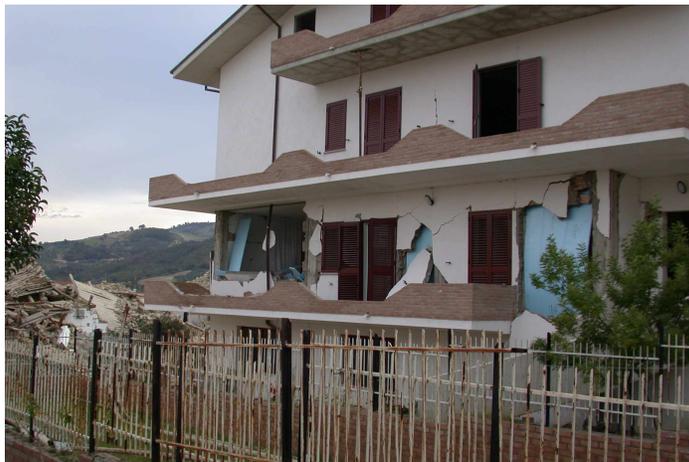
Fig. 19. A concrete building in the saddle zone

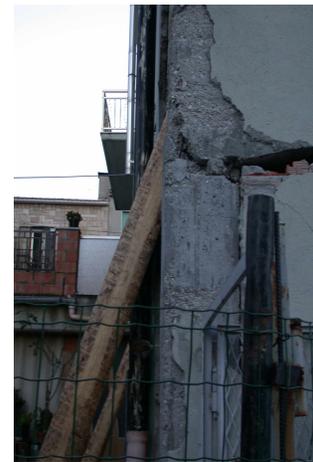
Fig. 20. Joint badly executed

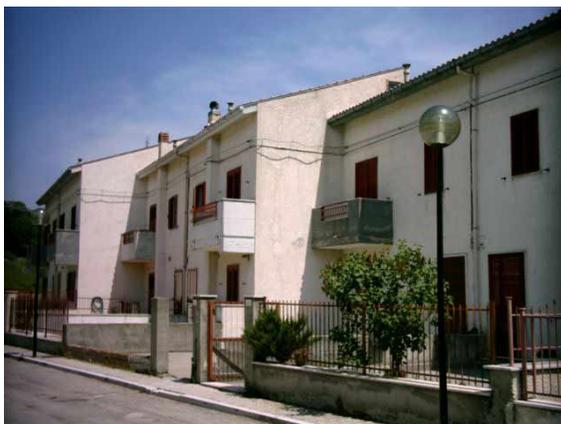
The Northern area represents the future of the town. Modern concrete buildings containing more than one apartment have been built. Damages were very low. It is worth noting that buildings almost undamaged have defects and require an anti-seismic improvement. The most important case is that of Figure 21, in which the different blocks are simply placed close together without seismic joints: the resulting structure is extremely long and the well-known phenomenon of hammering could happen. Also some masonry constructions present the same problem (Fig. 22). In the first case the buildings should be separated, in the second one the two buildings could be connected to make them an organic unity.

Fig. 21. Concrete buildings without seismic joints

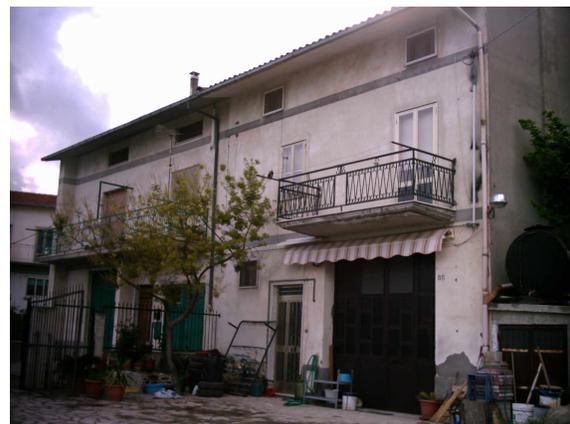
Fig. 22. Two masonry buildings just placed close together
