THE SEISMIC PERFORMANCE OF BAHAREQUE DWELLINGS IN EL SALVADOR

Manuel LÓPEZ¹, Julian BOMMER² and Patricia MÉNDEZ³

SUMMARY

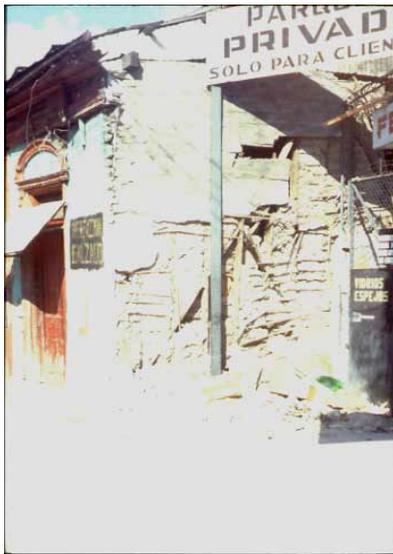
Another earthquake severely damaged San Salvador on 10 October 1986. This M_w 5.7 event left more than 1500 dead and 10,000 injured (Durkin [17]). As in previous earthquakes affecting the capital city, this one had a very superficial focal depth (approx. 8 km) and was located just below the metropolis. It is reported that the new *bahareque* construction held up well, on the average, under the ground shaking (Anderson [18]). However, failure of this building system was extensive in the southern sector of San Salvador. Again, it is stated that the failure of this system was often due to failure of structural timber caused by rot or damage by insects. Figure 8a shows a typical *bahareque* failure where the bamboo was in very bad shape. Once this reinforcement fails the mud-filled wooden lattice breaks down. It is interesting to note that as in the aftermath of some other past events, dwellings are rebuilt by using the same building practice (Figure 8b).

Figure 8. (a) Bahareque house damage in the 1986 San Salvador earthquake, (b) Bahareque house rebuilt following the 1986 earthquake in San Salvador.

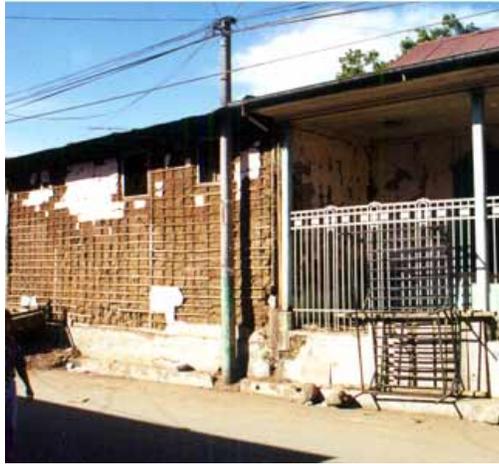
Figure 9. (a) Superficial damage to *bahareque* in Santiago de Maria caused by the 13 January 2001 earthquake, (b) Collapse of *bahareque* dwelling in San Agustín due to the 13 January 2001 earthquake.

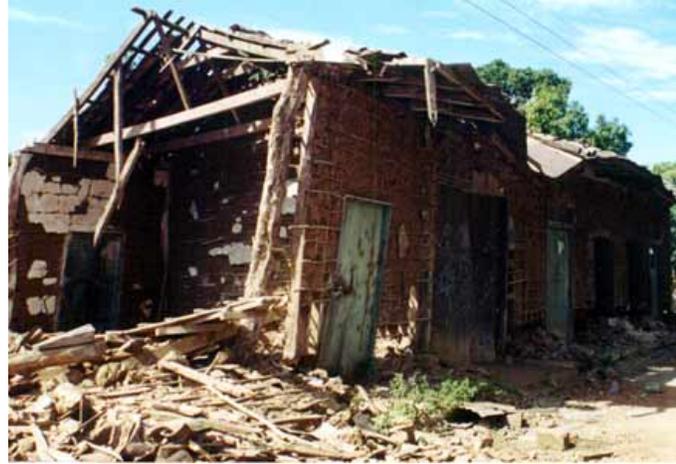
(b)

The first two seismic events affecting El Salvador in the new millennium were on 13 January and 13 February 2001. The first one was a subduction earthquake with a magnitude M_w 7.7. The death toll was reported as 844 (Bommer *et al.* [7]). The second earthquake was an upper-crustal event, and took place along the volcanic chain, with a magnitude M_w 6.6; the number of casualties was 315. In both events the overwhelming majority of the damaged houses were *adobe* and *bahareque*, with the former being the most susceptible type of housing. The damage to *bahareque* ranged from plaster falling (Figure 9a), to complete collapse (Figure 9b). Again, it has to be pointed out that the condition of the structural wood in *bahareque* and the weight of the roof were important factors in the seismic behavior of *bahareque* dwellings [19].

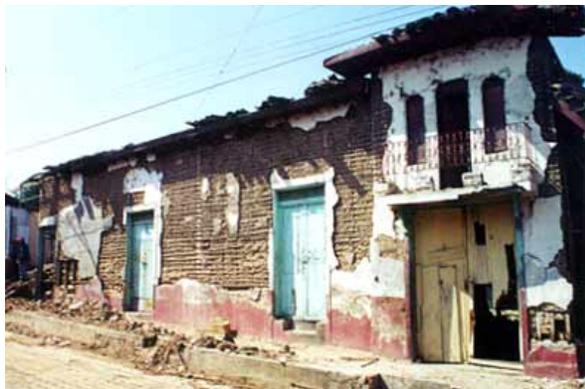
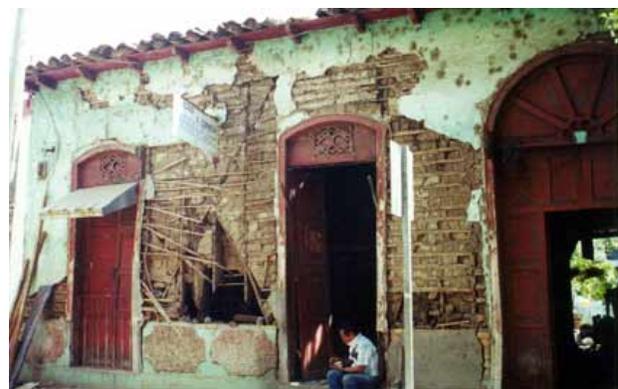
Figure 10. Damage to *bahareque* in San Vicente caused by the 13 February 2001 earthquake
