THE BIGNOL, EASTERN TURKEY, EARTHQUAKE. CO-SEISMIC PHENOMENA AND DAMAGE DISTRIBUTION

Stylios LOZIOS¹, Eythimios LEKKAS² and George DANAMOS³

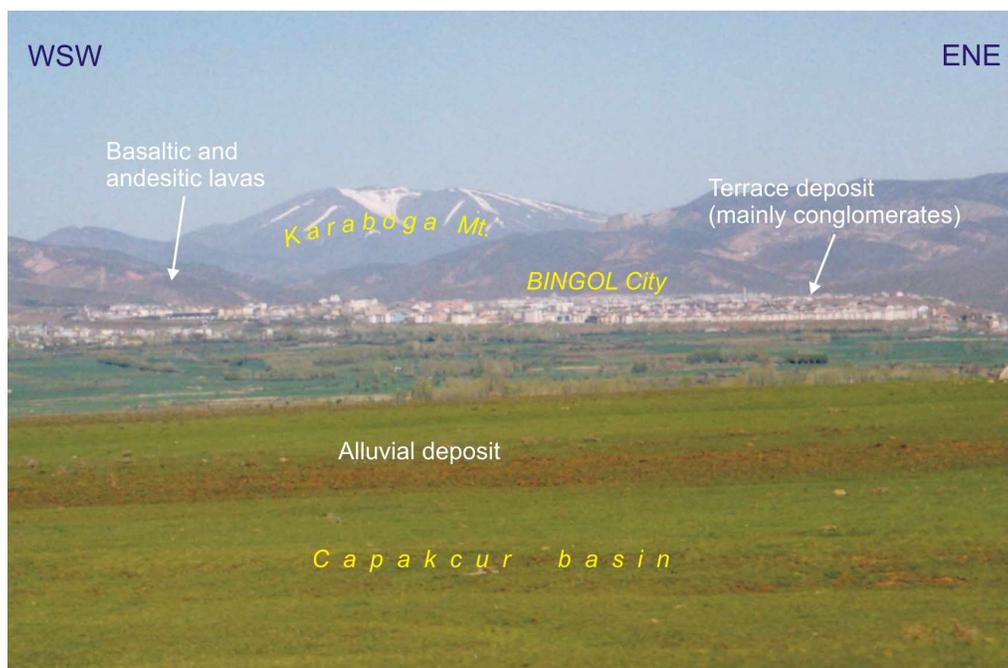
Figure 3. Soil conditions of Bingol city and the major area.

It is remarkable that Bingol city is located at the cross-cutting point between the NE-SW and NW-SE fault systems. The city is built on the alluvial fans and terraces of the northern border of Kapakcur basin, which mainly consist of conglomerates. The geologic formations of the bed-rock and the surrounding region are mainly composed of Plio-Quaternary basaltic and andesitic lavas (Figure 3).

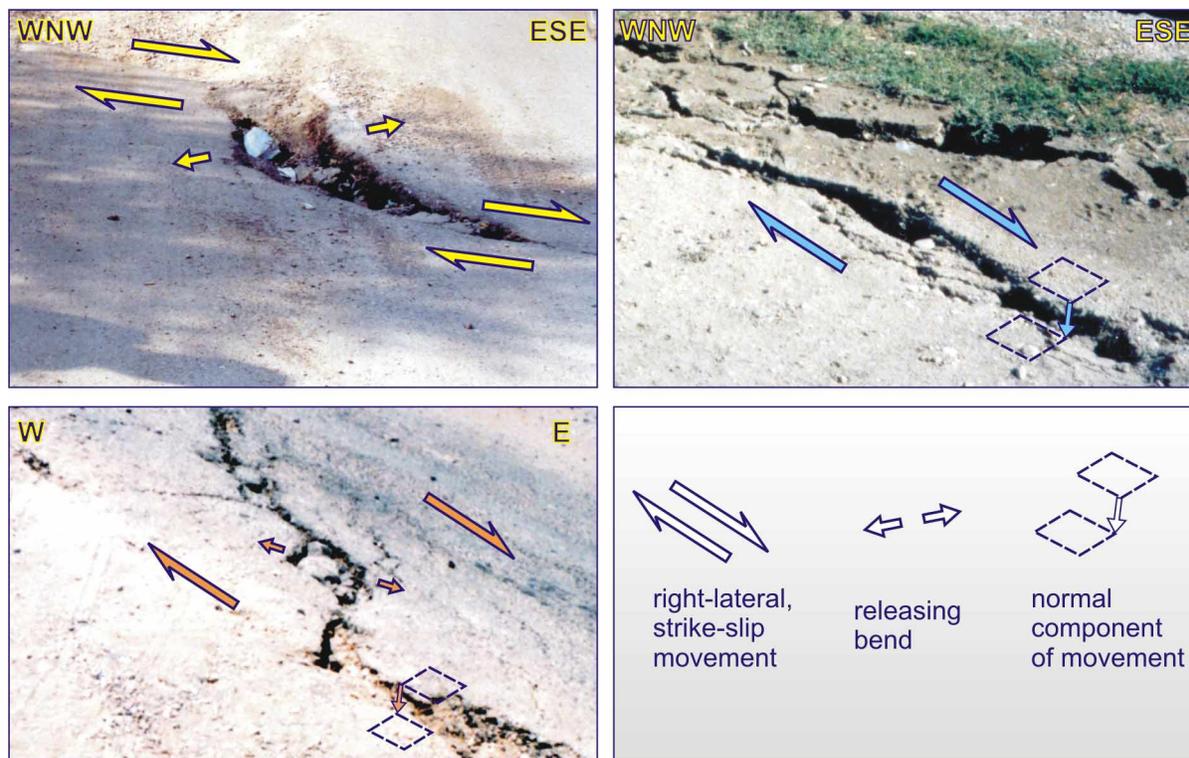
Figure 4. Kinematic interpretation of the NW-SE surface raptures.

The most of the NW-SE raptures form a scarp in the surface of a few centimeters and rarely of more than 10-15 cm. No particular opening has been observed along these raptures, which mainly dips 70-80 degrees to the SW. The overall geometry and kinematics of these raptures, except the main dextral strike-slip movement (hanging wall has been moved to the SE and footwall to the NW), also indicate a very small normal movement, with the north-eastern part uplifted in relation to the south-western one, giving as a result a normal oblique-slip kinematic character to these raptures.

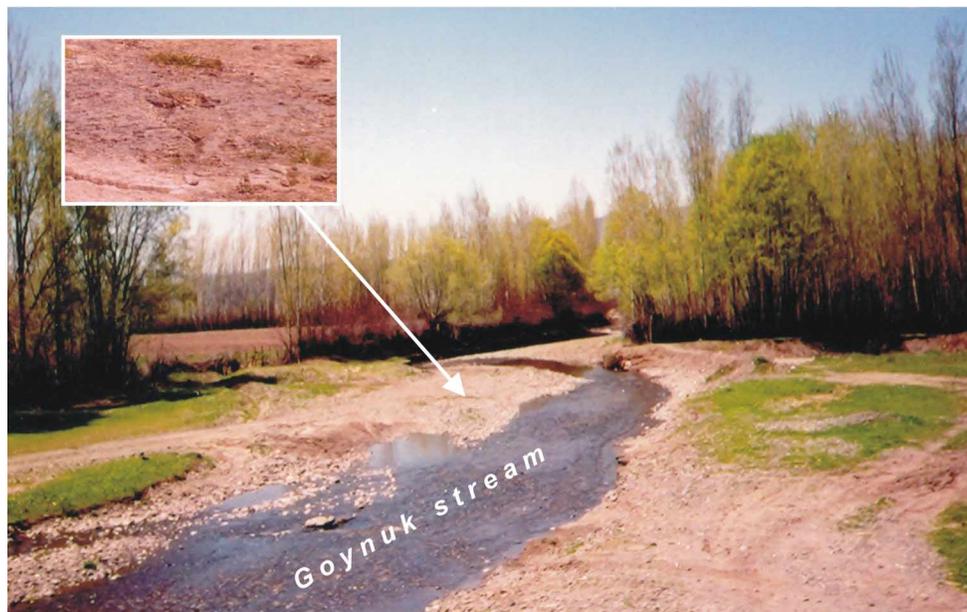
Figure 5. Small scale liquefaction phenomena south of Bingol city.

The restricted liquefaction phenomena have been observed only in two places along the Goynuk stream and recognized in the surface as small scale sand boils or extensional failures. They are related to the local ground conditions (alluvial deposits in the flood plains of the rivers), as well as to the depth of water table (Figure 5).

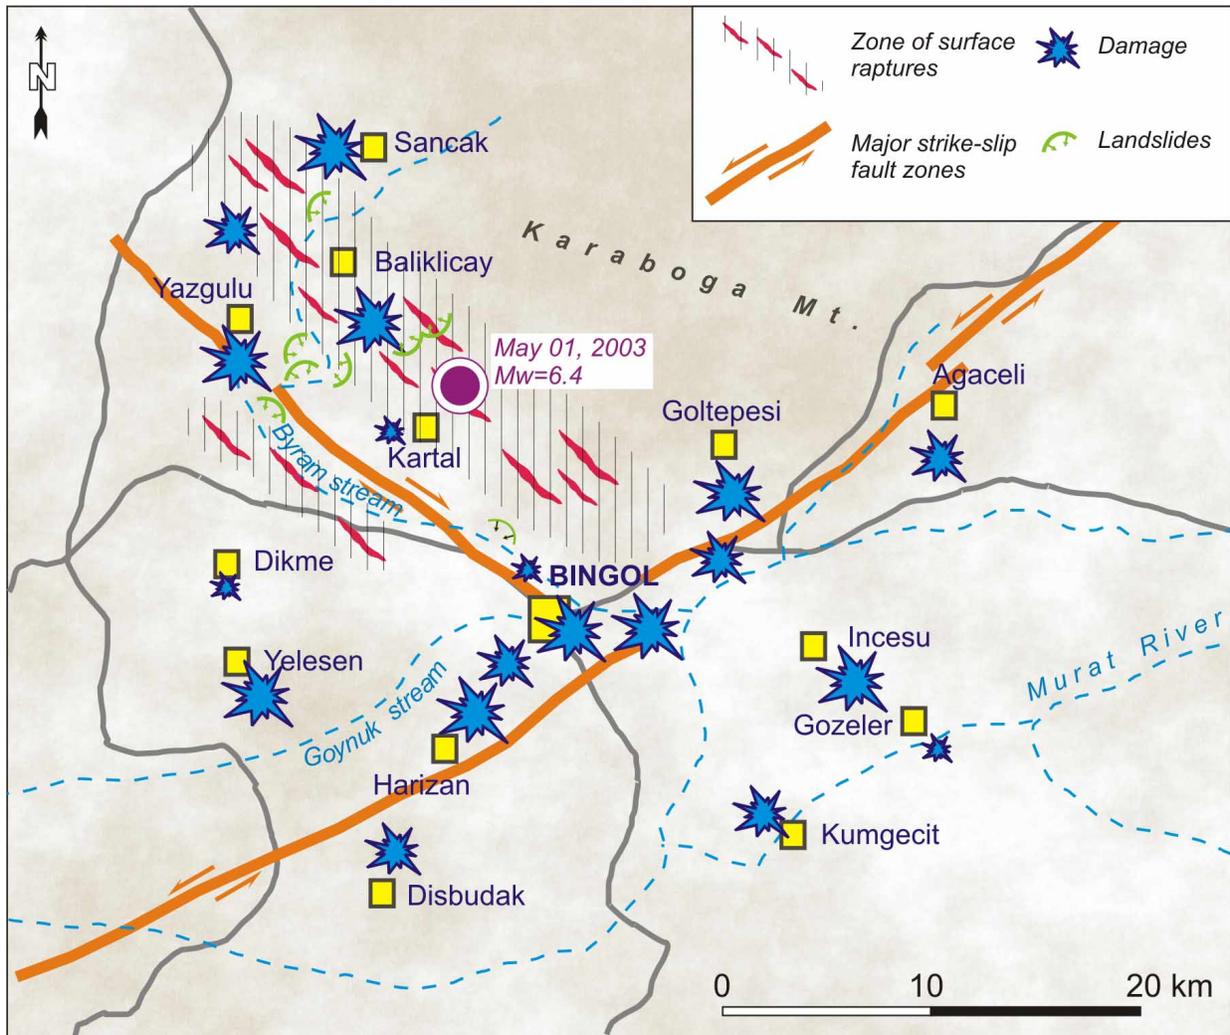
Figure 6. Spatial distribution of surface ruptures, geotechnical effects and damages.

The geotechnical effects observed in the area due to the earthquake was mainly slope failures and some restricted liquefaction phenomena. The slope failures were represented mainly by landslides, settlements and topple failures and were observed in many places within the stricken area. Their spatial distribution, although scattered, follows a secondary NW-SE zonation (Figure 6).

Most of the damage occurred in Bingol, Sancac, Baliklicay, Yazgulu, Goltepesi, Dikme, Yelesen, Incesu and Harizan. Serious damage occurred to Ilicalar, Ekiniolu, Y. Akpınar and Akdurmus. Minor damage was also observed in other villages in the wider area, such as Arıcalar, Kartal, Agaceli, Gozeler and Disbudak.

The main axis of the macroseismic intensities and the spatial distribution of the damage follow the NW-SE Baliklicay - Incesu direction and coincide with the aftershock distribution as well as with the distribution of surface ruptures and geotechnical effects (Figures 6 & 8). A secondary NE-SW axis of heavy damages, from Harizan village to SW up to Incesu village to the NE, also occurs and coincides with the general trace of the NE segment of the EAF. It is also remarkable that the most of the damage localized at the junction point of these two axes and at the footwall of the main NW-SE zone of surface ruptures.

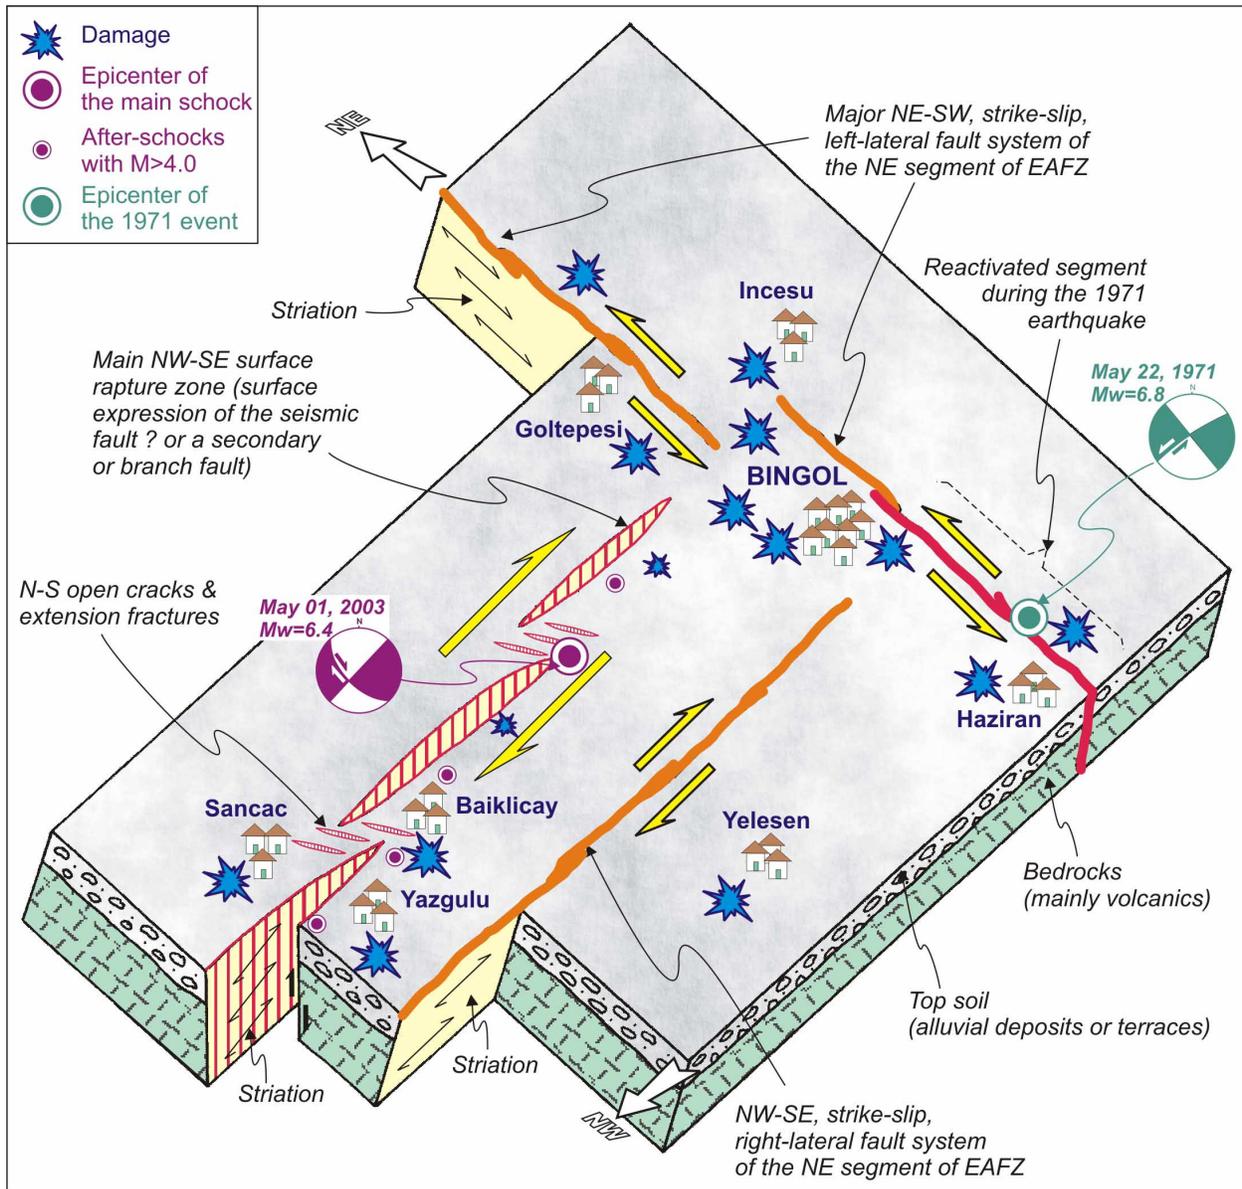
Figure 8. Schematic block-diagram representing the tectonic structures, geotechnical effects and damages occurred during the May 1, 2003 earthquake.

The geometric, kinematic and dynamic characteristics of the NW-SE ruptures indicate that they could be regarded as the expression in the surface of the seismic fault or of a secondary tear fault or branch fault (Figure 8). The NE-SW left lateral fractures, which are more rare and accompanying in some places the NW-SE one, possibly represent the conjugate Riedel (R') shear. The N-S extension fractures and open cracks represent en-echelon structures due to the right-lateral shearing of the reactivated fault.
