PERFORMANCE OF R/C AND MASONRY STRUCTURES DURING THE 2003 BINGOL EARTHQUAKE IN TURKEY

Necdet TORUNBALCI¹, OZKAN ISLER²

SUMMARY

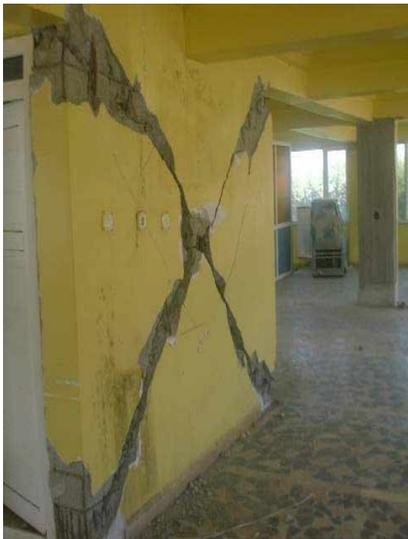
Fig. 1 Damage in a shear wall

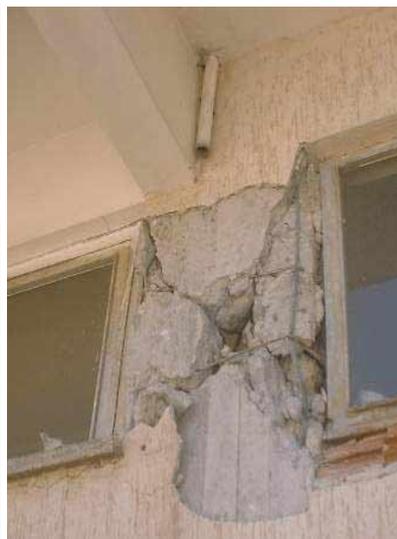
Fig.2 Short column

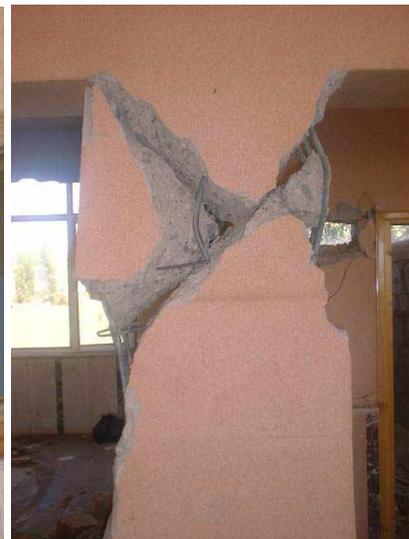
Fig. 3 Diagonal tension failure

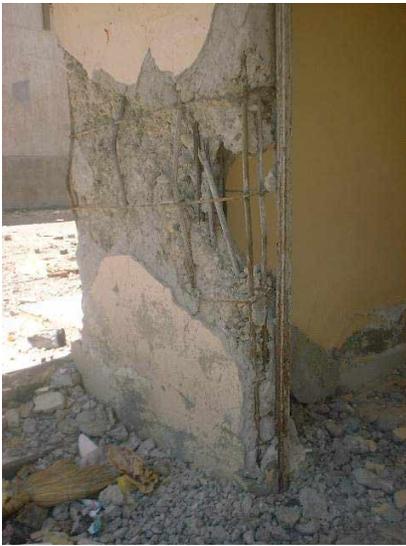
As explained above, local materials have been used in almost all reinforced concrete buildings until the last destructive earthquake in Bingol, and concrete has been produced through primitive methods. The ready mixed concrete plants have been idle since people have not given up their habits. Also, even though these installations had been used, since the production would have been with the local material, the same results could have been reached. The biggest problem in the production of concrete is the use of casual aggregate and not an appropriate granulometric mixture. The materials observed in the reinforced concrete buildings both in rural areas and in the center of the city by the writers are not within the acceptable limits. The minimum concrete strength should be C20 (20MPa) according to the Turkish Earthquake Code 1998 in Bingol and its vicinity which is considered a 1st degree earthquake region in the earthquake zones map of Turkey. However the average concrete strength is way below the limit value of the code in the damaged buildings. As described above, the aggregate maximum grain diameters are high values such as 13-15 cm, and this leads to the weak resistance of concrete. The getting together of such big pebbles has created flaws in structural members and damage happened in these parts. The partial defects formed because of poor concrete, mixture defects and very big aggregate, have led to the formation large cracks in structural members and to the collapse of concrete under the shear and compression forces.

Fig. 4 Poor quality concrete

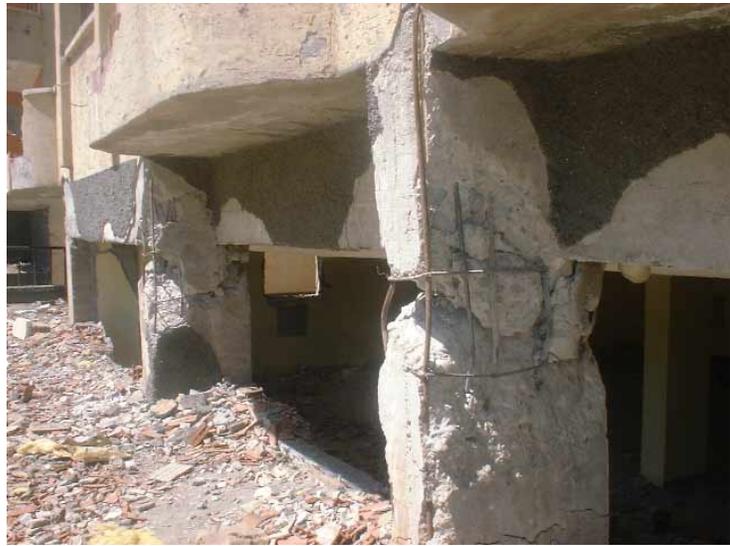
It has been noted damage in the columns mostly because of strong beam-weak column situation, and damage at column-beam intersections because of improper reinforcements and poor concrete. The Turkish Earthquake Code, which has become effective in 1998 stipulates enforcements for the application of especially strong columns-lesser strong beams condition. In the reinforced concrete buildings, which have been constructed according to the Turkish Earthquake Code of 1975, the structural member dimensions and column dimensions in general, are inadequate, it was based on the construction of stronger beams than the columns, Ozgen [2].

Fig. 5 Strong beam-weak column connection, Diagonal tension failure of a column

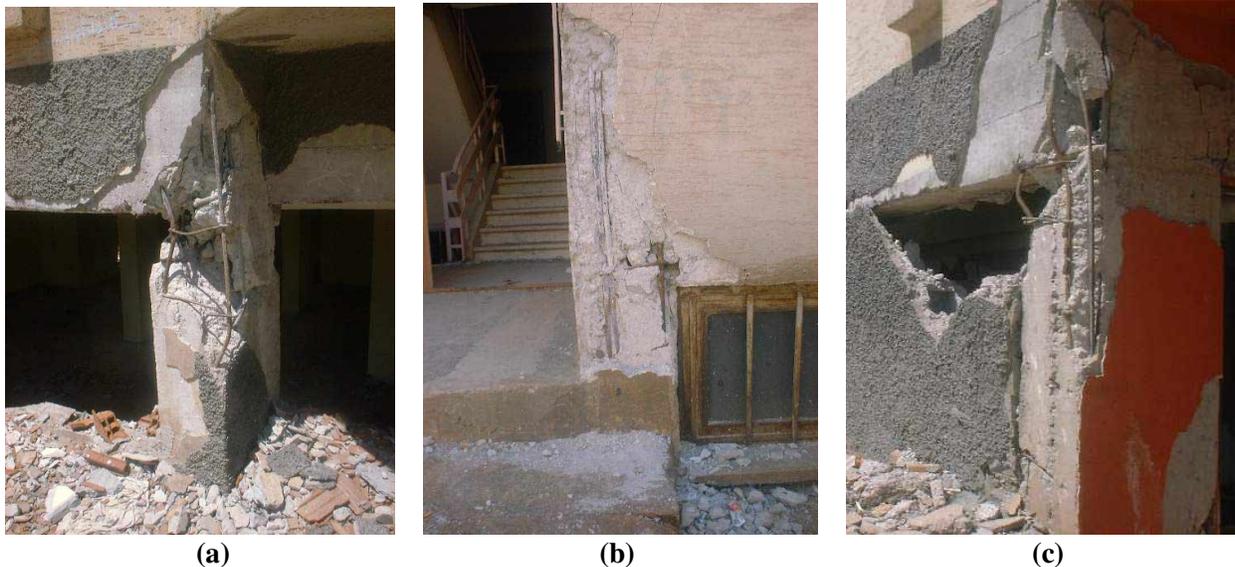
The most important deficiency observed has been that shear reinforcements have been placed with intervals of 35-40 cm mostly, and sometimes up to 50 cm. and the shear reinforcement at the column-beam intersection points have not been used. This situation is not within the limits of both the old and the new code.

Fig. 6 Lack of confinement steel in columns, inadequate reinforcement arrangement

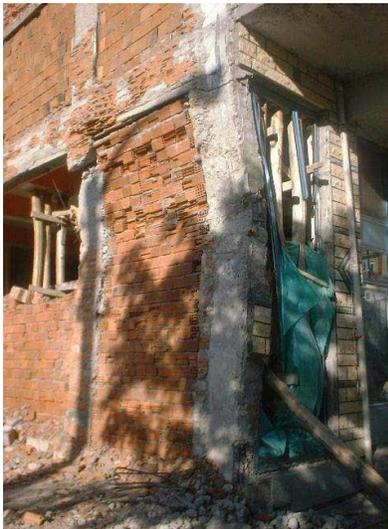
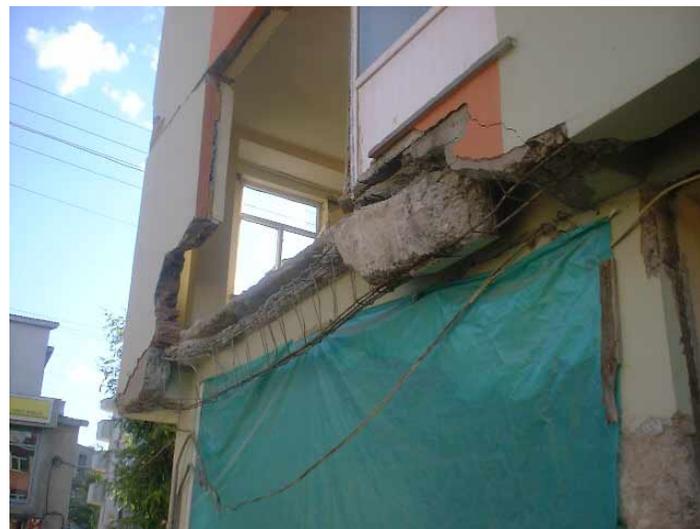
Fig. 7 Damages during the demolitions after the earthquake

An interesting and legally very complex situation is that, a building without damage or with minimal damage after the earthquake, is damaged during the demolition of a building which has severe damage. It has been noted several buildings in Bingol, which have been damaged because of this.

This situation requires a very sensitive inspection such as the technical inspection during the construction of a building. The damages during the demolitions such as this, is a clear proof of inadequacy of the technical equipment infrastructure and technical staff in the local governments.

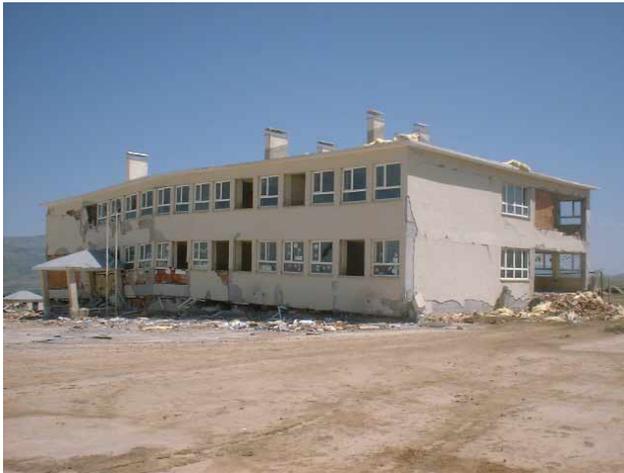
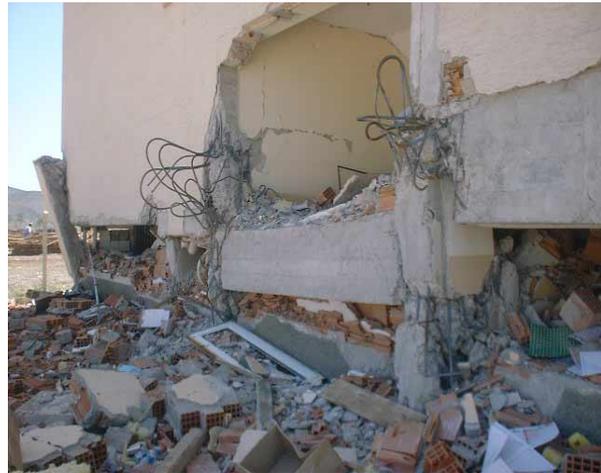
Fig. 10 Collapse of the ground floor of Celtiksuyu Primary School

Primary School Building collapsed through the complete fracturing of its columns, scattering of the concrete of its columns, heavy damage at its joints and the scraping of its reinforcements from the concrete. Although 1st and 2nd floors have not collapsed, these floors have been heavily damaged. The high vertical acceleration of the earthquake has caused the fracturing and the scattering of the columns at

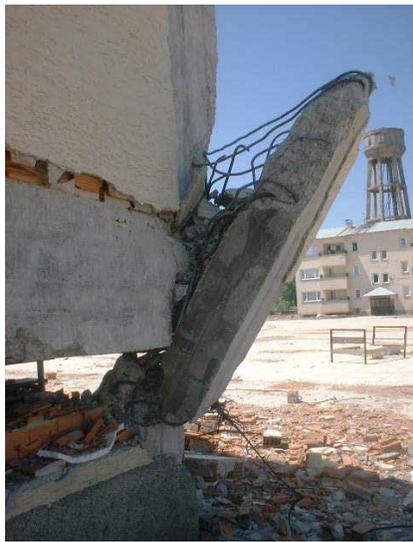
Fig. 11 Lack of proper anchorage and joint steel

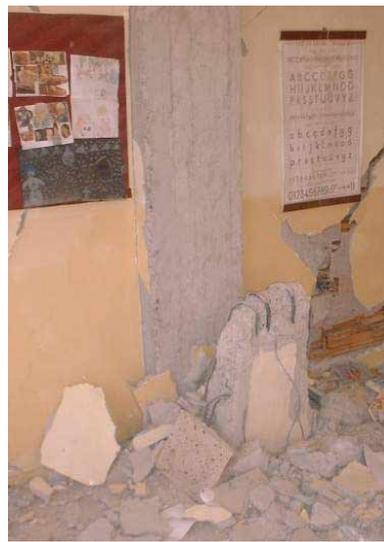
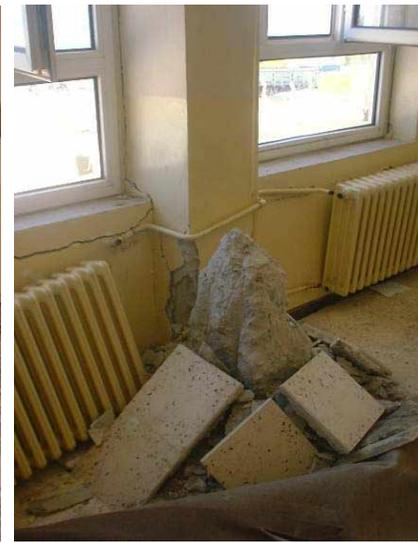
the ground level. The columns, which have not collapsed but fractured from their joints, have been pushed horizontally and have punched the upper floor slabs, which have fallen on them. 1st floor slabs, which have fallen on the fractured ground floor columns have been punched by the ground floor columns also by the effect of excessive horizontal displacements. Upon the examinations, it has been noted that the pebbles in the concrete mix were 12-15 cm, and the stirrup distances were at the 40 cm level at some locations. The poor quality of the building concrete has also negatively affected the adherence. Because of the use of mild and smooth surfaced steel, the reinforcements have been scrapped from the concrete and have deformed tremendously.

Fig. 12 Punching 1st floor slabs by ground floor columns

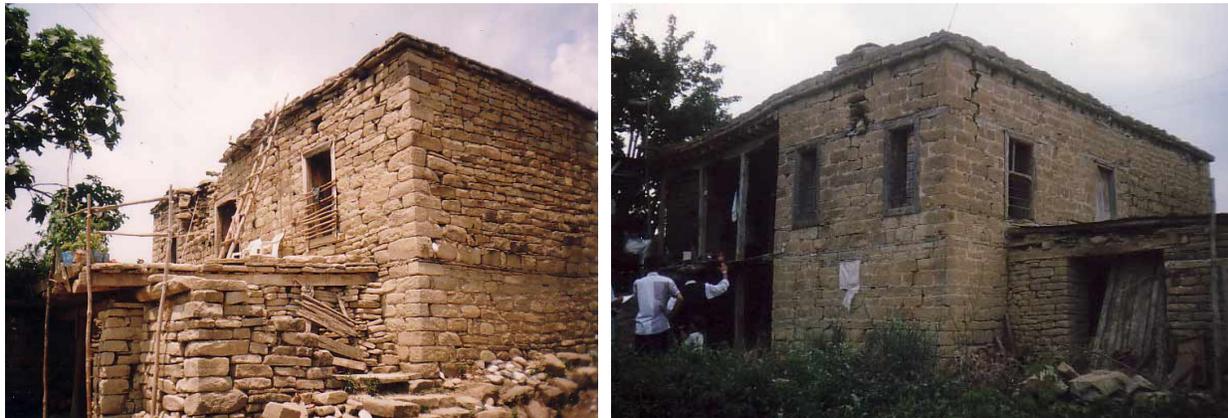
Fig. 13 Typical cracks in masonry buildings

Separations in upper tips of corner joints of flat roof, Deterioration in the stone walls as a result of the clay mortar's loosing its binding properties through the seasonal effects, Because of the reasons above, the log beams which bearings the landfill flat roof break loose and the roof collapses, In case the windows and the door are close to corner joints, the cracks resulting in moderate damage and/or collapse in the wall, In case the wall length goes above 5.00 m, no wall stability and collapse as a result of moderate and severe damage in stonework wall.

In the damage examinations at the brickwork buildings, it has been determined that, The damages are greater in buildings constructed with only lime mortar instead of lime and cement mortar, There are cracks at the corners of windows and doors along with tie beams, Since there are not enough spaces between the corners and the windows/doors, the diagonal shearing cracks reach the tie beams, and important damages emerge as a result of this depending on the thickness of the wall, and the resistance of mortar material.
