## A RATIONAL APPROACH TO THE INVESTIGATION, EVALUATION, AND SEISMIC RETROFIT OF MODERN RESIDENTIAL WOOD-FRAMED STRUCTURES

Gary R. Searer<sup>1</sup>, James A. Mahaney<sup>2</sup>, Richard A. Dethlefs<sup>3</sup>, and Douglas L. Gadow<sup>4</sup>

### SUMMARY

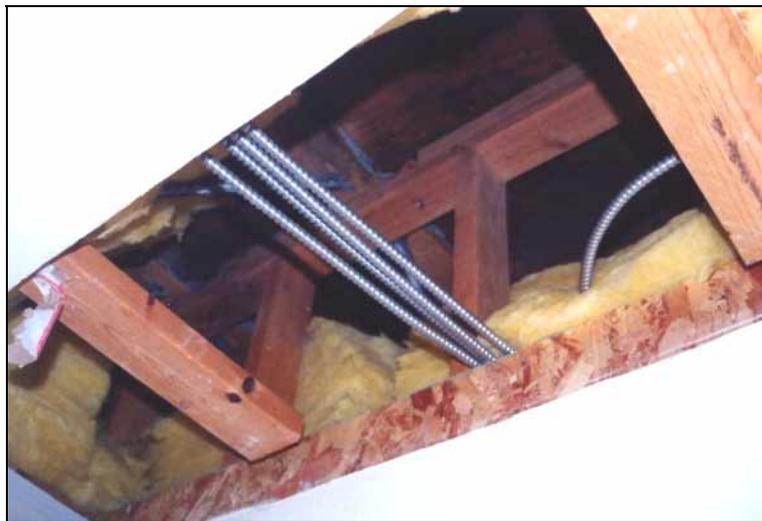
In a significant number of projects, we have found that contractors often omit plywood at some of the walls where plywood is required. We have never come up with a satisfactory reason for how or why specified plywood gets omitted; but it occurs (or fails to occur) in many projects that we have investigated. Omission of sheathing might be a function of difficulty or sequencing of construction trades; certainly plywood installation is labor intensive and somewhat expensive, but plywood shear walls are typically relatively easy to identify on the plans. We often see walls where the designer specified plywood on both sides that lack plywood on one of the two sides. We also often find plywood to be missing above the ceiling level in attic spaces or in ceiling soffits (Figure 1). Our best assessment is that the plywood is sometimes simply missed or overlooked when multiple construction trades are working simultaneously and are under a tight construction schedule. In any case, it is important to probe walls and inspect attics to ensure that the specified plywood is present.

**Figure 1: The plywood sheathing on this wall stopped at the underside of the ceiling and was not installed above the ceiling, resulting in a discontinuous load path.**

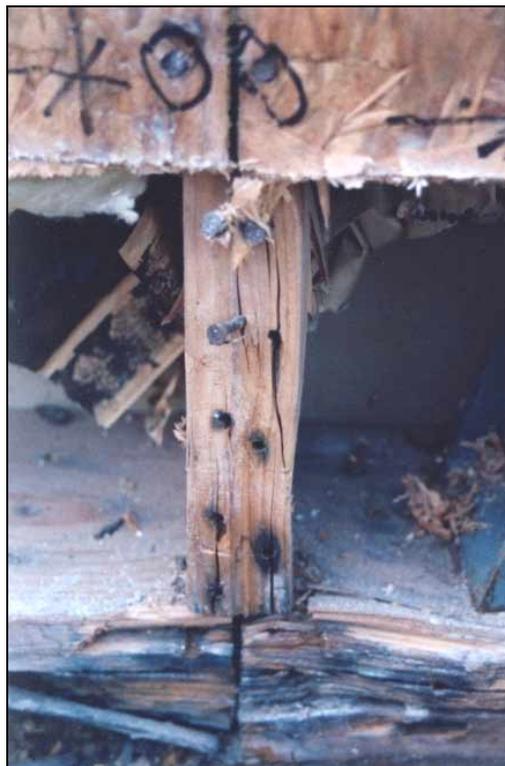
Failure to stagger nails is also a common problem, even among the best contractors. Even with notes and diagrams showing that nails should be staggered or “weaved,” the laborer’s natural instinct is to install the nails in a nice, straight line. Failure to stagger the nails has the potential to cause splitting (Figure 2).

**Figure 2: Nails were installed too close together at this stud, causing the stud to split.**

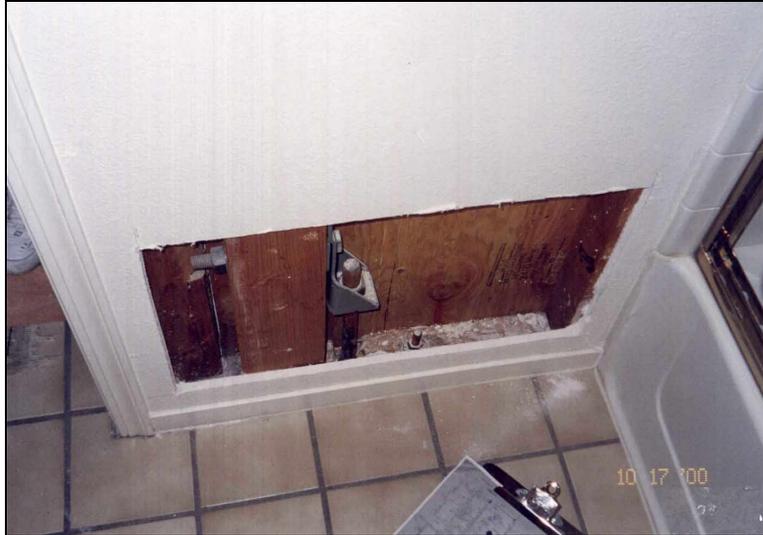
Generally, the designer calculates the tension in a particular holddown assuming that the holddown is at the very end of the wall, and the structural plans typically reflect this assumption. Unfortunately, most holddowns that we find are inset (Figure 3), either to allow installation of bolts to connect the holddown to the studs or due to possible uncertainty in the concrete subcontractor where exactly to locate the holddown rods. This inset increases the holddown forces and can cause other problems associated with the inset, as described below.

**Figure 3: This holddown is inset by more than 12-inches.**

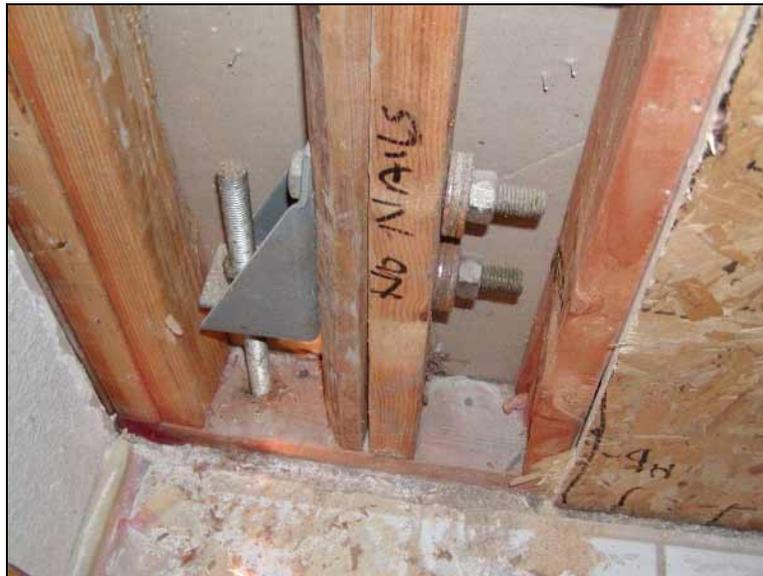
If the post or studs to which the holddown is connected is not at the very end of the wall, failure to edge-nail the sheathing to the holddown posts is a common mistake and can result in a load path discontinuity (i.e. the sheathing is not well-connected to the holddown post and can then uplift much sooner than the design engineer anticipated). Figure 4 shows this deficiency.

**Figure 4: This holddown was inset; the holddown studs were not internailed; and the plywood was not nailed to the holddown studs.**

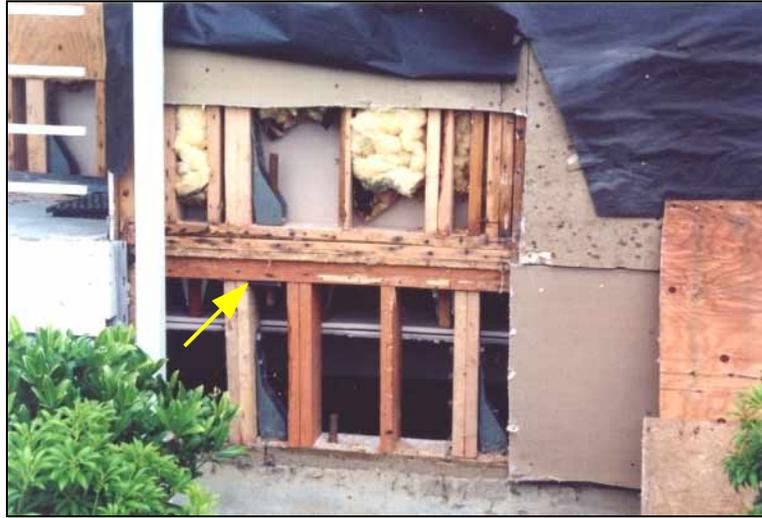
it is clear from the installation that the contractor never really understood the purpose of the holddowns in the first place (Figure 5).

**Figure 5: The holddown on the first floor is not connected to anything but a plate washer on the underside of the double top plate of the crawlspace (yellow arrow), resulting in a discontinuous load path.**

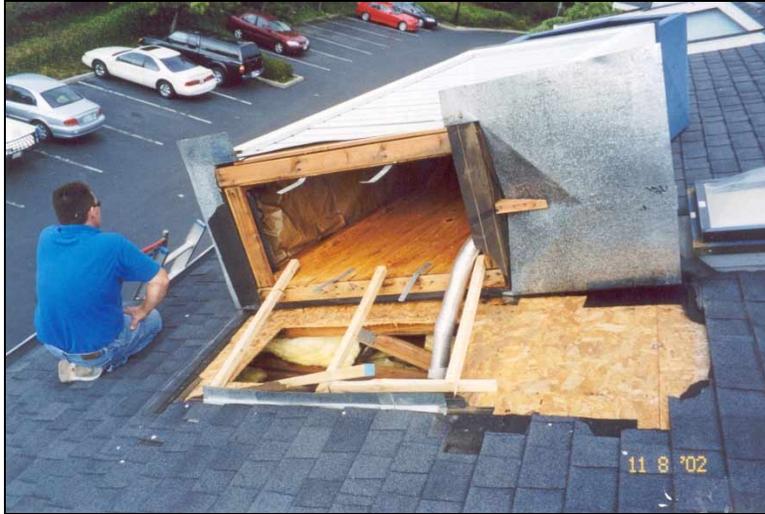
Holddown straps pose unique problems, since they require that the installer understand the purpose for which the strap is being used. Often we see the wrong size nails used (i.e. whatever size nail is readily available is used, rather than the nails specified by the strap manufacturer). Other common errors are failure to install the straps plumb or level, resulting in some nails missing the wood studs altogether, often called “air nails” or “shiners”; failure to install wood studs behind the straps, also resulting in air-nails or shiners; and failure to install the strap symmetrically so that the strap has an equal number of nails to each element that they are connecting. In a recent project in the San Francisco Bay Area, failure to connect the lower halves of a number of holddown straps to the supporting wood framing resulted in large wood-framed chimneys toppling over during a moderate windstorm (Figure 6).

**Figure 6: This chimney collapsed during a wind storm due to the contractor's failure to nail the bottom halves of the holddown straps.**

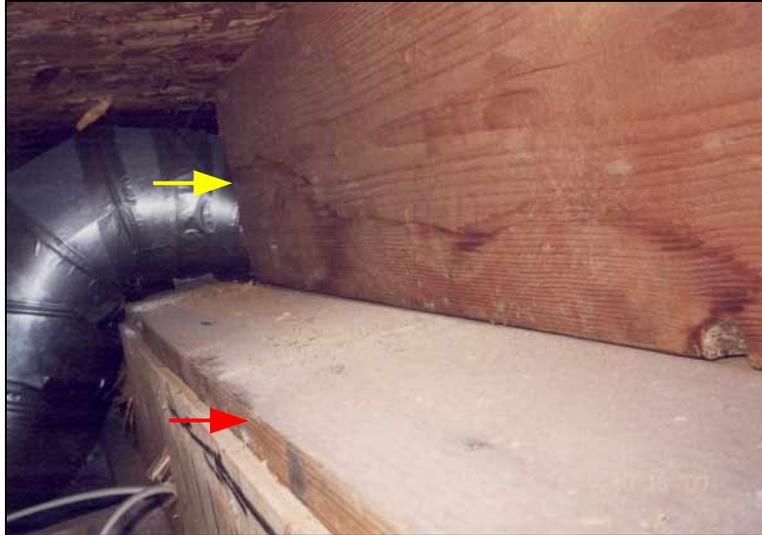
Sheet metal clips or toenailing are often omitted in the construction of through-floor shear transfer details (Figure 7). If the clips (or toenailing) are present, they may be installed at a spacing that exceeds the design requirements, may lack the required nailing, or may have smaller-than-required nails. It is not clear why sheet metal clips are so often mis-installed; however, it may be explained by a simple lack of understanding of the purpose and importance of the details.

**Figure 7: The required clips from the rim joist (yellow arrow) to the double top plate (red arrow) were not installed.**

Simple cost-effective solutions can also be implemented. If through-floor clips are missing at one level and sole plate nailing is deficient directly above, the simple solution is to open the ceiling, install the through-floor clips and using long nails or screws to engage the sole plate above. In this example, costly repairs to wall finishes can be avoided.

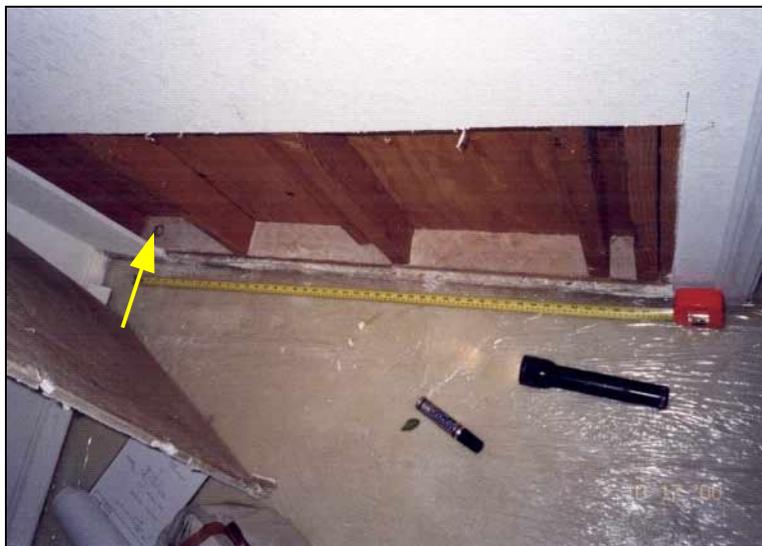
Sole nailing is another poorly constructed aspect of through-floor shear transfer details. The most common problem is installation of sole plate nailing at one nail per stud space (1 nail every 16-inches is code minimum), when closer spacing is required by the structural drawings (such as 6-inches on center or 2-inches on center). Another problem is that nails that are installed in the center of the sole plate often miss the rim joist or solid blocking below, decreasing the shear capacity of the shear transfer detail. Figure 8 shows a sole plate without the required nailing.

**Figure 8: This sole plate only had one nail (yellow arrow) in 48-inches.**

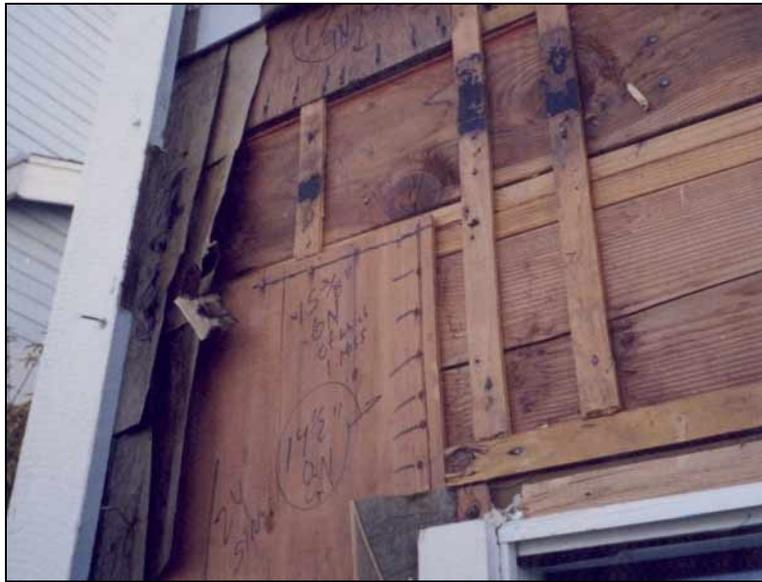
second floor sole plate (Figure 9), resulting in a discontinuous load path unless sheet metal clips are installed to connect the second floor sole plate to the rim joist and the rim joist to the double top plate. Similarly, if a lower sheet of plywood is nailed to the bottom plate of the double top plate and the upper sheet of plywood is nailed to the upper plate, a load path discontinuity results unless the double top plates are internailed with sufficient capacity to transfer the design shear.

**Figure 9: The second floor plywood was nailed to the second floor sole plate and the first floor plywood was nailed to the first floor double top plate, resulting in a discontinuous load path. Furthermore, the first floor plywood nails were installed *between* the plates of the double top plate, resulting in a connection with little or no capacity.**

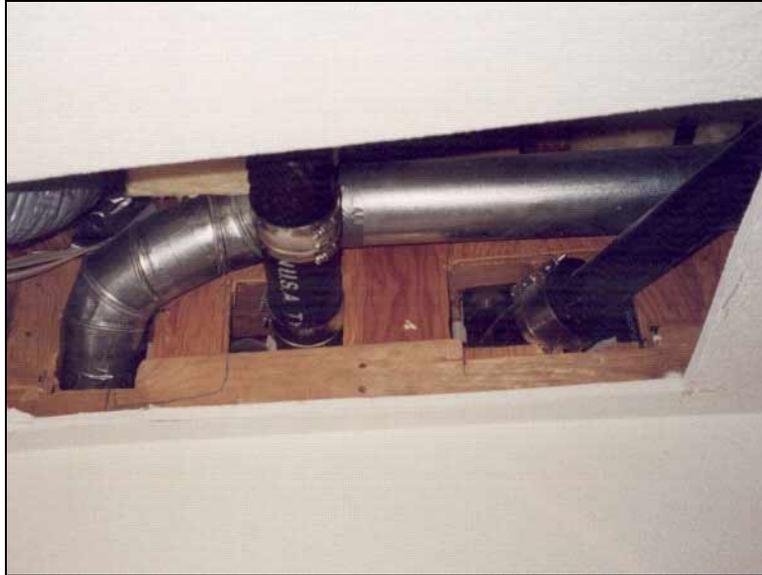
Plumbing and HVAC systems are typically installed after the wood framing, and these contractors often cut numerous holes in top plates, sole plates, and sheathing during their installation efforts (Figure 10). Typically, the damage that these contractors do to the wood framing is not identified or repaired during construction, potentially resulting in a significantly damaged lateral force resisting system.

**Figure 10: This plywood shear wall is severely compromised by the HVAC and plumbing installation.**
