## **EXPERIMENTAL TEST ON A FULL SCALE REPAIRED R.C. STRUCTURAL WALL**

**Paolo RIVA<sup>1</sup>, Alberto MEDA<sup>2</sup> and Ezio GIURIANI<sup>3</sup>**

### **SUMMARY**

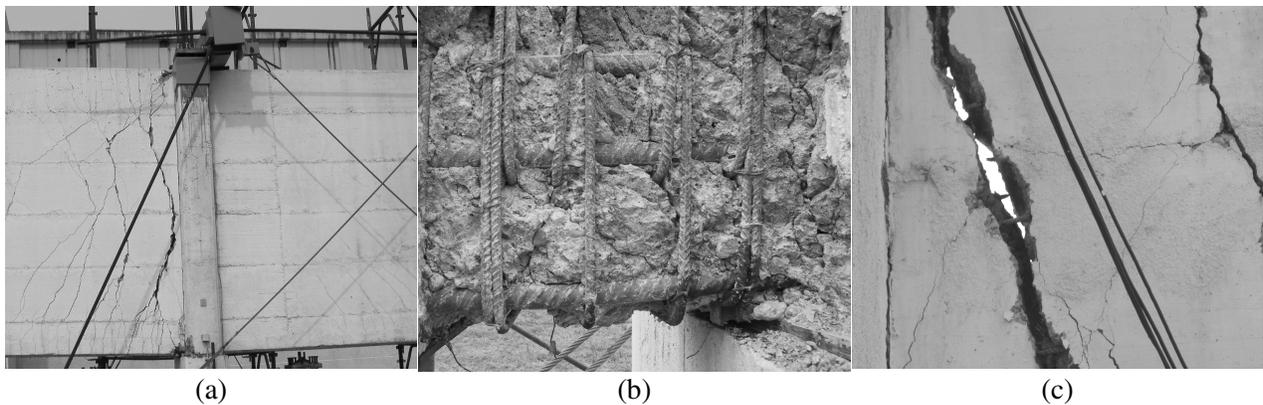
Figure 6a illustrates the critical region at collapse. A wide opened, arched crack is observed next to the support section. This crack developed after yield, when several smaller flexural cracks, starting from the outer chords, merged into a single crack. The main crack exhibited a maximum opening of approximately 50 mm towards the wall mid-depth and 10 mm at the chords. In the chords, concrete spalling, due both to compression forces and rebar bending, was observed (Figure 6b). The large crack opening in the middle part of the wall led to a marked strain localization in the longitudinal shear reinforcement, resulting in its tensile failure with necking (Figure 6c).

**Figure 6 – Detail of collapse mechanism.**

Concerning shear strength, the wide crack opening observed is not compatible with any aggregate interlock effect. Furthermore, the subsequent failure of the longitudinal panel reinforcement lead to a considerable reduction in the shear strength for dowel action. As a consequence, a shear failure occurred during the unloading phase, when the beneficial effect of compression in the upper chord, which enables the shear strength contribution due to friction, ceased to exist. Figure 6b shows that the main rebars are bent due to dowel action and consequent vertical wall displacement.

Finally, the stability of the wall response up to collapse leads to the conclusion that a considerable ductility margin was still available with respect to bending failure and that the shear reinforcement provided at the critical section was insufficient to avoid an early sliding shear failure.

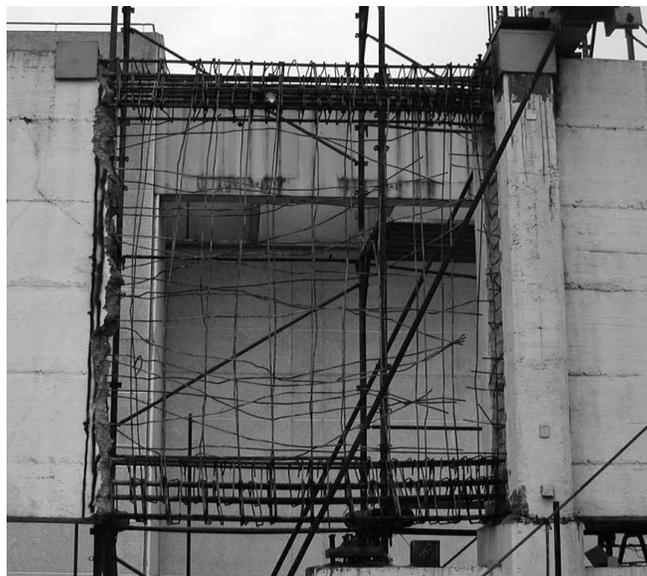
**Figure 7 – Critical region after concrete demolition.**

Figure 7 shows the critical section after the demolition. As expected, all of the longitudinal web reinforcement was cut next to the base section, where the main crack had occurred (Figure 6b). A maximum residual deformation approximately equal to 5%, evaluated by measuring with a caliber the rib spacing in the deformed bars, was measured in the outermost rebars next to the critical section. Non negligible residual deformations were measured in all the bars in the chords and in most of the demolished region, whereas no residual deformations were observed towards its end.

Given the above, all of the bars in the chords had to be replaced. Since lap-splicing could not be adopted, due to an insufficient development length, mechanical couplers (Ancon<sup>®</sup> MBT, Figure 8) were used to link the new bars to the existing ones.

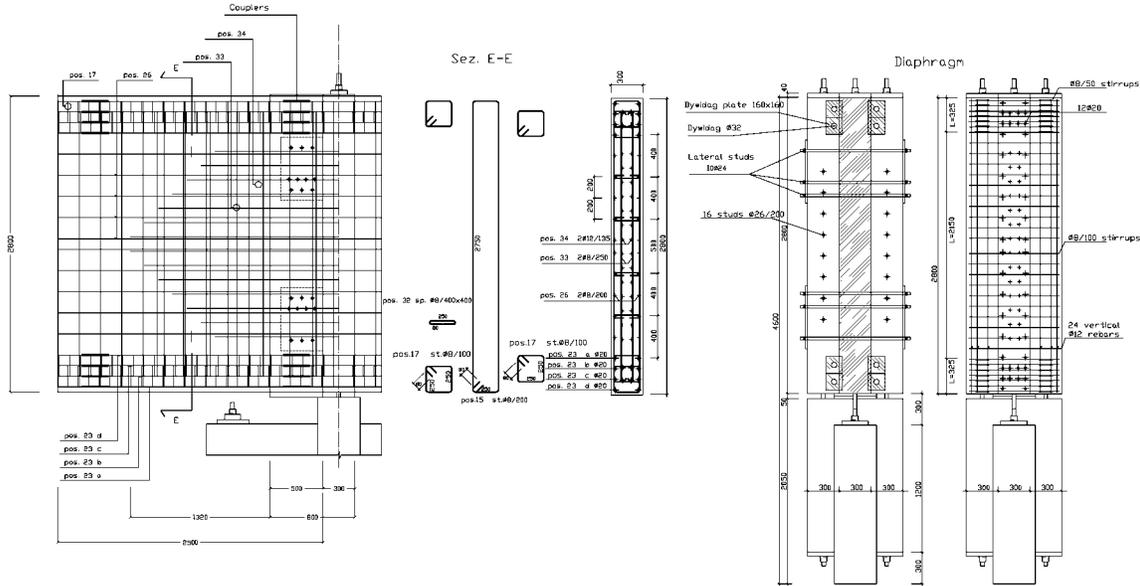
**Figure 8 – Reinforcement detailing for the repaired wall.**

In order to avoid cracking due to bearing stress acting on the mechanical couplers of the main rebars in the critical section, the base section was transversally confined and widened for all of the coupling length (0.50 m), adopting the same width of the diaphragm (Figure 8). In order to transmit, by dowel action, the total base shear between the newly cast and the old concrete 16  $\phi 26@200\text{mm}$ , 400mm long, grouted studs were inserted in the existing diaphragm (Figure 8).

Concerning web reinforcement, the original longitudinal and transverse  $\phi 8@200\text{mm}$  bars were replaced with new rebars, grouted for a depth of 100 mm into the ground floor diaphragm, and spliced to the original web reinforcement at the other end. In order to improve sliding shear strength, 28 $\phi 12@135\text{mm}$  longitudinal bars and  $\phi 8@200\text{mm}$  stirrups were added in the middle portion of the wall next to the base section. In the attempt to control the arched crack which led to the original wall collapse (Figure 6a), and to force the formation of a diffused truss mechanism, the longitudinal additional reinforcement was placed as shown in Figure 8.

For further safety of the testing setup, eight external, post-tensioned, unbonded,  $\phi 32$  Dywidag<sup>®</sup> bars were added between the two diaphragms, along the part of the wall simulating the underground floor of the box foundation (Figure 8).

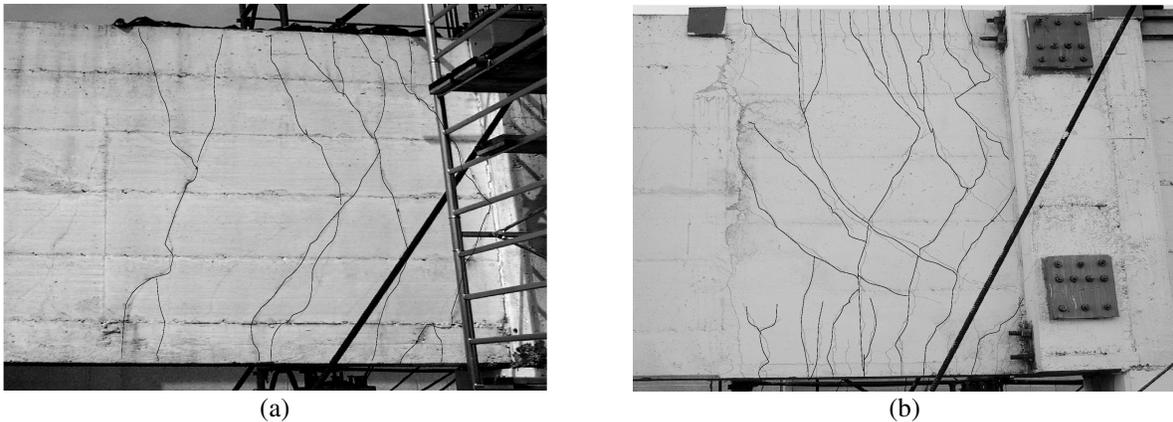
The crack pattern at the yield load for the two situations is shown in Figure 11. This Figure demonstrates that a more diffused crack pattern developed in the repaired wall, while in the original one the cracks tend to merge towards the base section, forming the arched crack which eventually led to collapse. Furthermore, the devised diffused truss mechanism was observed in the repaired wall.

No relevant differences were found in the zone between the supports for the two walls. A diffused crack pattern was detected in both cases, with a crack inclination of about  $45^\circ$ , typical of panels loaded by pure shear, and a reduced crack opening (lower than 0.1 mm).

**Figure 11 – Comparison of the original (a) and repaired wall (b) crack pattern at yield.**

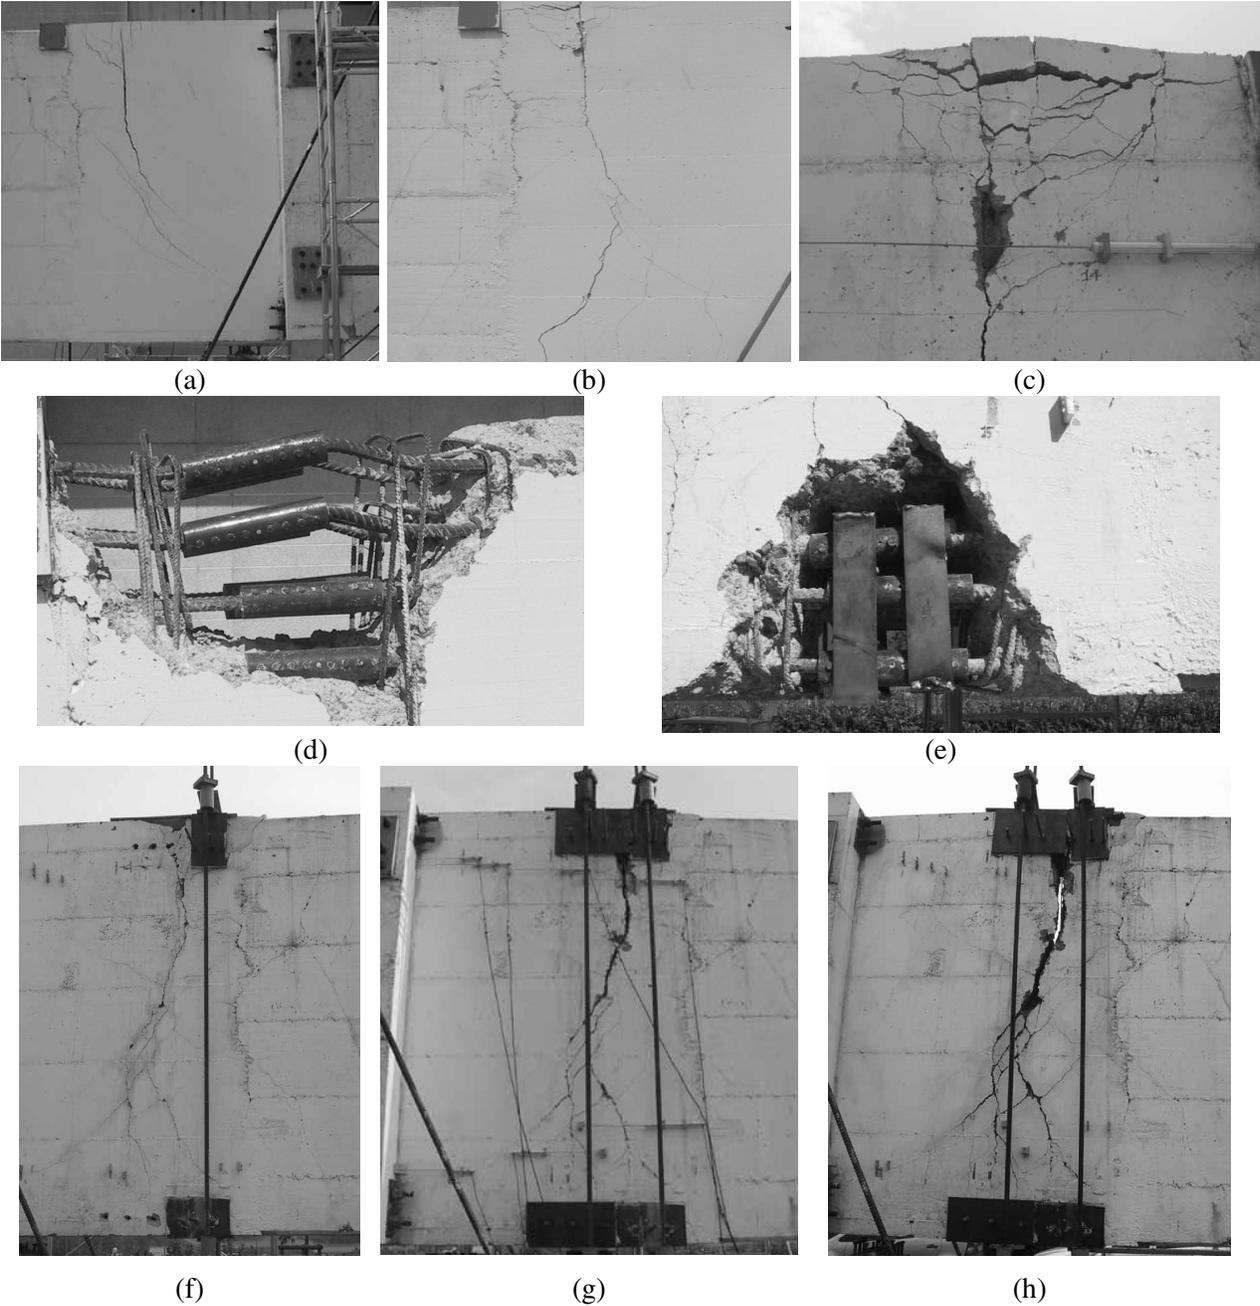
During the first cycle, while determining  $\delta_y$ , a large shear crack appeared close to the end of the repaired wall section (Figure 13a). After load reversal, a similar crack developed starting from the lower chord and merged to the previous one (Figure 13b). During the second cycle at  $\delta_y$ , severe concrete spalling was

observed in the upper chord, close to the end of the rebar couplers location (Figure 13c). After completion of this cycle, the test was interrupted, and the spalled concrete was removed.

Figure 13d shows that the outer longitudinal bars buckled next to the couplers. This phenomenon has been interpreted as a consequence of the compression bearing stress on the couplers end sections close to the concrete cover, where concrete confinement is not effective. Hence, a strengthening of the damaged section was necessary. The same problem, although less evident, was observed also in the lower chord.

After this repair, the test continued with a third cycle at  $\delta_y$ . During this cycle, the repaired main crack reopened. At this point, the confinement was extended, doubling the steel caps and confining bars (Figure 13g).

After this last repair, a fourth cycle at  $\delta_y$  was successfully completed. During the following cycle at  $1.5\delta_y$  the wall finally collapsed, once again due to the opening of the same crack (Figure 13h), which lead to a very large strain localisation in the web reinforcement, which failed in tension, likewise what was observed during the third cycle at  $3\delta_y$  in the original wall (Figure 6). The experimental behaviour following the theoretical yield is presented in Figure 14 (load versus end displacement  $F-\delta$ ), where the results of the original and repaired walls are compared.

In any event, the repaired wall showed a good behaviour only up to the structural yield. After this point, the presence of the mechanical couplers caused an excessive local damage in the outer chords due to compression bearing stress. Even after having heavily confined the section next to the couplers, shear collapse could not be prevented. In fact, once the main crack opened in bending at the chords, it further

developed due to a lack of web reinforcement. Under this respect, it is important to note that the shear crack developed outside of the theoretical critical section, which had a heavy web reinforcement against sliding shear.

**Figure 13 – Development of damage up to failure of the repaired wall.**

Accordingly, the buckled bars were straightened and the couplers were connected together with welded steel plates, in order to prevent any possible future buckling phenomenon (Figure 13e). The main crack was widened and filled with high strength concrete mortar. Finally, the damaged concrete in the chords was replaced with the same mortar.

To confine the chords, two steel caps were placed and prestressed across the section, by means of three threaded  $\phi 20$  bars. The section was further confined by means of two external unbonded, prestressed  $\phi 26$  Dywidag® bars, placed as shown in Figure 13f.

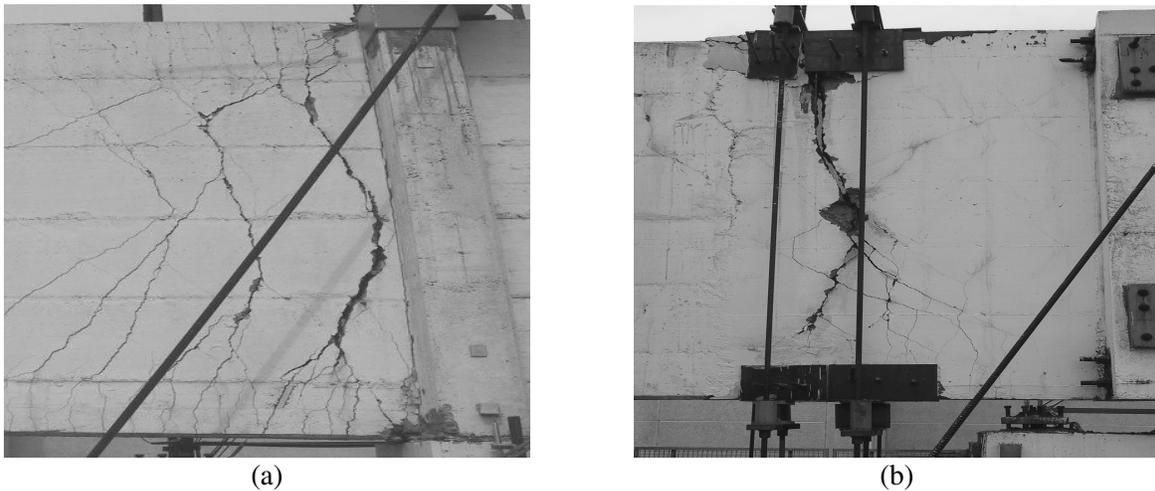
These Figures show that the structural yield point is almost the same for both walls. The response up to collapse of the repaired wall did not show any significant unstable behaviour and no significant pinching in the cycles appeared. In both cases, an anticipated collapse related to shear was observed, and the full bending ductility could not be developed. The collapse mechanisms for both the original and repaired walls are shown in Figure 15.

**Figure 15 – Comparison of the original (a) and repaired wall (b) failure mechanisms.**

The results also show that the longitudinal web reinforcement towards the end of the repair should have been better grouted into the old concrete, instead of being spliced to the original web reinforcement.
