## PERFORMANCE OF SEISMIC ISOLATED BUILDINGS DUE TO 2005 WEST OFF FUKUOKA EARTHQUAKE IN JAPAN

Keiko Morita<sup>1</sup> and Mineo Takayama<sup>2</sup>

**KEYWORDS:** Seismic Isolated Buildings, Response Behavior, 2005 West Off Fukuoka Earthquake

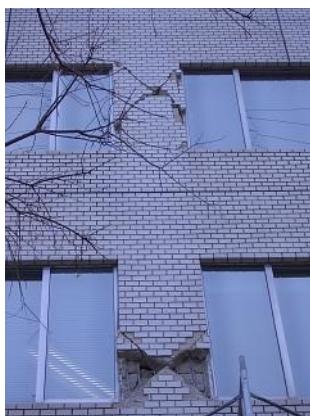
a) Shear Cracks of Columns

Photo 1 Damage of Non-seismic Isolated Building

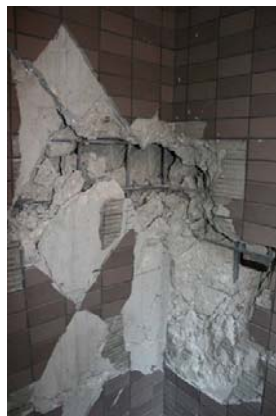
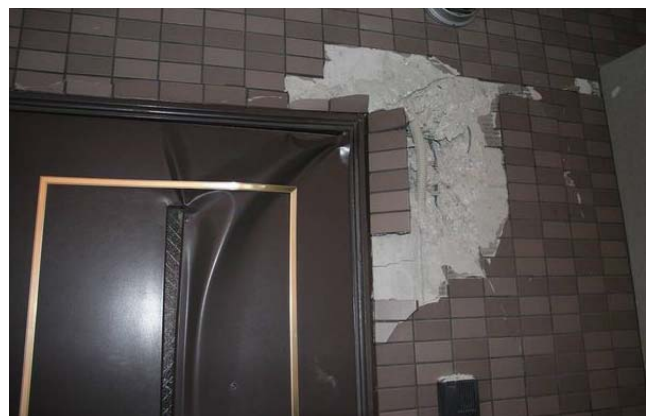
b) Damage of Nonstructural Members

In an earthquake proof building standing near Building C (SRC structure, 14 story apartment building, constructed in 1999), extensive damage occurred to nonstructural elements. Photo 1 b) shows an example of the damages. There were many units of this apartment in which the doors could not be opened or closed.

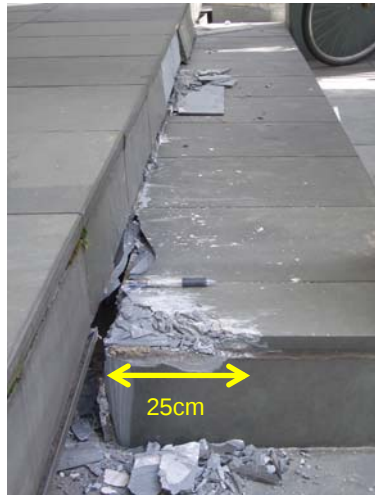
Building C stands near the Kego fault. Photo 2 shows the appearance of the building, and Photo 3 shows the damage of the entrance area. It is considered that the damage which occurred on the tiles of the staircase because the clearance between upper and lower is small. The width of the damage on the staircase is approximately 25cm, and it is presumed that larger displacement than that occurred. An orbit drawn by the angle of an iron sheet placed on the access to a side door was found (Photo 4). Although no displacement orbit in the south side remains, the movements of the seismic isolated buildings were greater in the direction of south-north than east-west, and it reached a maximum of approximately 30cm. The observed acceleration was greater in the direction of south-north than east-west, and the maximum acceleration of 203gal was observed at 65m underground, 489gal at the basement of seismic isolation layer, 238gal on the 1<sup>st</sup> floor and 234gal on the highest floor (the 7<sup>th</sup> floor). The maximum response acceleration was damped by half against the input acceleration.

Photo 3 Damage of the Entrance Area of Building C

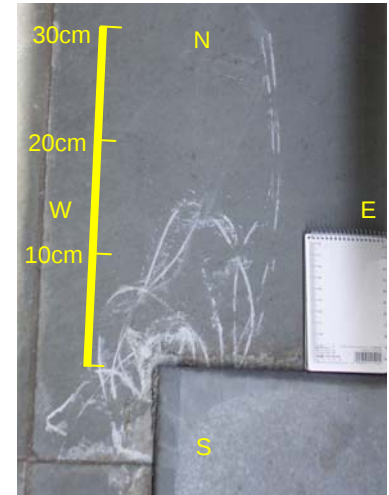
calculated through integration of the acceleration data observed at the basement and in the flooring of the 1<sup>st</sup> floor. A relative displacement record of the seismic isolation layer was obtained from the difference between both response deformations. From comparison of this Figure 3 with Photo 4, although the maximum deformations on the north side were in approximate correspondence with each other, the orbits before and after these maximal deformations were drawn in different behaviors. It is presumably that because, as shown in Photo 4, the iron sheet was just placed, the motion before and after the maximum deformation was too fast to leave its orbit. The maximum deformation of the seismic isolation layer was 30cm, which shows that the seismic isolation layer was affected by the deformation to the extent of that predicted at the time of design. It also shows that the seismic isolation layer moved linearly in the direction of north-east.

Photo 4 Orbit of Building C

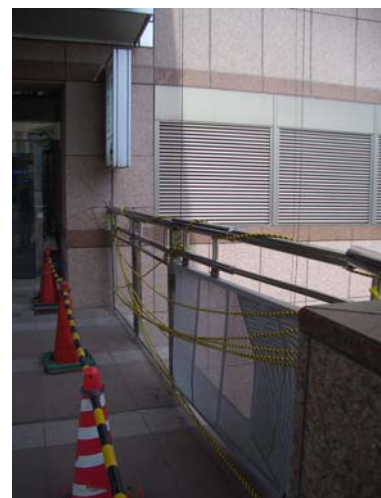
As shown by the appearance of the building in Photo 5, this is a large-scale hospital. The entrance bridge of the southern side is an expansion structure. However, the expansion part of handrail did not work well during the earthquake, and as that result, the handrail and exterior wall were damaged (Photo 6). From the observed acceleration record at the time of the earthquake, it is judged that this did not affect the seismic isolation capability of the building. An inpatient on the 6<sup>th</sup> floor said that she noticed the slow horizontal motion during the earthquake, but there was no damage or overturning of shelves. In an adjacent hospital ward, which is an earthquake-proof building, bookshelves overturned and cracks were generated in the wall. Photo 7 shows a displacement orbit drawn by an orbiter installed in the seismic isolation layer. The deformation volume of the seismic isolation layer was larger in the direction of south-north than east-west, and the deformation was repeating in approximately two cycles with the amplitude within the maximum displacement of 15 cm.

**Photo 6 Damage of Handrail of Expansion Bridge**

There were large accelerations which resonated from the earthquake which occurred off the west coast of Fukuoka Prefecture. Up to present, these were the greatest acceleration data ever recorded in Japan, affecting seismic isolated buildings in Fukuoka City. However, no extensive damage was reported in any of the buildings, thus it was verified that the seismic isolation members performed as anticipated. One building showed slight damaged to its seismic isolation clearance, and utmost attention should be paid in designing an expansion part.

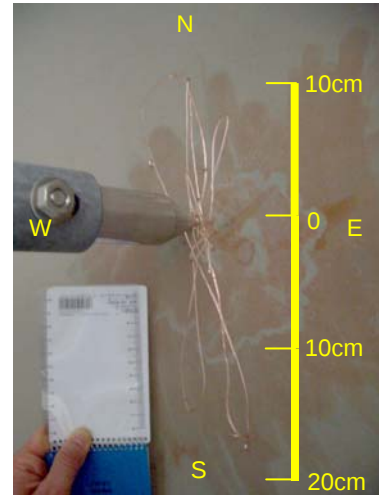
**Photo 7 Orbit of Building F**
