MOST IMPORTANT ACTIONS OF NUCLEAR POWER PLANT AT EARTHQUAKE ARE “STOPPING”, “COOLING”, “CONFINING RADIOACTIVE MATERIALS”

Motohiko Hakuno¹

¹ *Professor, Kogyokusha College of Technology, Tokyo, Japan
Email: hakuno@theia.ocn.ne.jp*

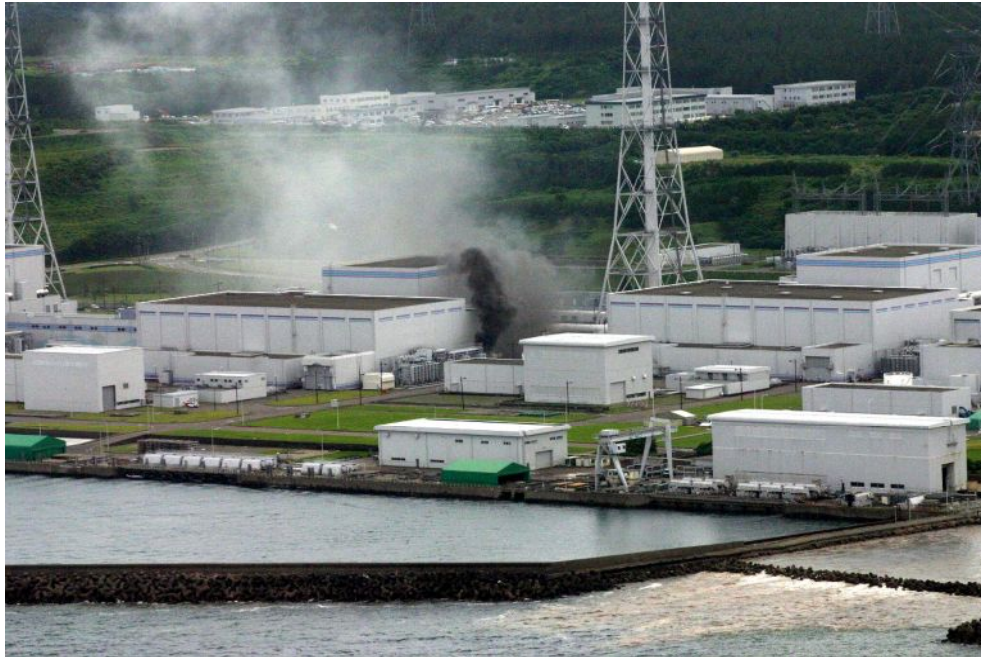
1. Fire of a transformer.

Figure 1 Fire of a transformer
by courtesy of 9th Regional Headquarters of Japan Coast Guard

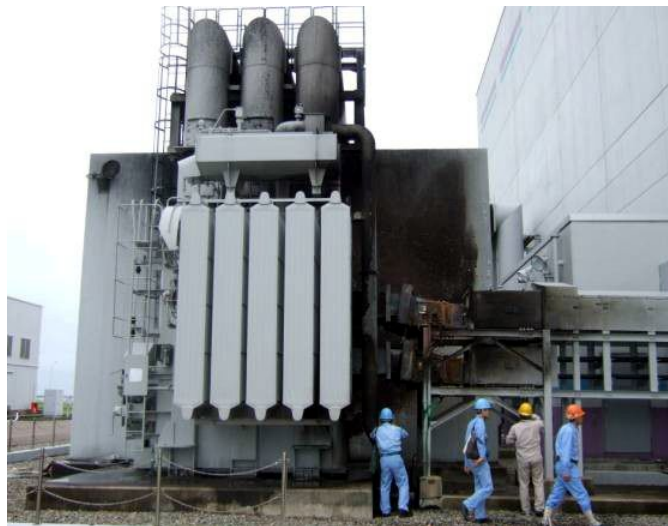
Figure 2 After the fire of the transformer
You can see the fire convention wall behind the transformer, change to dark color by smoking.
by courtesy of Tokyo Electric Power Co. (TEPCO)

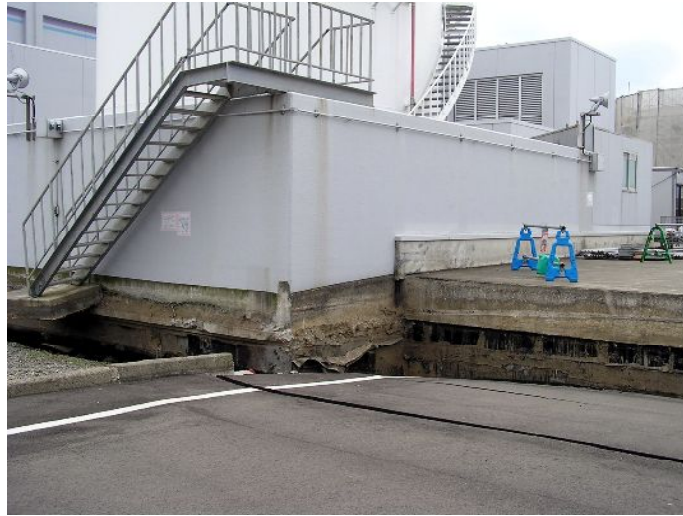
7. Subsidence of soft sand and ground.

Figure 3 Ground subsidence near the building
The building was supported on the bedrock.
by courtesy of TEPCO

Many damage occurred in Kashiwazaki Kariwa nuclear power plant are caused originally from the settle down of the backfilling soil. The buildings supported by the rock, did not suffer any damage by earthquake shaking, however, the cause of the fire of the transformer was the subsidence of the soil. Generally speaking, soft soil or ground is very weak against the earthquake. As a result, many damage occur in the facilities constructed on the soft soil or ground. A or B Class structures were constructed on the rock., therefore, they had almost no damage.

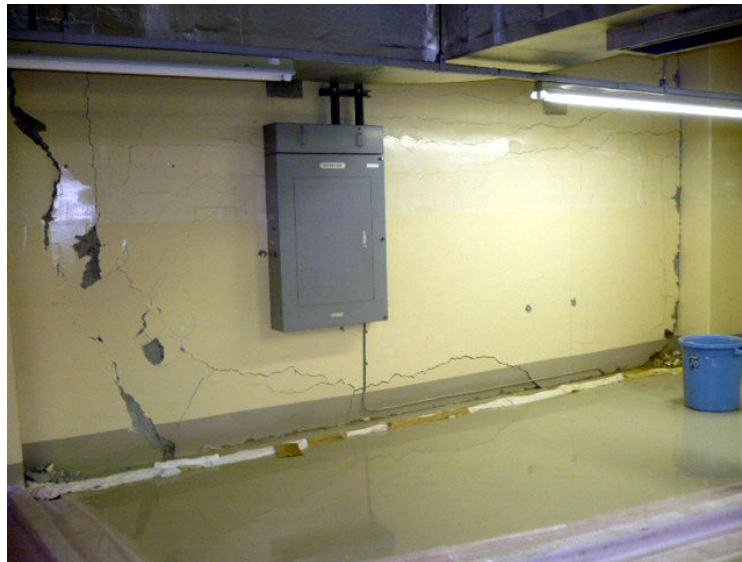
Figure 4 Cracks on the underground RC wall of a C class building produced by earth pressure
by courtesy of TEPCO

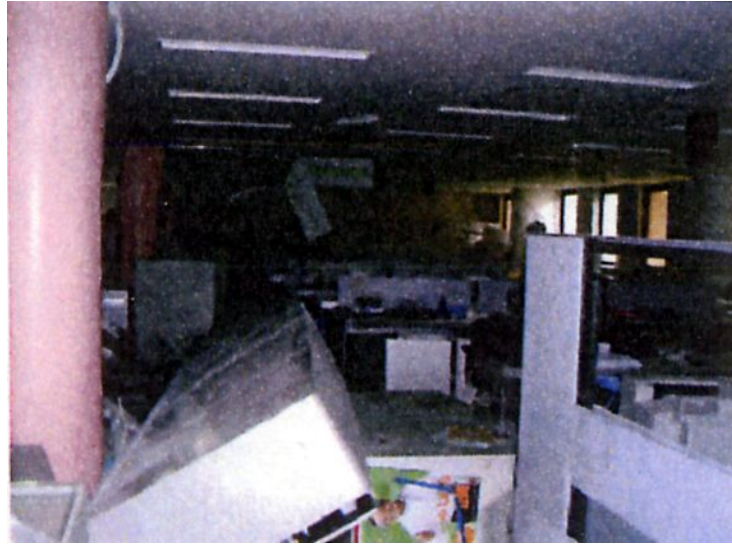
8. Various damage on the C class group.

Figure 5 Falling down of various things inside of a C class building
by courtesy of TEPCO

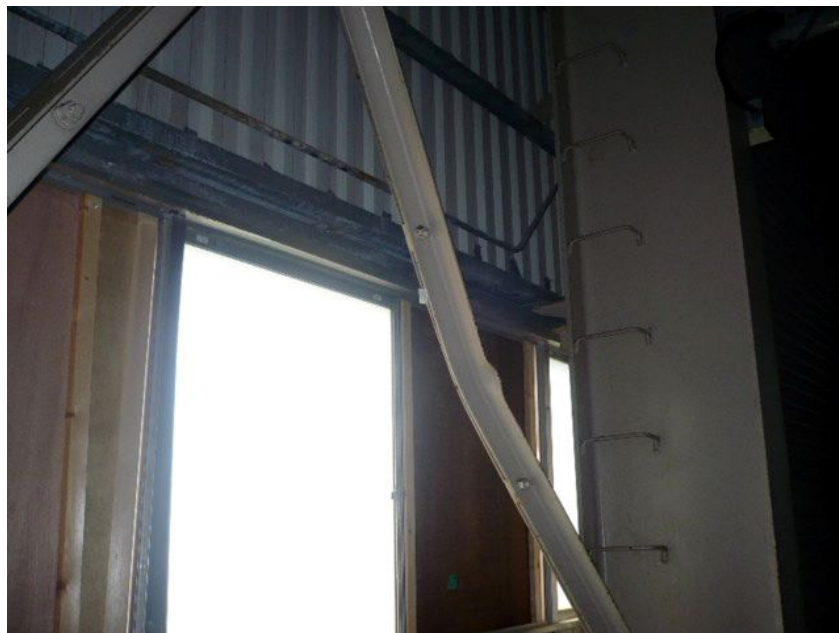
Figure 6 Buckling of a steel bracing in a C class building
by courtesy of TEPCO

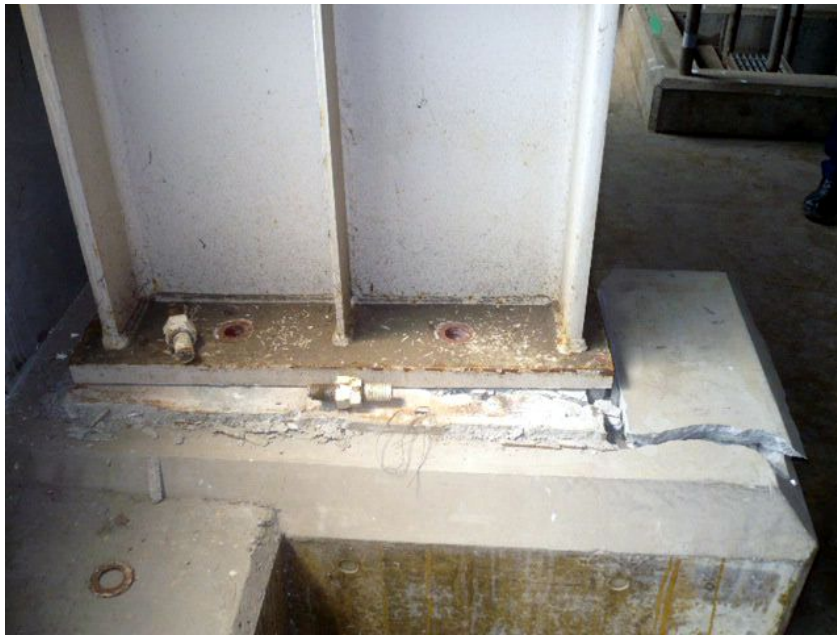
Figure 7 Damage of bolts in a C class building
by courtesy of TEPCO

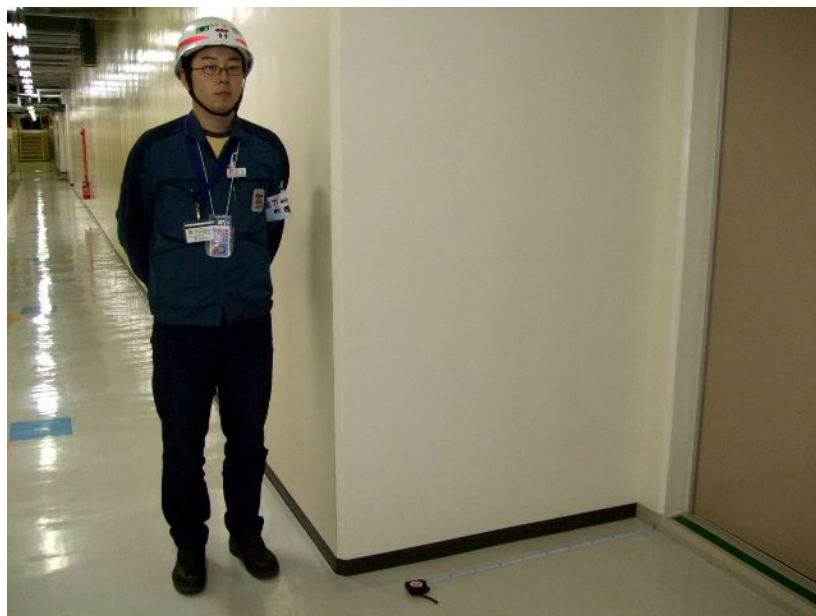
9. No damage on A class building.

Figure 8 RC wall 1.5m thick of an A class Reactor building
The thickness was decided by the earthquake force 0.48G, 3 times of C class building.
by courtesy of TEPCO

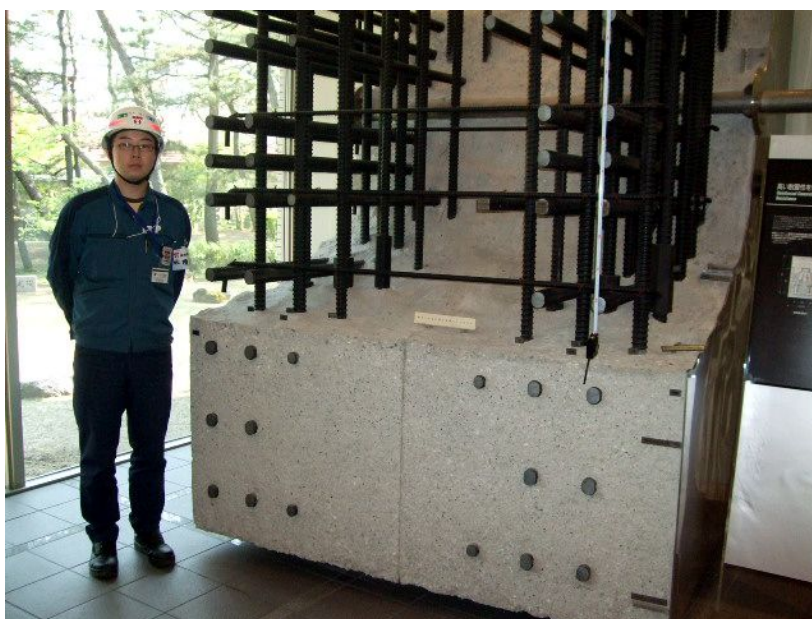
Figure 9 Reinforcing steel bars 51mm of diameter in the RC wall
A lot of steel bars give the facilities a lot of “ductility”.
by courtesy of TEPCO

Why did not the facilities in the plant have the damage due to 680gals ground motion ? I can point out the following reason. The facilities are designed so that the stress remains within the elastic range due to $3 \times C_1 (=0.48G)$ earthquake force. Even if the strain comes beyond the elastic range, it must remain within 2000 micro. The safety allowance of the strain is approximately 20 times of the elastic limit. This is a large amount of safety allowance. Therefore, even the C Class facilities designed for $1 \times C_1 (=0.16G)$ earthquake force, did not suffer severe damage, owing to the sufficient safety allowance(ductility). The ductility of RC structures comes from the amount of steel bars used.
