Investigation of Damage of Masonry Garden Wall by The Niigata-ken Chuetsu-oki Earthquake in 2007

Y. Nakamura¹, M. Urai² and K. Sato²

¹ Assistant Professor, Dept. of Architecture, Niigata University, Japan

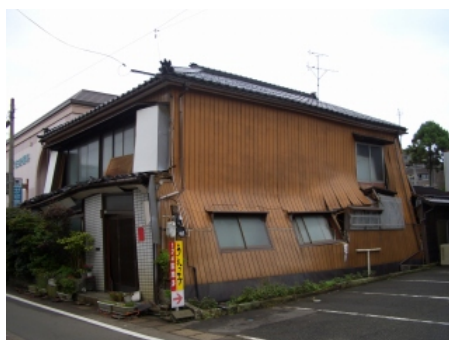
Photograph 4 Collapsed house (Kashiwazaki)

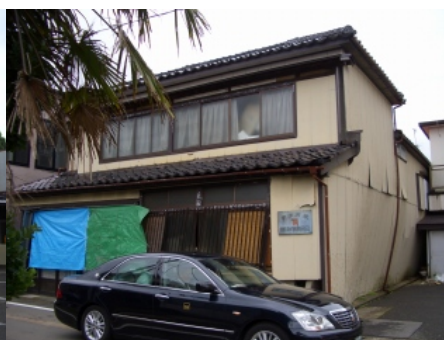
Photograph 5 Heavy damaged house (Kashiwazaki)

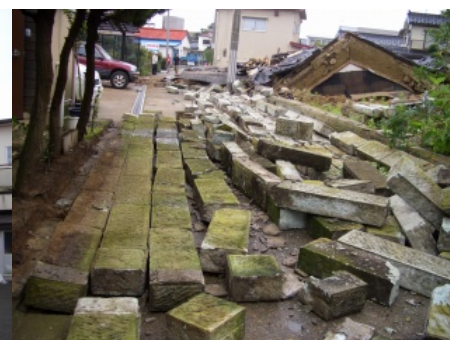
These two observation points are located on the Kashiwazaki local municipal office. Collapsed houses were observed around these points. Houses for combined residential and commercial use with opening front of a street were obviously damaged. Eighty percents stone masonry garden walls were falling down in this area. A concrete garden wall which was set reinforced steel bar and counterfort, was fallen by weak foundation. Damage of asphalt road surface was occurred. RC buildings in Kashiwazaki dai-ichi Junior high school which is about 0.5 kilometers from this point were moved individually. 17cm gap at expansion joint which connected two buildings was occurred. (Photograph 1-12)

Photograph 6 Collapsed stone masonry walls. The street completely blocked by with both side walls. (Kashiwazaki)

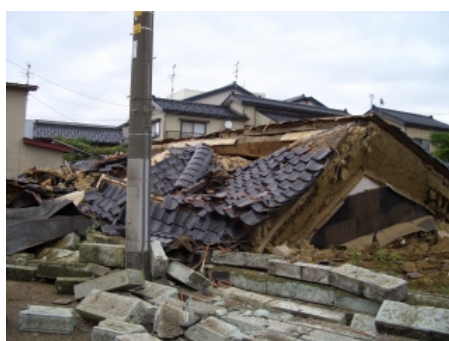
Photograph 7 Collapsed house and stone masonry wall (Kashiwazaki)

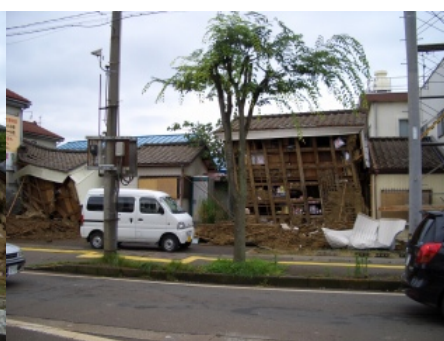
Photograph 8 Heavy damaged warehouse with mud wall. (Kashiwazaki)

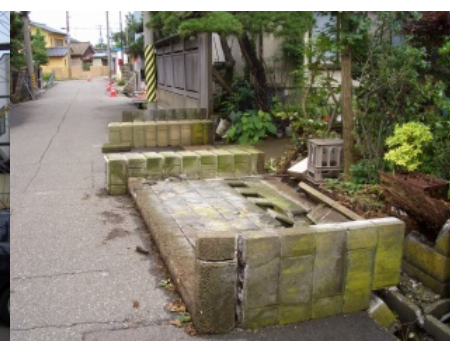
Photograph 8 Concrete block masonry wall with reinforced steel bar and counterfort falling (Kashiwazaki)

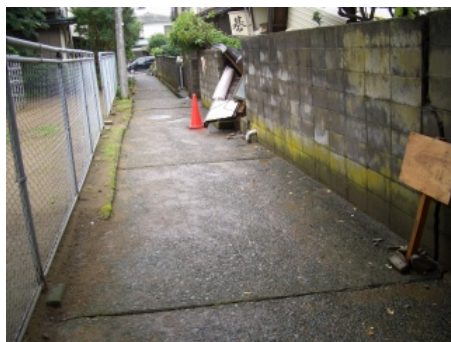
Photograph 9 Cracked block masonry wall and street surface. (Kashiwazaki)

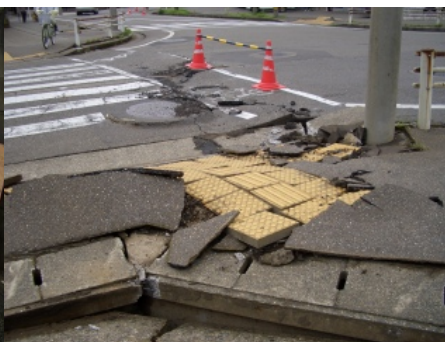
Photograph 10 Damage of asphalt road surface (Kashiwazaki)

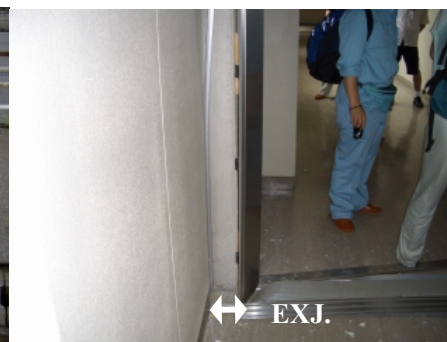
Photograph 12 A gap in expansion joint of Kashiwazaki daiichi Jr high school buildings. (Kashiwazaki)

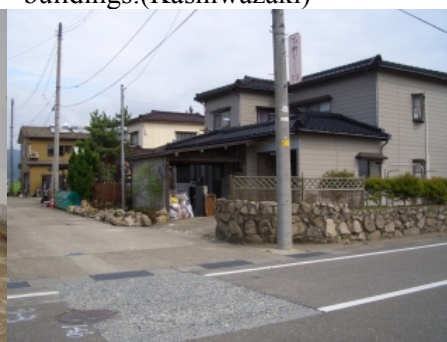
This observation point is located on the Kariwa public office. There is rice field around this point. There is not collapsed house. A two-story warehouse, a stone masonry wall and a lantern were collapsed. (Photograph 13-16)

Photograph 15 Collapsed stone masonry wall (Kariwa)

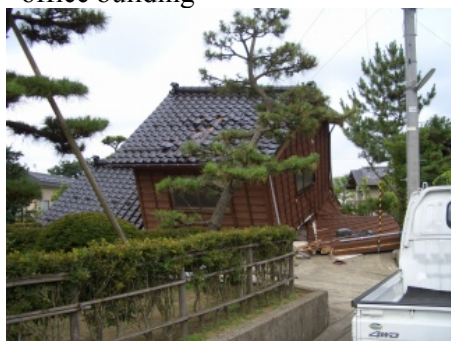
Photograph 16 Collapsed two story warehouse (Kariwa)

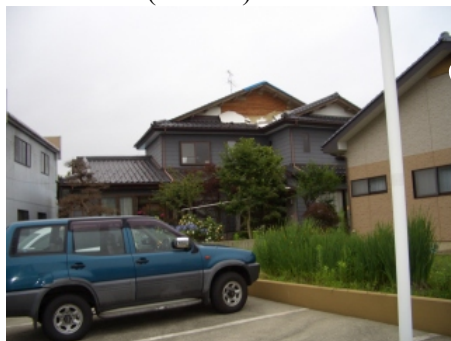
Photograph 19 Cracked gable surface of house (Nishiyama)

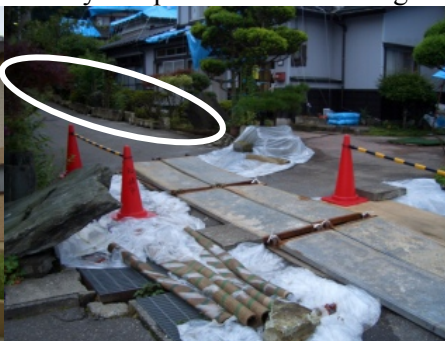
This observation point is located on the Nishiyama public office. Cracks in the ground and concrete block masonry wall leaning were occurred around this point.

Photograph 20 Concrete block wall falling and road surface gap (Nishiyama)

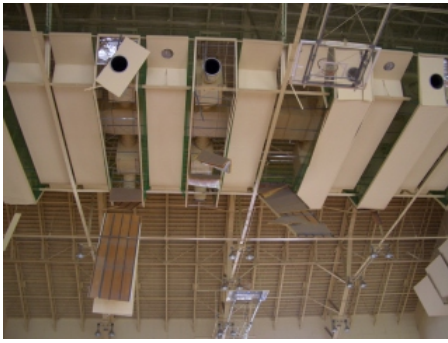
Ceiling panels of gymnasium in Nishiyama Junior high school which is about 0.5kilometers from this point, were fallen down. Cracks and Gap in the ground were occurred. There was inundation by water supply pipe damage. (Photograph 17-23)

Photograph 22 Damage of ceiling panel of gymnasium in Nishiyama Junior high school(Nishiyama)

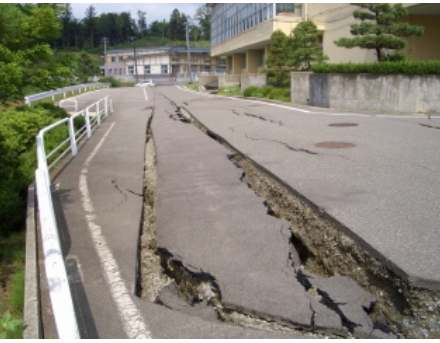
Photograph 23 Gap of asphalt surface front of Nishiyama Junior high school. (Nishiyama)

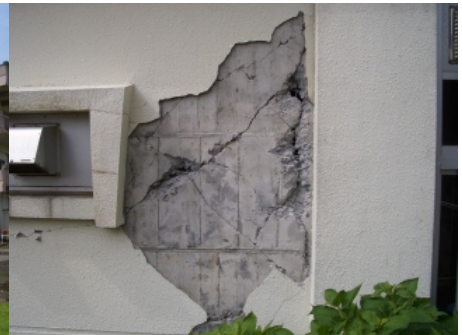
In Shimo-Oguni elementary school which about 2 kilometers from this point, a three-story RC building which was build in in1963 was damaged. This building was also damaged by the 2004 Niigata-Chuetsu earthquake and judged light damage by damage level classification. It became more severe damage by the Niigataken Chuetsu-oki Earthquake in 2007. There are shear failure columns and walls with opening. Six columns were damage class three and a column was damage class five. Walls with opening which were damage class four or five were observed.(Kato(2007)) (Photograph 24-28)

Photograph 27 Shear crack of wall of Shimo-Oguni elementary school (Oguni)

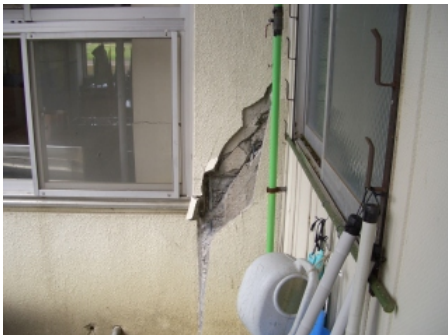
Photograph 28 Shear crack of column of Shimo-Oguni elementary school (Oguni)

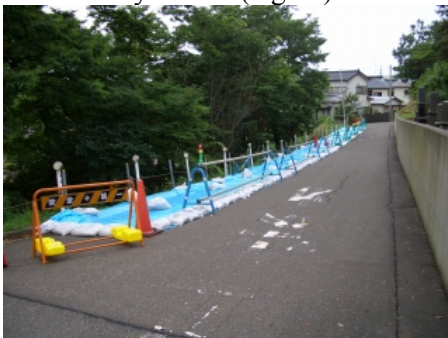
Photograph 31 Blue sheet was covered on the road by surface cracked(Kakizaki, Joestu)

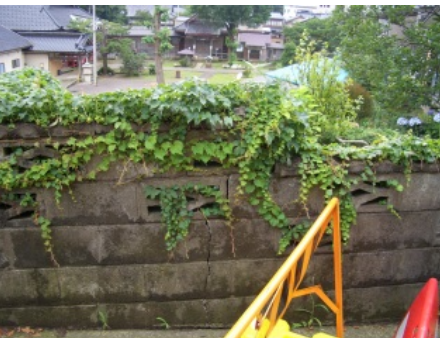
This observation point is located on the Kakizaki, Joetsu public office. This office is built on the hill. There is not remarkable office building damage but crack on the ground near office building was observed. Cracks of concrete block masonry wall and on the ground were occurred. (Photograph 29-32)

Photograph 32 Crack of concrete block wall (Kakizaki, Joestu)

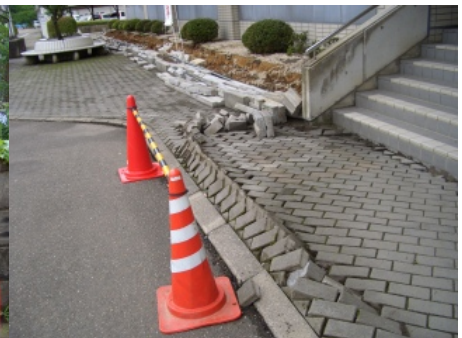
This observation point is located on the public welfare office near Yoshikawa, Joetsu public office. Server building damage was not around this point. Inter rocking blocks front of Yoshikawa, Joetsu public office were damaged. (Photograph 33)

Photograph 33 Damage of Inter Rocking Block(Yoshikawa, Joestu)
