## SEISMIC PERFORMANCES and TYPICAL DAMAGES OF BEAM-COLUMN JOINTS IN THE RC BUILDINGS

### ABSTRACT:

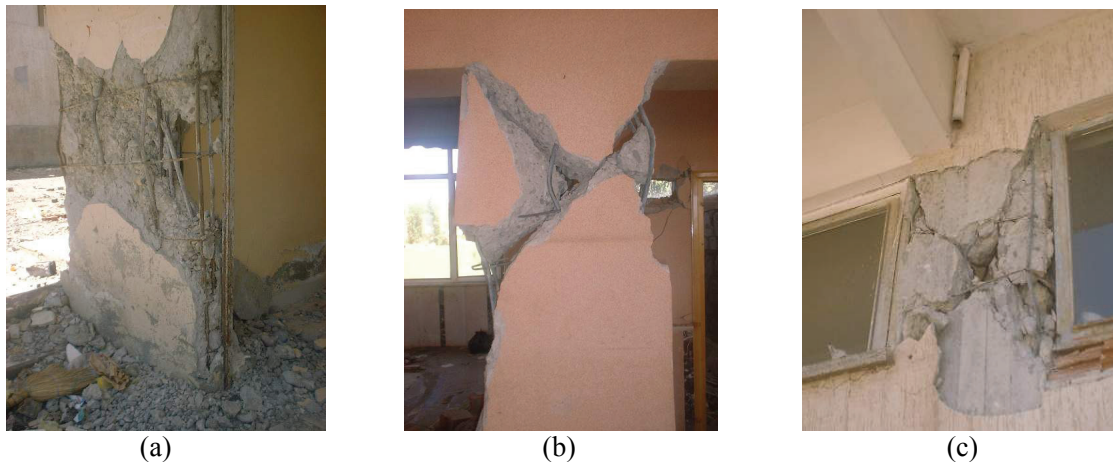
Figure 1      Some examples of earthquake damage  
(a) Poor quality concrete  
(b) Diagonal tension failure  
(c) Short column

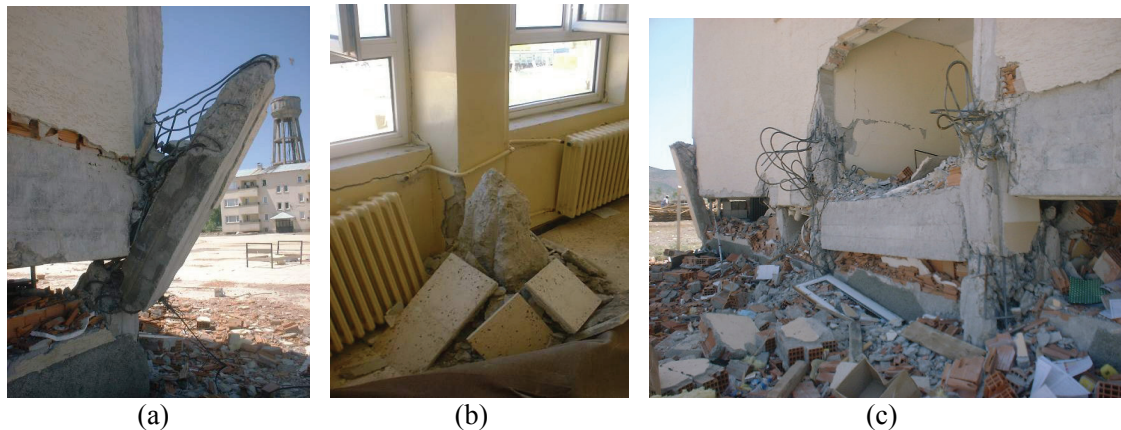
Figure 2 Examples of column-beam joint damages of an earthquake effect in vertical direction  
(a) Lack of proper anchorage and joint steel  
(b) Punching 1st floor slabs by ground floor columns  
(c) Weak column- strong beam and eccentric beam connection

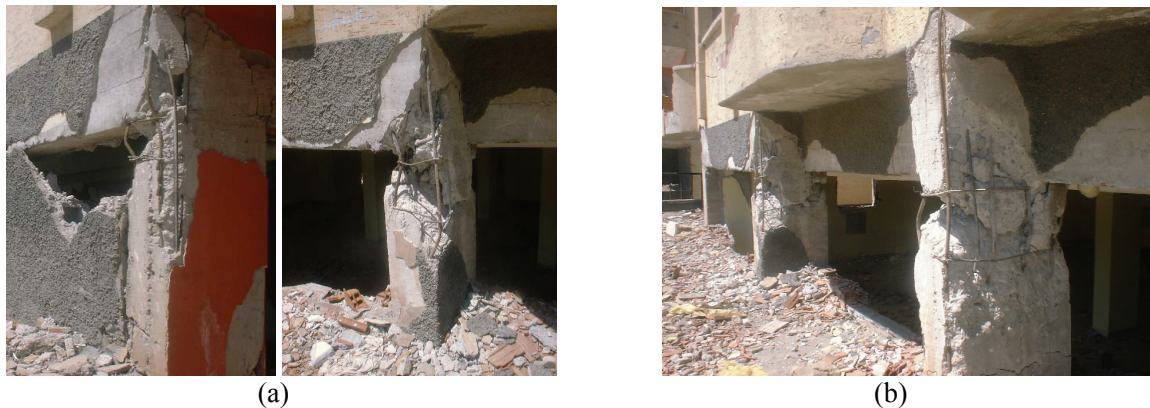
Figure 3

- (a) Lack of confinement steel in columns, inadequate reinforcement arrangement
- (b) Eccentric continuous beam connection, diagonal torsion (tension) failure of a column
