# LESSONS LEARNT FROM REPAIR PROJECT OF 300 BUILDINGS DAMAGED IN DARB-E-ASTANEH, IRAN EARTHQUAKE OF MARCH 2006

In 31<sup>st</sup> March of 2006 an earthquake of 6.1 magnitude hit the Silakhor plain in Lorestan Province, Iran, which affected cities of Boroojerd and Dorood, and created damage in hundreds of building, including houses in these two cites and their neighboring villages. 'Behsazeh-Andishan Aria Consulting Engineers' has been chosen as one the consulting firms for seismic evaluation and retrofit or repair design of damaged buildings, and has been responsible for around 300 buildings in Boroojerd. Most of these buildings were of non-reinforced masonry and semi-skeleton type. At first, seismic evaluation of buildings was performed and then, an estimation of repair costs was done for each case so that the owner of the building can make decision on doing the full repair, doing just minor repair, or demolishing the building. Because of time pressure, and very high number of buildings, doing test on the existing materials was not possible, and this led in some decrease in the precision of seismic evaluation, and therefore the repair design was decided to be conservative to som

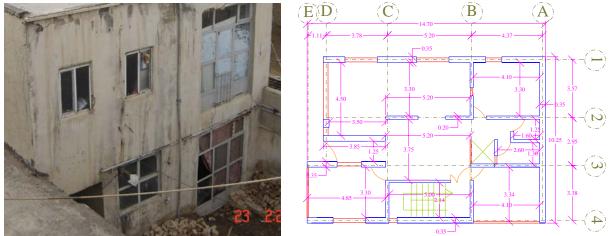
Figure 1. A view of the sample building and its architectural plan

This selected sample building is a 2-story masonry building for residential use of around 10 people. The load bearing system is consisted of just walls without any horizontal or vertical ties. To show briefly the vulnerability of this building Figures 2 and 3 show the plans of ground and first floor of the building along with the observed damage at each wall. On this basis the strength of the building has been estimated.

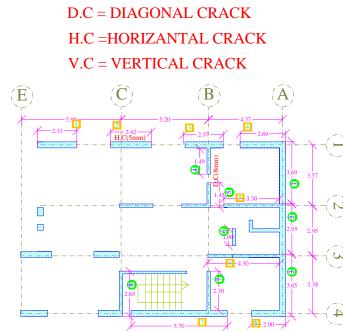
D.C = DIAGONAL CRACK H.C =HORIZANTAL CRACK V.C = VERTICAL CRACK

Figure 3. Plan of the 1<sup>st</sup> floor of the sample building, and the observed wall damages

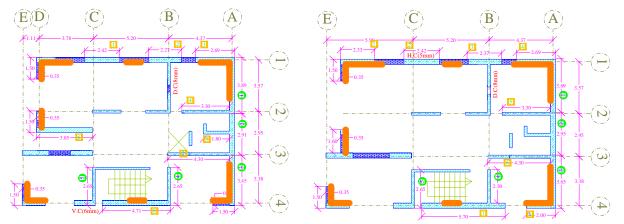
Figure 4. The locations of shotcrete construction at the building's walls

It can be seen in Table 2 that adding the walls' strength (by steel mesh and shotcrete) has the most advantages in removing the deficiencies and providing the required conditions for the sample building. The locations of shotcrete construction are shown in Figure 4.

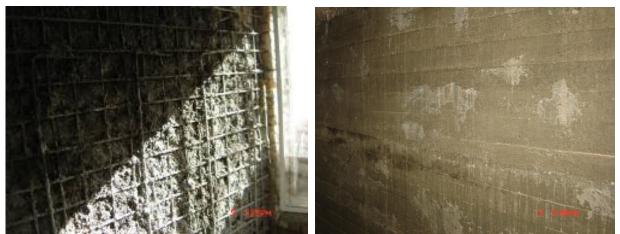
Figure 5. Sample of shotcrete construction, steel mesh (left) and the finished surface (right)

It should be noted that there were some cases that the wall area was not enough based on the shear resistance calculations. In such cases, at first the wall area has been added by brick masonry, and then the shotcrete has been constructed. Figure 5 shows the sample of shotcrete construction.

The diameter of steel bars of the mesh has been 6 mm in this case, and the thickness of concrete cover has been 50 mm. If the require shear strength can not be provided by shotcrete on one side of the wall the other side is used as well. The calculation of shear strength of the retrofitted walls is done by using the following simple formulas.

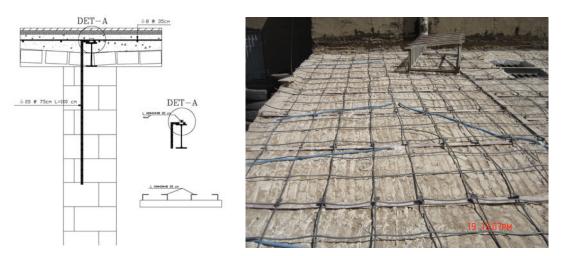
Figure 6. Connection details of added roof slab to the walls (left), and the slab construction (right)

Figure 6 shows the details of connection of added reinforced concrete slab at the top of the building roof with the walls, and also the top slab under construction.

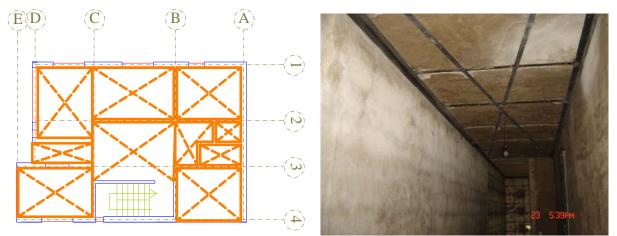
Figure 7. Locations of steel diagonals and frames at floors (left), and their construction (right)

Figure 7 shows the locations of added diagonal steel profiles for increasing the floor diaphragms integrity in the plan of the building and a sample of constructed steel diagonals.

It should be noted that to add steel diagonals it is necessary to add some steel frames as well, as shown in Figure 7, and these steel frames should be also connected together by passing them through the walls' corners. With regard to modification of openings Figure 8 shows how the brick masonry has been added to the existing walls at edges of openings, and also at those places where the wall thickness has not been enough.

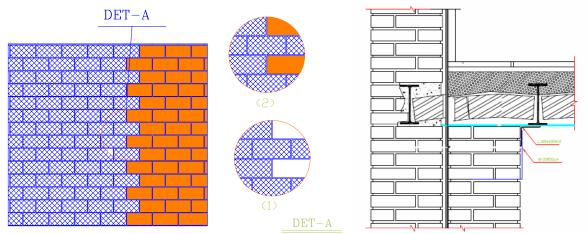
Figure 8. Wall addition for modification of opening edges with completer connection to the existing wall (left)and also the places where the wall thickness has not been enough (right)

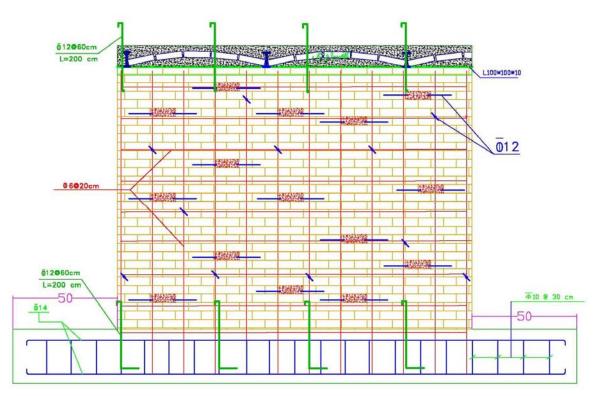
Figure 9. Adding reinforced concrete ties beneath the wall and connecting the wall masonry to it and to the floor

Figure 9 shows the modification of the wall foundations by adding reinforced concrete ties beneath the walls and connecting the wall masonry to it.

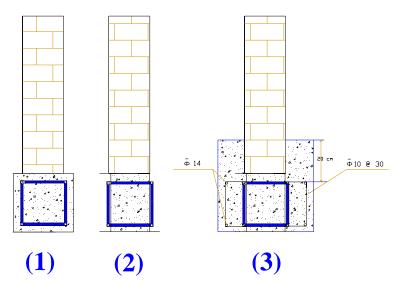
Figure 10. Addition of ties beneath the walls by passing the steel bars trough the wall and adding some more concrete around it

Also Figure 10 shows how the ties have been added beneath the walls by passing the steel bars trough the wall and adding some more concrete around it. This part of retrofit constriction is one the most deliberate parts, since it needs to remove the materials under the walls and if it is not done with enough care it can cause serious damages to the wall and the whole building, as the walls are under the vertical loads and there is not way to transfer the vertical loads to somewhere else.
