## PERUVIAN SEISMIC DESIGN PRACTICE PRODUCED UNDAMAGED BUILDINGS IN PERU'S LATEST EARTHQUAKES

J.R. Pique<sup>1</sup> and R. Salinas<sup>2</sup>

**The 14<sup>th</sup> World Conference on Earthquake Engineering**  
**October 12-17, 2008, Beijing, China**

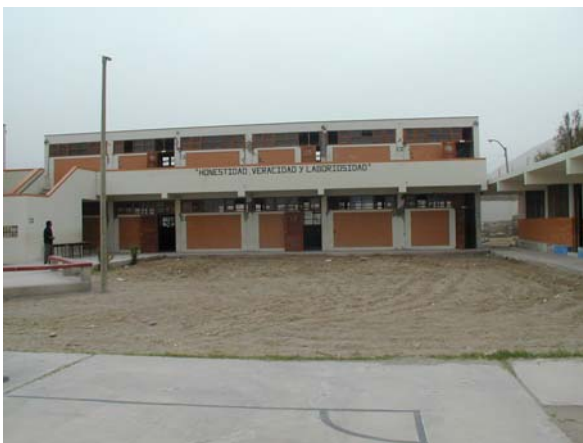
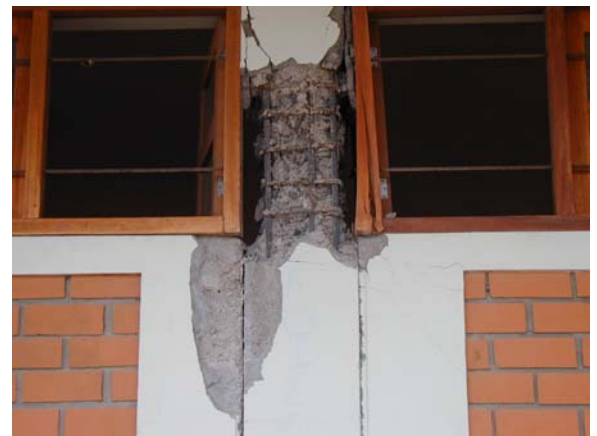
All these schools experienced the 21 June 2001 earthquake. All those designed with the 1977 standards suffered damage. In most cases related to short column behavior, in spite of a seismic separation specified in blue prints and actually built. Evidence of excessive lateral displacement could be observed in most cases, although designs comply with the current Standard at the time. As seen all in other seismic areas damage is related to excessive deformation. Photographs shown in Figure 8 shown the type of damage observed in these schools.

Figure 8. Damage to building designed using 1977 Standard.

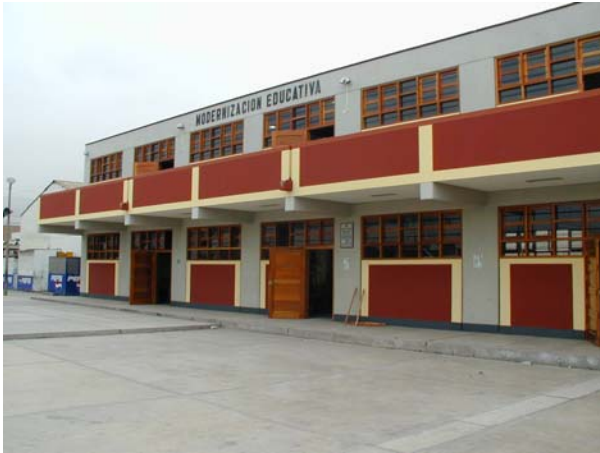
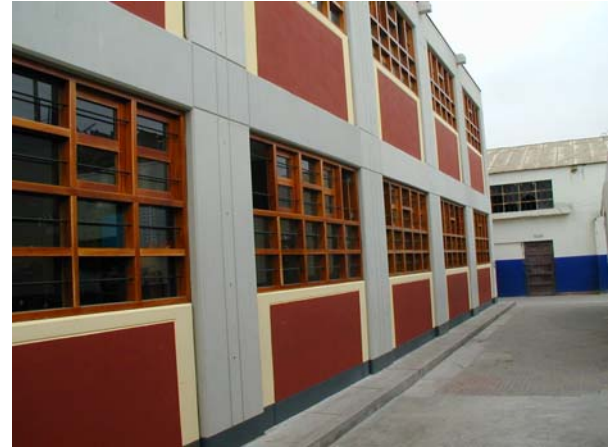
None of the schools in the region designed and built under the 1997 Standard suffered damage at all. Stiffness was larger enough as to make seismic separation unnecessary. Figure 9 shows post earthquake condition of these schools.

Even when peak ground acceleration must have been higher than design acceleration (record showed above with almost 0.3g was registered 100km south from Arequipa region where schools were located, even further from epicenter) , there was no damage and the schools continue to operate unharmed.

Figure 9. Post earthquake condition of school building designed using 1997 Standard.

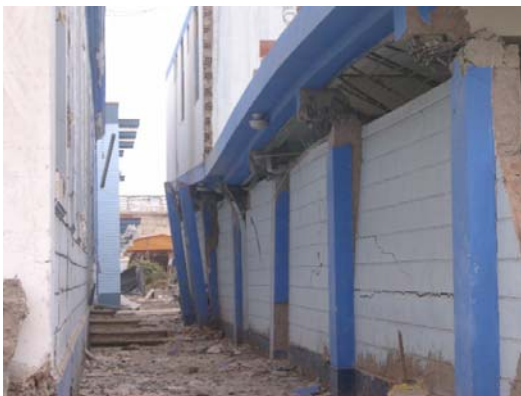
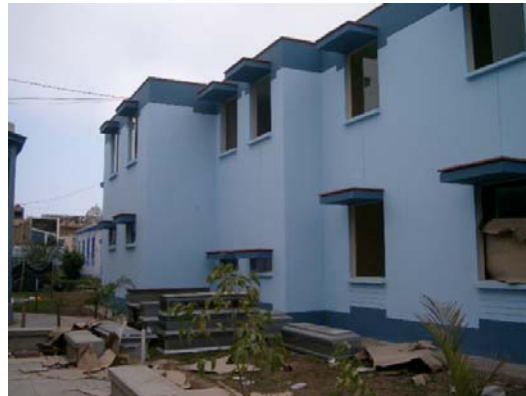
Again we have observed (Salinas et al, CISMID 2007) buildings design and built with older standards have suffered extended damage and collapse. Figure 10 and 11 show two hospital facilities that had to be demolished after Pisco earthquake. In Figure 10 (right) a pavilion at the same hospital, but designed and built with latest seismic standards has no damage at all, even for the intensities reported. Structure has a higher wall density, in order to comply with stiffness requirements.

Figure 10. “San Juan de Dios” Hospital, Pisco. Left: Old Pavilions, Right: New pavilion, designed with latest seismic standards

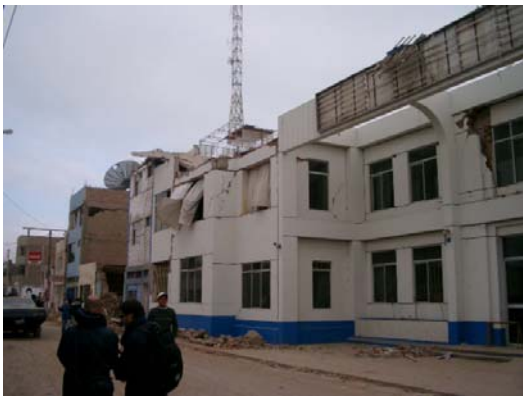
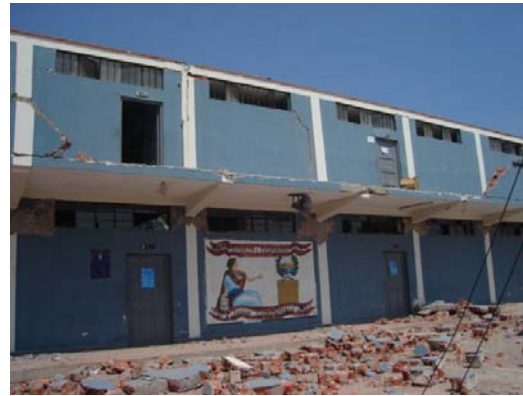
Figure 11 shows another hospital building, this from the social security and a school building, both designed with older standards and heavily damaged. On the other hand, in the same city of Pisco, new school buildings designed and built with 1997 and 2003 standards with no damage whatsoever.. Figure 13 shows a typical structural plan of these school buildings (Miranda et al, 2005). The structure is confined clay masonry in one direction and a frame with wide columns in the other. Older designs used slender columns which resulted in a flexible structure with large displacements. Because stringent limited displacements new designs had a need of more rigid columns which resulted in reduced displacements. These show excellent response.

Figure 11. Antonio Skrabonja Social Security Hospital. School building, non structural and structural damage. 1977 design standard. Pisco

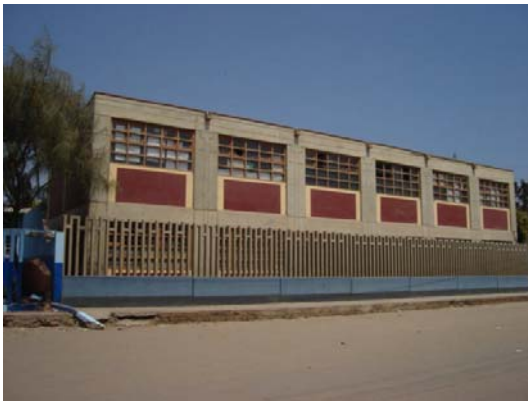
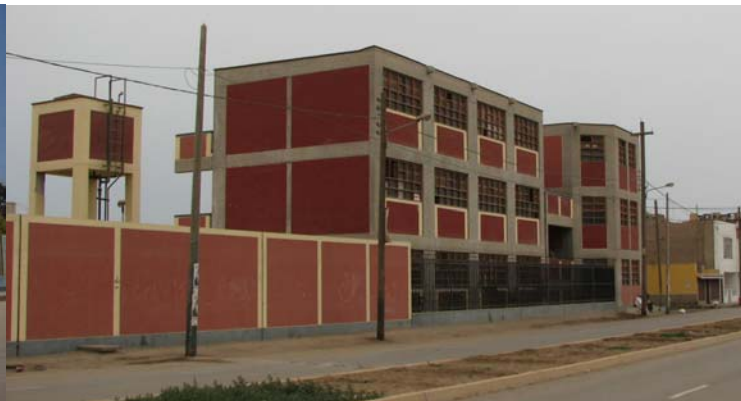
Figure 12. New school pavilions in Pisco. 2003 design standard. No damage.
