VULNERABILITY ASSESSMENT IN EDUCATIONAL BUILDINGS – INFERENCE OF EARTHQUAKE RISK. A METHODOLOGY BASED ON SCHOOL DAMAGE IN THE JULY 9, 1998, FAIAL EARTHQUAKE IN THE AZORES

M.A. Ferreira¹, J.M. Proença² and C.S. Oliveira³

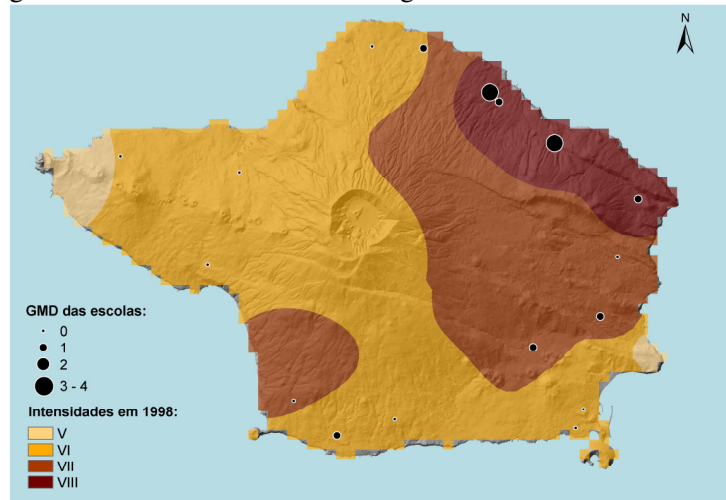
The detailed scenario illustrated in Figure 2 shows different levels of earthquake intensity obtained from Faial event. With this intensity values and knowing each vulnerable index was possible to obtain results similar of the referenced from post-earthquake inspection data; a mean damage grade, $\mu_D=3$ and $\mu_D=4$, was obtained for the intensity VIII as observed after the earthquake. These two schools with mean damage grade equal to 3 and 4 consists in unreinforced masonry buildings with manufactured stone units and traditional constructions (rubble

stone), respectively, having little resistance to lateral loading which increases the chances of collapse.

Figure 2 Isoseismal map of the 9 July 1998 Faial earthquake and mean damage grade

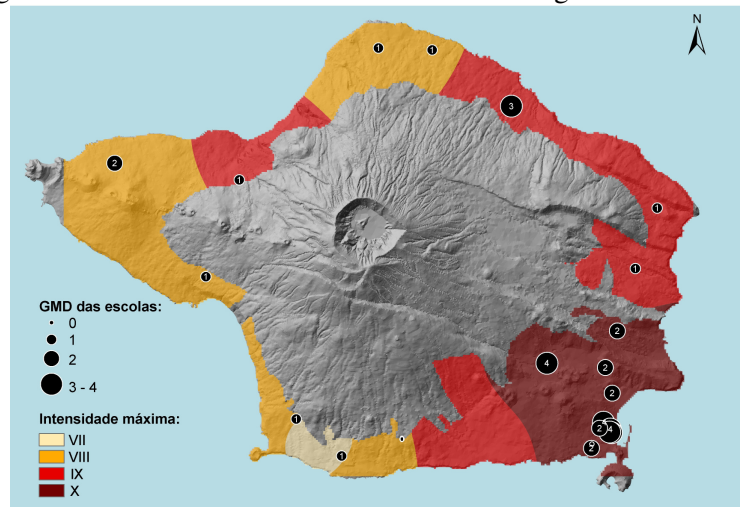
Table 4 and Figure 3 refer the mean damage grade that could occur in each school building considering the maximum intensity for each locality.

The city of Horta and considering a maximum intensity X must be expected very heavy damages ($\mu_D=4$, heavy structural damage and very heavy non-structural damage) due to a high percentage of buildings of high

vulnerability. We conclude that both the variation in building types as well as local soil conditions significantly affect the mean damage grade and should be taken into account in damage scenario modelling.

Figure 3 Mean damage grade assuming maximum intensities
