## DYNAMIC BEHAVIOR OF ADOBE HOUSES IN CENTRAL MEXICO

### ABSTRACT:

Inside the towns of Zacatepec, Coyoacán and Tlayacapan exists adobe houses damaged by earthquakes. In Zacatepec typical adobe house was chosen in order to determine their dynamic behavior experimentally *in situ*. A reproduced model 1:10 was tested on vibration table, reproducing seismic ground motion caused by an earthquake at that period.

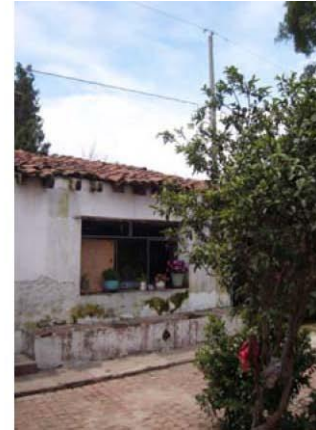
Fig. 2. Adobe house, Zacatepec; Puebla.

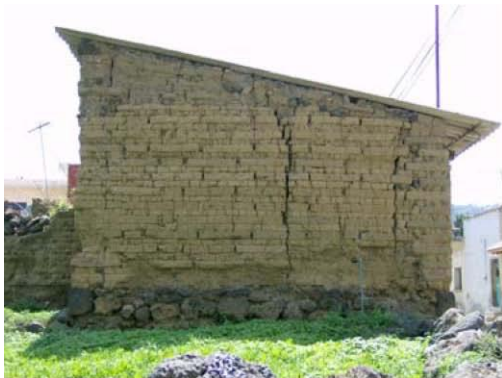
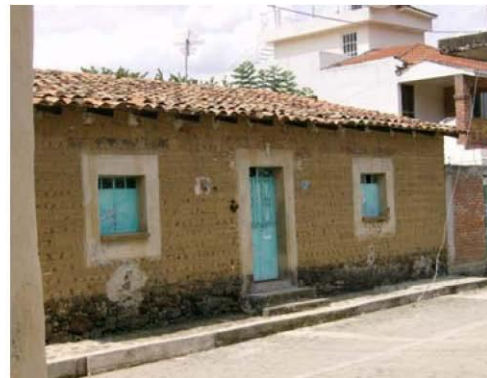
In Tlayacapan, we found a house with two vertical cracks (Fig. 11) and have no columns, beams and frames in window and door and reflecting self- building. A house with a wall of stone in its base of 0.5m to 1m thick, the adobe blocks with a long between 45 and 50 cm, which gives them good stability to adobe walls, roofs with tiles or sheets (prior coverage insulating material) and wooden beams (figure 12).

Figure 11.- Adobe house in Tlayacapan, presents vertical cracking, there are not beams or columns. A short wall with frames on doors and windows and in its base of stones in base is not sufficient, in supports the house with stones about 50 cm high. The roof is with tiles on foot. Its roof is laminate.

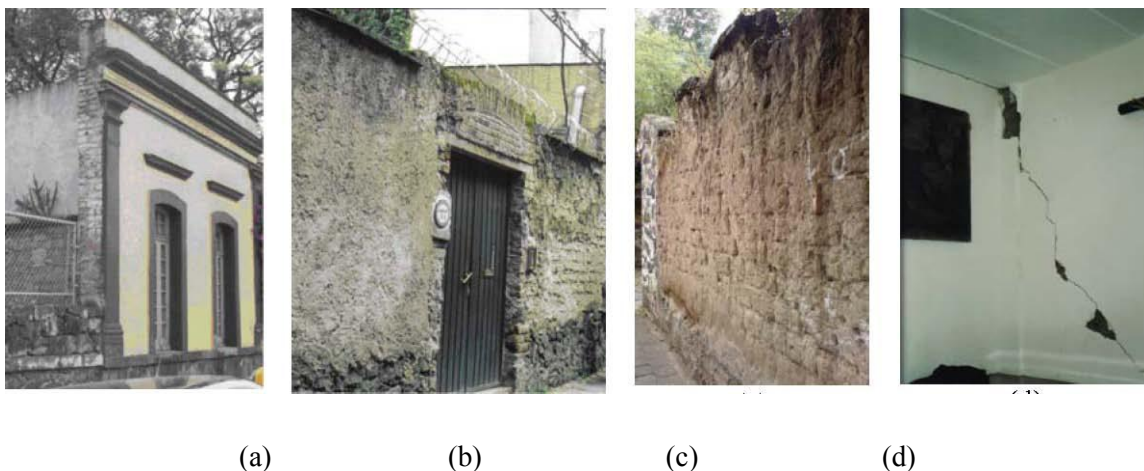
The adobe house showed in Fig 13(a) have a good state of preservation, as well as the presence of wall in its base and frames to doors and windows made of stone, also shows coverage and flattened in good condition in the façade

Figure 13.- Adobe houses in Coyoacán D.F.. (a) The first photo shows a good coverage of cement in its façade. (b) The facade neglected, without frames in its door. These houses have a wall in its base with stones near 1 m. (c) It is a fence made of adobe without columns, only a short wall of stones in its base. (d) Shows a diagonal crack in its interior as in its exterior. in the room with adobe walls (church “La Conchita”).

The house in the Fig 13(b) is in a state of neglect, but not manifests a state conservation severely damaged from its facade. Like the previous houses presenting stone at the base of their walls. It is appreciated that the construction of adobe walls is reinforced by a column of brick to be located between two orthogonal adobe walls. Despite the damage to the flattened, the structure of the exterior walls of the house shows no significant damage as mud cracks.

In the Fig 13(c) a wall of stone at the base, however a lack of columns at one end of the wall, just where the property ends on the street. It has in certain places in the top of the wall, coverage for the rain. Some parts of the wall are leaning. At the base of the walls there is a minor than 50cm high of stones. The case of fences made of adobe, not showed the existence of a column that shared the wall of stone and adobe.

In the Fig 13(d) presents a room damaged by a diagonal crack of tension in the adobe wall viewed in its interior as in its exterior (Church “La Conchita”), because of the slight sinking of its sacristy.
